Izbira najprimernejšega utrjevalca pri obnovi Langusovih stenskih poslikav v cerkvi Marijinega oznanjenja v Ljubljani

Izvirni znanstveni članek

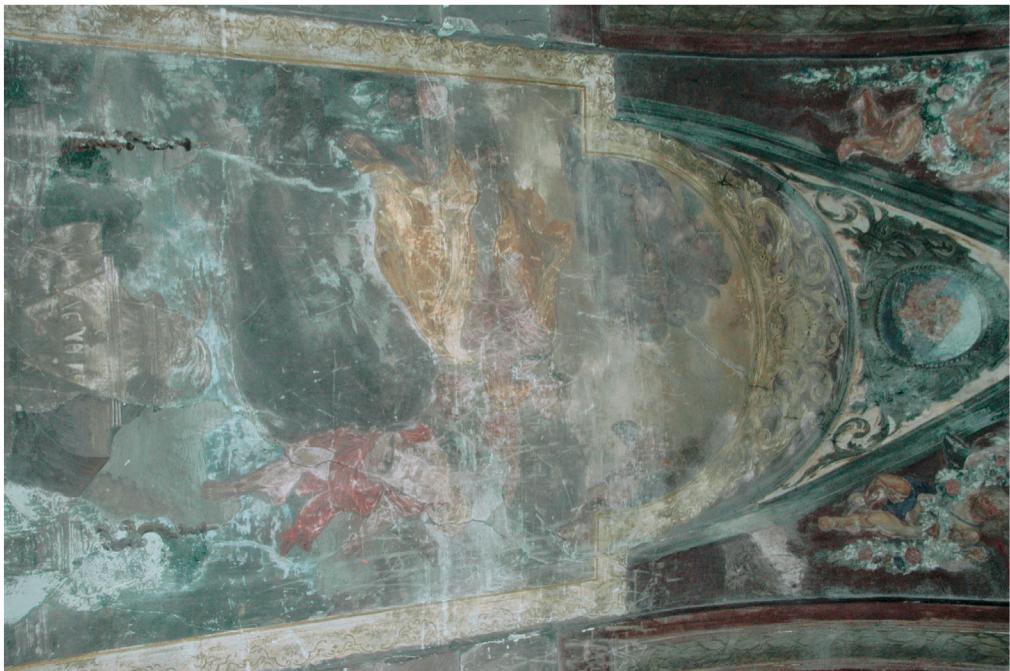
tudi poškodbe slikarske plasti, ki so nastale zaradi neprimernega mehanskega čiščenja; ponekod je morala biti poslikava agresivno čiščena z neprimerimi sredstvi oziroma orodji, kar ji daje videz zmečkanine (sl. 1).

1. M. Langus, cerkev Marijinega oznanjenja, stenska poslikava, last: RKC; detalj na južni steni kapele sv. Lucije, Apolonije in Agate; neprimereno čiščenje; videz zmečkanine na barvni površini (foto: arhiv ZVKDS RC)

M. Langus, Church of the Annunciation, wall painting, property: RC Church; detail on the south wall of the chapel of St Lucy, St Apollonia and St Agatha; unsuitable cleaning; appearance of bruising on the painted surface (photograph: ZVKDS RC)

Besides overpaintings and retouchings that in the meantime have darkened or otherwise altered, we can also observe damage to the pictorial layer that has occurred as the result of unsuitable mechanical cleaning; in places the painting must have been aggressively cleaned using unsuitable agents or tools, which gives it a bruised appearance (Fig. 1).

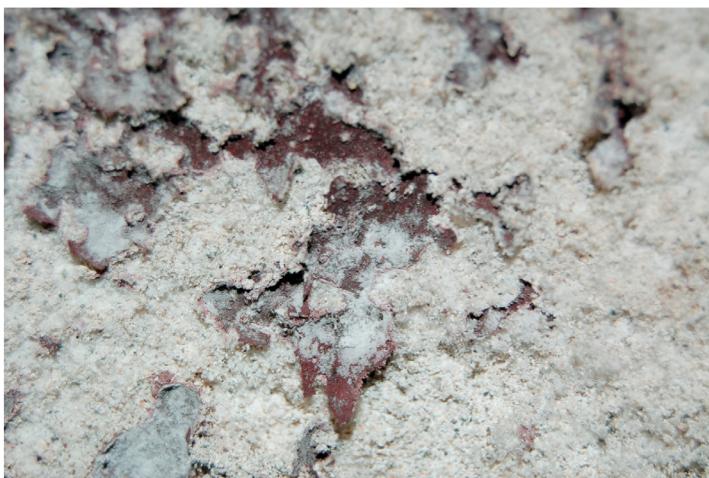
Topne soli v tleh ob temeljih ali v materialih v zidu z vodno raztopino potujejo skozi steno v omet in skozi omet na površino slike (sl. 2). Pojav sulfatizacije oziroma kristalizacije sulfatnih soli na stenskih poslikavah v kapelah je bil zelo razširjen in prisoten pri vseh vzorcih,

2. M. Langus, cerkev Marijinega oznanjenja v Ljubljani, kapela sv. Lucije, Apolonije in Agate; detalj; pojav kristalizacije topnih soli na barvni površini (foto: arhiv ZVKDS RC)

M. Langus, Church of the Annunciation in Ljubljana, chapel of St Lucy, St Apollonia in St Agatha; detail; crystallisation of soluble salts on the painted surface (photograph: Archives of the ZVKDS RC)

Soluble salts present in the ground at the level of the foundations or in the materials in the wall travel with an aqueous solution through the wall into the plaster, and through the plaster to the surface of the painting (Fig. 2). The phenomenon of sulphation – the crystallisation of sulphate salts – was very widespread in the wall paintings in the chapels and present in all the samples taken from various sections of painting. Sulphate corrosion, identified in all the samples taken, had gradually penetrated from the surface towards the interior of the painted material. The reaction was very probably caused by high levels of air pollution in 1980s and 1990s.

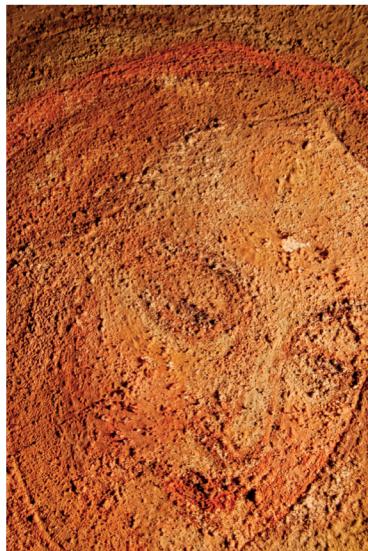
Kalcitne površine umetniških predmetov, kot na primer stenske poslikave in kamniti kipi, so večinoma zelo izpostavljene propadanju. Med najbolj škodljive naravne dejavnike, ki vplivajo na propadanje barvnih slojev stenskih poslikav v notranjosti cerkva, spadajo nihanja temperature in relativne vlage, ki imajo za posledico kondenzacijo vlage na površini predmetov. Zaradi žveplovega dioksida v zraku, ki je vodotopen, je kondenzacijska vlaga na površini rahlo kisla in topi površinski sloj. Ob izsuševanju pride v prvi fazi do izločanja kalcijevega sulfita, ki z oksidacijo preide v kalcijev dihidrogen sulfat (sadro). Omenjena mineraloška pretvorba kalcita v sadro se manifestira v zmanjšanju vezivnosti in upraševanju površine (Ropret, 2008) (sl. 3).

3. M. Langus, cerkev Marijinega oznanjenja v Ljubljani, kapela sv. Lucije, Apolonije in Agate; detajl Marije: pojav upraševanja/pulverizacije pigmentov na barvni površini (foto: arhiv ZVKDS RC)

M. Langus, Church of the Annunciation in Ljubljana, chapel of St Lucy, St Apollonia in St Agatha; detail of the Virgin Mary; pulverisation of pigments on the painted surface (photograph: Archives of the ZVKDS RC)

The calcite surfaces of works of art such as wall paintings and stone sculptures are more often than not very exposed to decay. The most harmful natural factors causing the decay of the paint layers of wall paintings inside churches include fluctuations of temperature and relative humidity, the consequence of which is the condensation of moisture on the surface of the artworks. As a result of the sulphur dioxide in the air, which is water-soluble, the condensation on the surface is slightly acidic and dissolves the surface layer. As it dries, a first phase of deposition of calcium sulphite occurs. With oxidation, this then becomes calcium dihydrogen sulphate (gypsum). The mineralogical conversion of calcite into gypsum is manifested in a reduction of adhesiveness and pulverisation of the surface (Ropret, 2008) (Fig. 3).

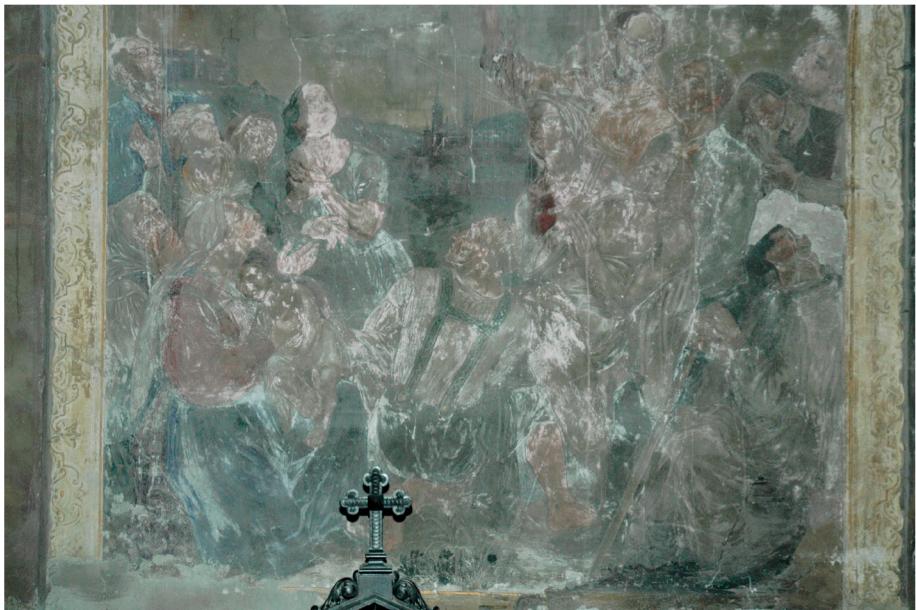
V preteklosti so notranjost cerkve vsakodnevno ogrevali z neprimernimi grelnimi telesi. Snov, ki nastaja pri izgorevanju grelnih teles, se je več let nalagala na površino barvne plasti. Na barvno plast in med razpokami so se usedale tudi saje od gorenja sveč. Plast nečistoče oziraoma sajasto prašne umazanje je dala poslikavi spremenjen, temačen in nejasen videz, ki je ponekod spominjal na negativ (sl. 4). Določeni deli poslikave so zaradi potemnelosti izgubili prvotno globino in so delovali zelo ploskovito. Vse kasnejše preslikave so bile za odtenek ali nekaj odtenkov temnejše. Potemnele so lahko zaradi sprememb pigmentov, bolj verjetno pa je, da se je na nerestavriranih predelih nadaljeval proces propadanja in odpadanja mikrodelcev barvne plasti, kar je posledično povzročilo svetlejši videz poslikave, saj je na površje prosevala svetla barva intonacca. Ker je kondenzacijska vlaga na površini topila površinski sloj, so se v strukturo samega barvnega sloja na površini ujeli tudi prašni delci iz zraka, kar je povzročilo temnenje celotne površine.

4. M. Langus, cerkev Marijinega oznanjenja v Ljubljani, kapela sv. Lucije, Apolonije in Agate; detajl na severni steni; pojav negativnega videza in temnenja barvne površine (foto: arhiv ZVKDS RC)

M. Langus, Church of the Annunciation in Ljubljana, chapel of St Lucy, St Apollonia in St Agatha; detail on the north wall; »negative« effect and darkening of the painted surface (photograph: Archives of the ZVKDS RC)

In the past the interior of the church was heated using unsuitable sources of heat. The substance that forms during combustion in these sources of heat was deposited on the surface of the paint layer for several years. Soot from candles also settled on the paint layer and between cracks. The layer of dirt or sooty dust gave the painting an altered, dim and indistinct appearance that in places was reminiscent of a negative (Fig. 4). As a result of the darkening, some parts of the painting lost their original depth and had a very two-dimensional effect. All later overpaintings were a shade or several shades darker. They may have darkened because of changes in the pigments but it is more likely that the process of decay and the falling away of microparticles of the paint layer continued in the unrestored sections, consequently giving the painting a lighter appearance because the light colour of the *intonaco* shone through onto the surface. Because condensation on the surface dissolved the surface layer, dust particles from the air were also caught in the structure of the paint layer on the surface, causing the darkening of the entire surface.

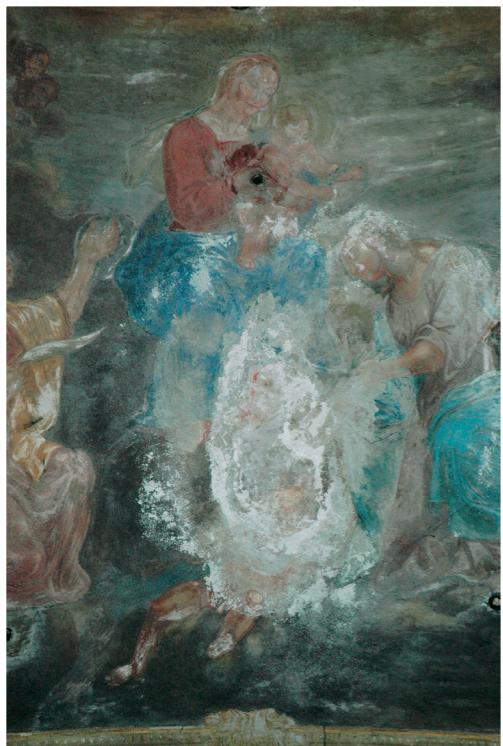
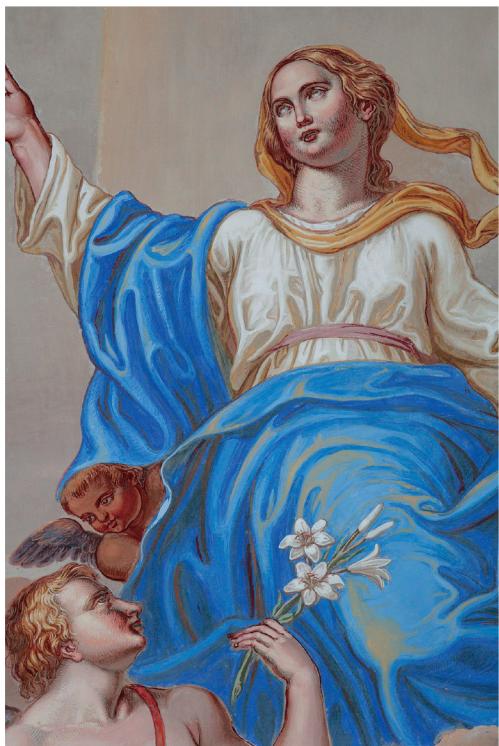
5. Primerjava dveh različnih Langusovih stenskih poslikav, ki sta nastali istega leta, danes pa je stanje obeh popolnoma različno (levo cerkev Marijinega oznanjenja v Ljubljani, desno podružnična cerkev Matere Božje na Šmarni gori) (foto: arhiv ZVKDS RC)

Comparison of two different wall paintings painted by Langus in the same year. The condition of the two paintings today is very different (on the left, the Church of the Annunciation in Ljubljana; on the right, the chapel of ease dedicated to the Virgin Mary on Šmarna Gora) (photograph: Archives of the ZVKDS RC)

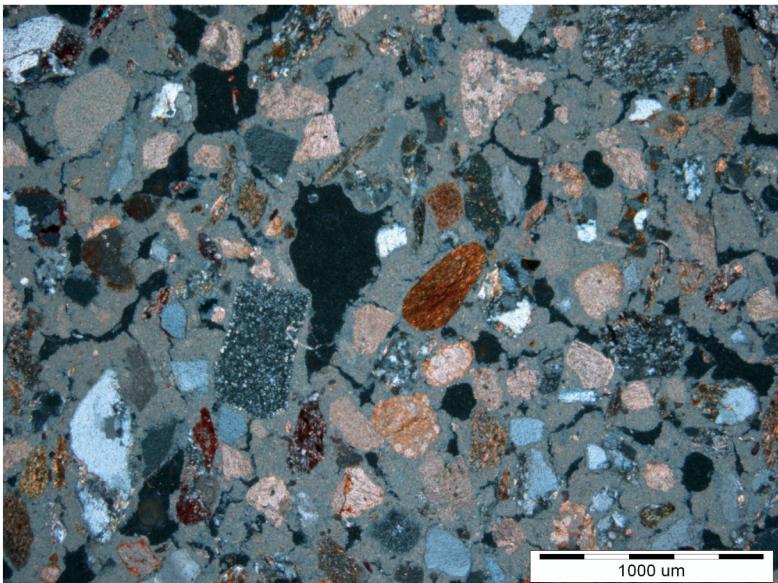
Na podlagi preiskave ometov v dveh kapelah franciščanske cerkve z optično (sl. 6) in elektronsko mikroskopijo lahko zaključimo, da je originalen omet apnen. Agregat sestavlja zaobljena karbonatna zrna (kalcit in dolomit) ter litična zrna magmatskih kamnin. Zaobljeni delci nakazujejo na rečni izvor agregata – mivke. Opazne so bile tudi kasnejše

6. Posnetek arriccia z optičnim mikroskopom: karbonatna in silikatna zrna agregata ter karbonatizirano apneno vezivo. Presevna svetloba, prekržani nikoli (foto: arhiv ZVKDS RC)

Image of arriccio seen through an optical microscope: the carbonate and silicate grains of the aggregate and the carbonated lime binder. Transmitted light, parallel polars (photograph: Archives of the ZVKDS RC)

On the basis of examination of the plasters in two chapels of the Franciscan church using optical (Fig. 6) and electron microscopes, we can conclude that the original plaster is lime-based. The aggregate consists of rounded carbonate grains (calcite and dolomite) and lithic grains of magmatic rock. The rounded particles indicate the origin of the aggregate as river sand. Later fillings done in true fresco technique can also be observed. These differ from the original plaster above all in terms of the aggregate used, which in this case consists of sharp-edged grains of calcite. Crystallisation of salts is evident on the surface of the plasters – gypsum is present, the consequence of decay processes. Using Fourier transform infrared spectroscopy, we identified the presence of epoxy-based resin and proteins in the plaster (Kramar and Kavkler, 2009). Although a range of organic additives for improving the properties of plasters are known (Kučková *et al.*, 2009), the deliberate addition of proteins is not confirmed in our case. The presence of proteins is in all likelihood the consequence of previous consolidation of the wall paintings using ammonium caseinate, which was and still is frequently used in conservation-restoration interventions. This theory is also supported by the fact that the proteins were present both in primary and secondary layers.

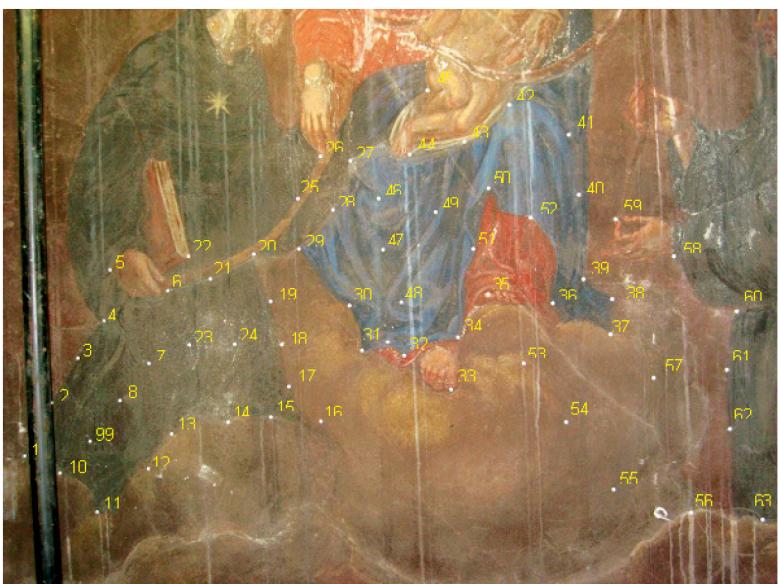
7. Eden izmed štirih merilnih poligonov v kapeli sv. Pashala Bajlonjskega. Številke označujejo merilna mesta.

One of the four test areas in the chapel of St Pascal Baylon. The numbers indicate the measuring points.

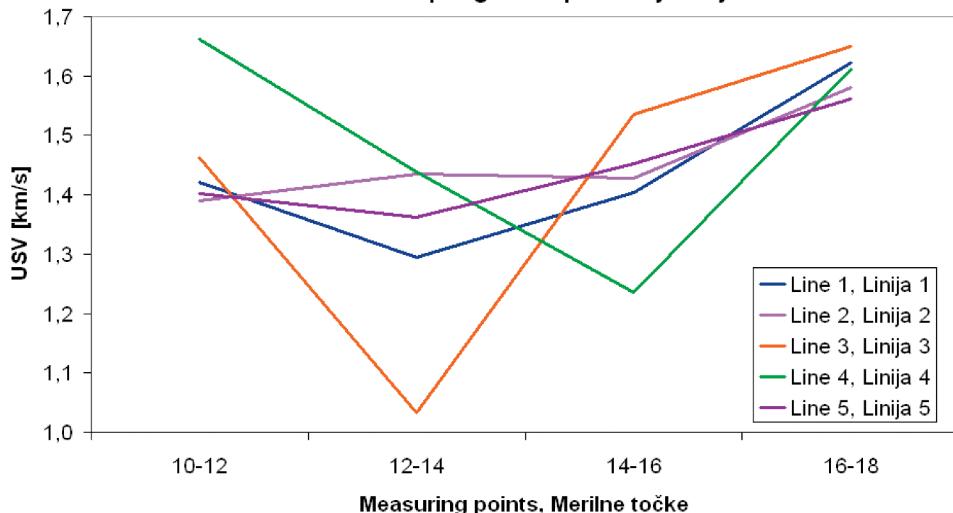
Pri meritvah pred utrjevanjem smo z metodo lahko ugotovili mesta, kjer je mehanska trdnost substrata zmanjšana. Na poligonu 1 je bilo tako videti mesto odstopanja poslikave med točkama 12 in 14, kjer je bila hitrost zvoka izrazito nizka (sl. 8).

8. Sprememba hitrosti vzdolž vzporednih linij na merilnem poligonu 1. Upad hitrosti nakazuje spremembo v koheziji podlage.

Change of speed along parallel lines in test area 1. A drop in speed indicates a change in the cohesion of the ground.

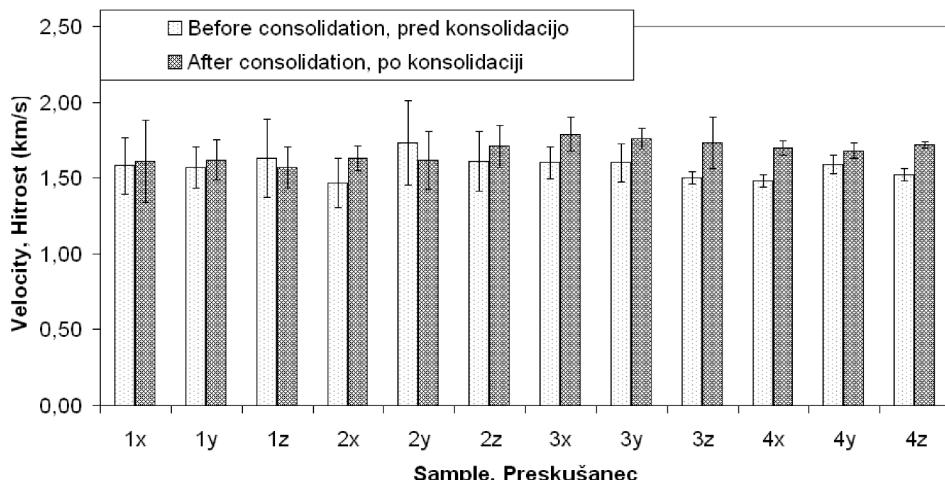
Čeprav je metoda v veliki meri odvisna od pogojev meritve (na primer od vlažnosti substrata in posledično od temperature), rezultati kažejo, da se je hitrost zvoka po nanosu utrjevalca na splošno povečala (sl. 9). Za vrednotenjem rezultatov smo izvedli še meritve v laboratorijskih pogojih.

9. Hitrost zvoka skozi laboratorijske preizkušance malte pred utrjevanjem in po njem

Speed of sound through laboratory samples of mortar before and after consolidation.

Although the method used is to a large extent dependent on the conditions of measurement (for example the humidity of the underlying layer and, consequently, temperature), the results show that following application of the consolidant, the speed of sound generally increased (Fig. 9). In order to evaluate the results we carried out further measurements in laboratory conditions.

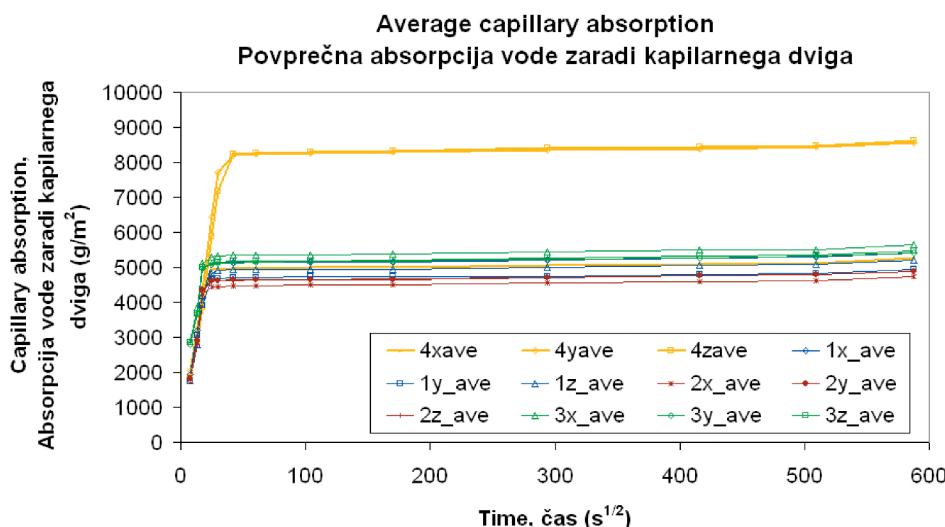
10. Sprememba povprečne absorpcije vode impregniranih preizkušancev zaradi kapilarnega dviga. Vzorci se razlikujejo glede na koncentracijo utrjevalca (oznaka 1 – utrjevalec : tekočina = 1 : 9, oznaka 2 – utrjevalec : tekočina = 3 : 7, oznaka 3 – utrjevalec : tekočina = 4 : 6, oznaka 4 – utrjevalec : tekočina = 10 : 0) in števila nanosov (x – 1-kratni nanos, y – 5-kratni nanos, z – 15-kratni nanos).

Change in the average absorption of water of impregnated samples as a result of capillary lift. The samples differ in terms of the concentration of the consolidant (1 – consolidant:liquid = 1:9, 2 – consolidant:liquid = 3:7, 3 – consolidant:liquid = 4:6, 4 – consolidant:liquid = 10:0) and the number of applications (x – 1 application, y – 5 applications, z – 15 applications).

It is also evident from the results of capillary rise that the number of applications does not significantly affect capillary absorption in the case of mixtures 1, 2 and 3. A typical difference in the number of applications is, however, evident in the case of mixture 4, which represents the maximum concentration. In this case a difference is evident between a single application, tenfold application and fifteenfold application. We would have expected a higher concentration and a greater number of applications to cause less capillary absorption, but it turned out that this correlation is inversely proportional (Fig. 10).
