CERKEV SV. HELENE NA GRADIŠČU PRI DIVAČI

Mednarodna poletna šola konserviranja-restavriranja stenskih poslikav
– Gradišče Summer School 2021–2023

THE CHURCH OF ST HELEN IN GRADIŠČE PRI DIVAČI

International Summer School for the Conservation-Restoration
of Wall Paintings – Gradišče Summer School 2021–2023

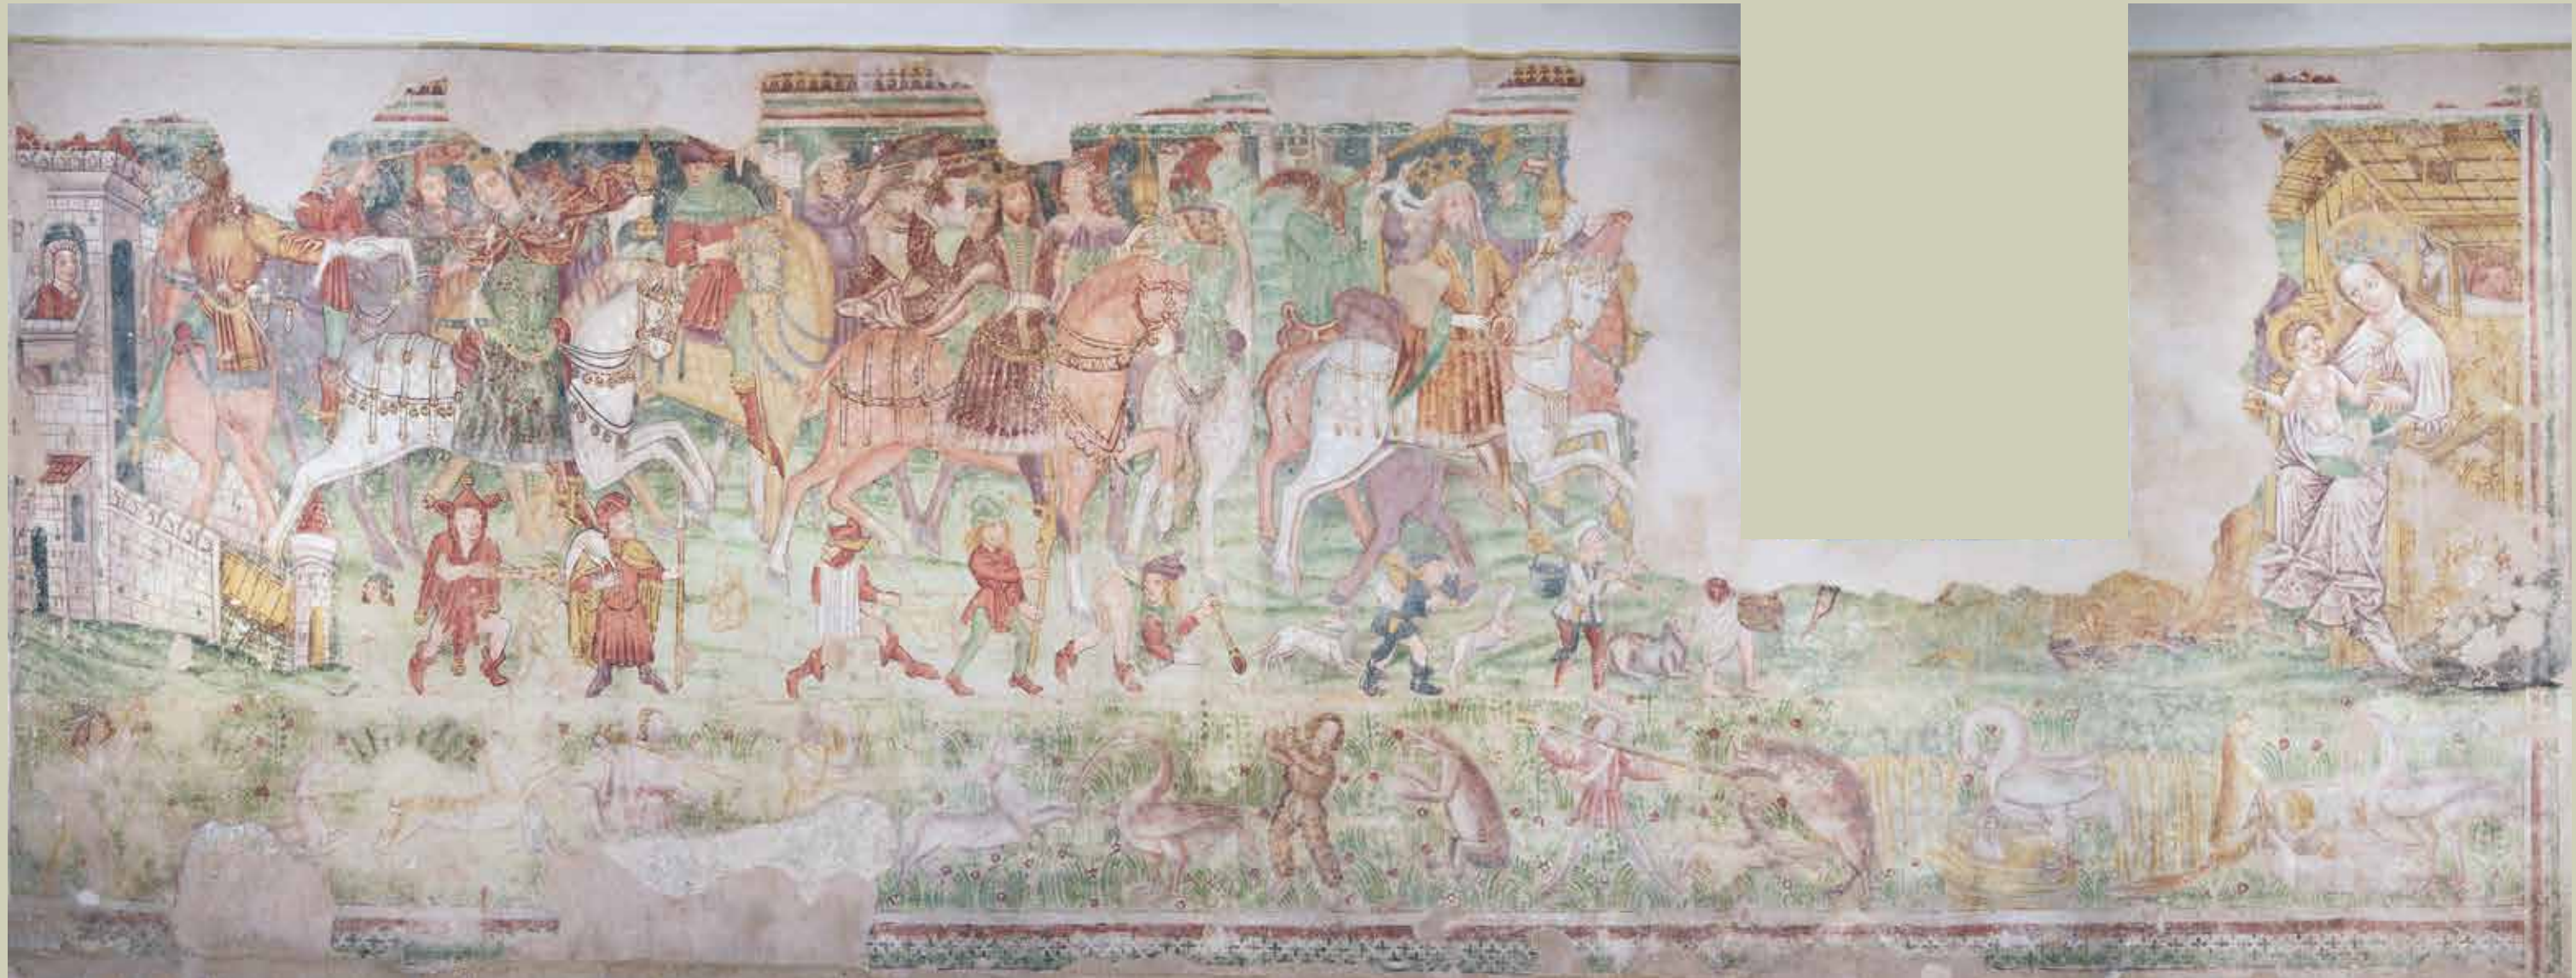
SEVERNA STENA / NORTH WALL

Pohod in poklon svetih treh kraljev / Journey and Adoration of the Magi

| 1 | Pas trikraljevskega spreveda | The Journey of the Magi sequence |
| 2 | Pas žanrskih figur | The sequence of genre figures |
| 3 | Fikcijski pas | The fictional sequence |

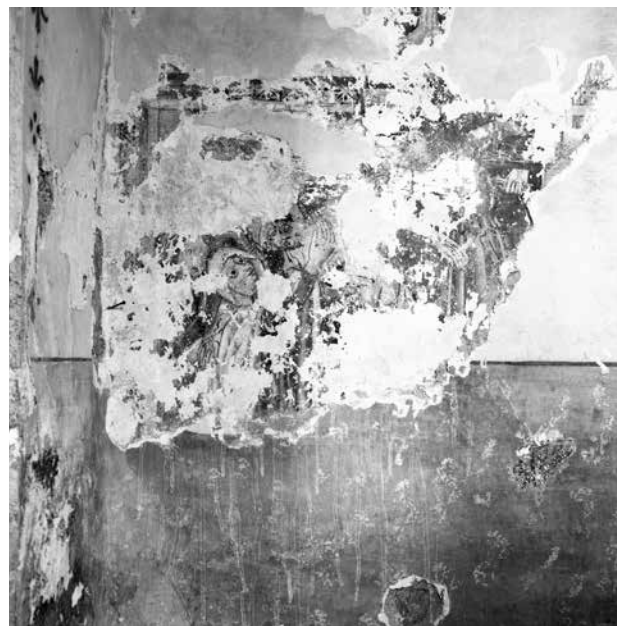
Slika 2: Delno odkrite poslikave na južni ladijski steni, prizor *Snemanje s križa* (foto: Emil Smole, 1968).

Fig. 2: Partially uncovered paintings on the south wall of the nave, scene of the *Descent from the Cross* (photo: Emil Smole, 1968).

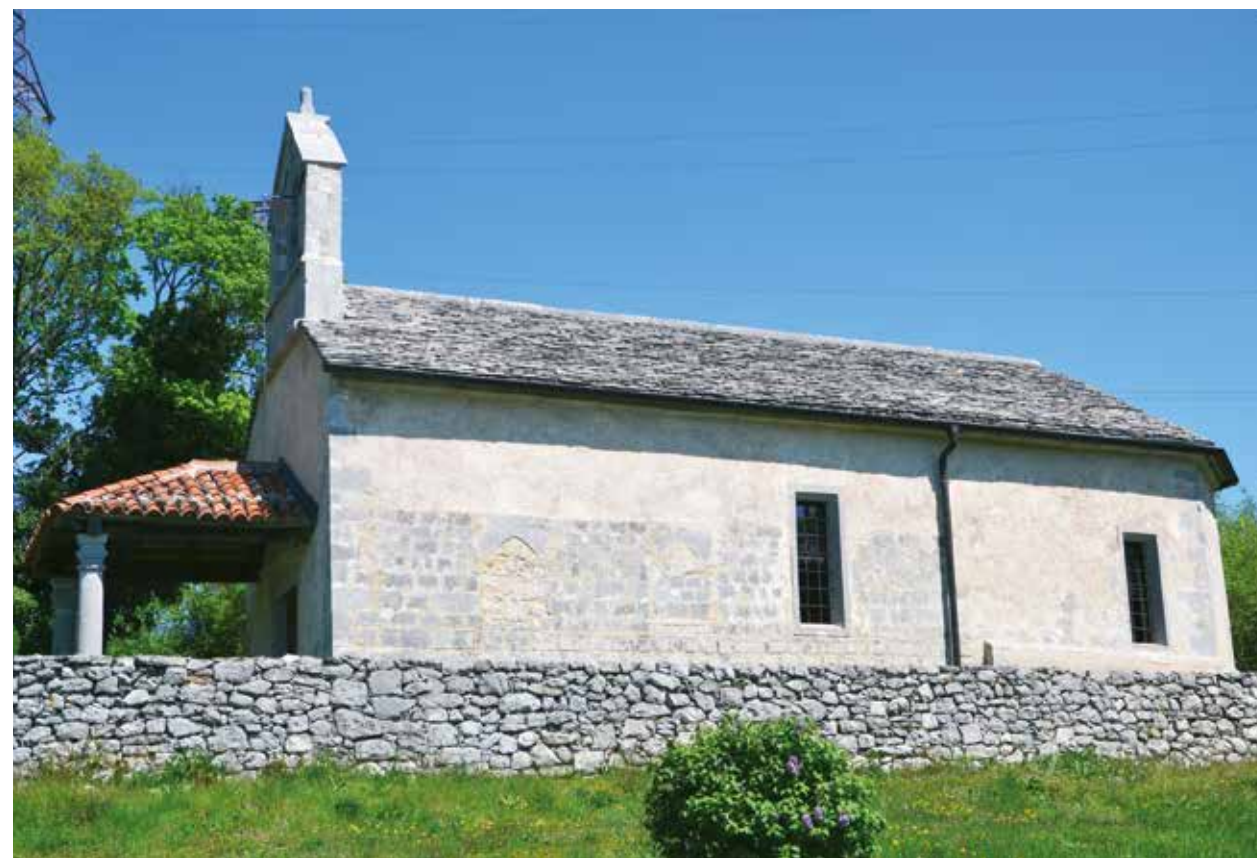
Slika 3: Pogled na južno fasado (Foto: Minka Osojnik, 2023).
Fig. 3: View of the south facade (photo: Minka Osojnik, 2023).

pravilno oblikovanih klesancev, ki se vrstijo v urejenih horizontalnih plasteh. Stiki med njimi so majhni in zapolnjeni z apneno malto. Na južni fasadi se kot del prvotne zidave kažeta dve manjši zazidani kamniti okni s šilastim zaključkom. Severna fasada, kot je značilno za srednjeveške cerkve, oken prvotno ni imela. Zgornji del fasade ladje je ometan z enakim ometom, kot ga vidimo na prezbiteriju (slika 3).

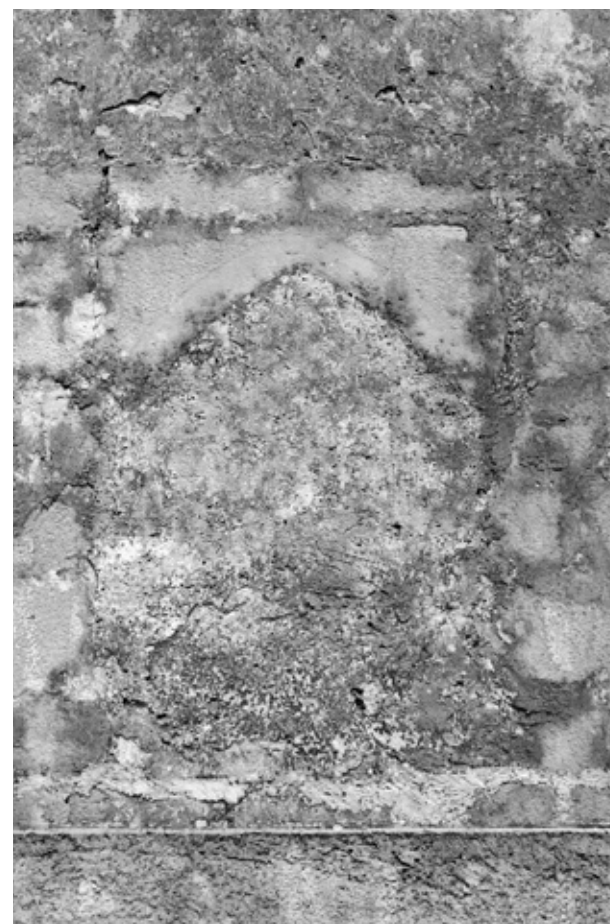
Slika 5a: Zazidano gotško okno na južni fasadi ladje (foto: Emil Smole, 1968).

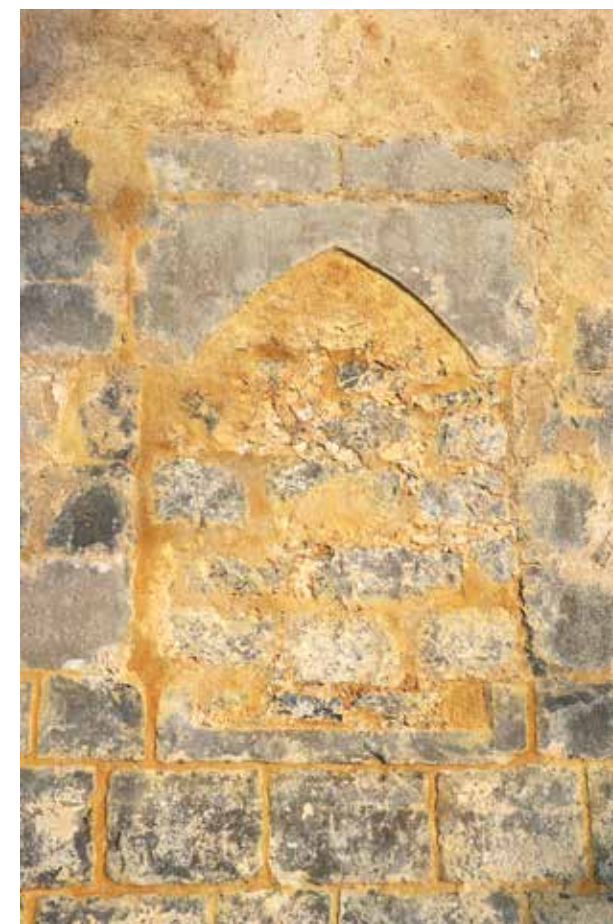
Slika 5b: Isto okno po zaključeni obnovi zunanjščine (foto: Minka Osojnik, 2024).

Fig. 5b: The same window after the exterior was renovated (photo: Minka Osojnik, 2024).

obnovo fasade leta 2022, ko sta bili konservirani-restavrirani tudi zazidani okni, se je na obeh pokazala spodnja polica, vendar je jasno vidno tudi, da sta bila pokončna kamna špalet pred zazidavo odstranjena (sliki 5a in 5b). Cerkev je bila morda že od samega nastanka poslikana. Levo od okna v južni steni ladje je namreč v vogalu prizora *Križanja* ohranjen fragment neke starejše poslikave, ki očitno sega pod poznogotsko poslikavo *Kristusovega pasijona*.

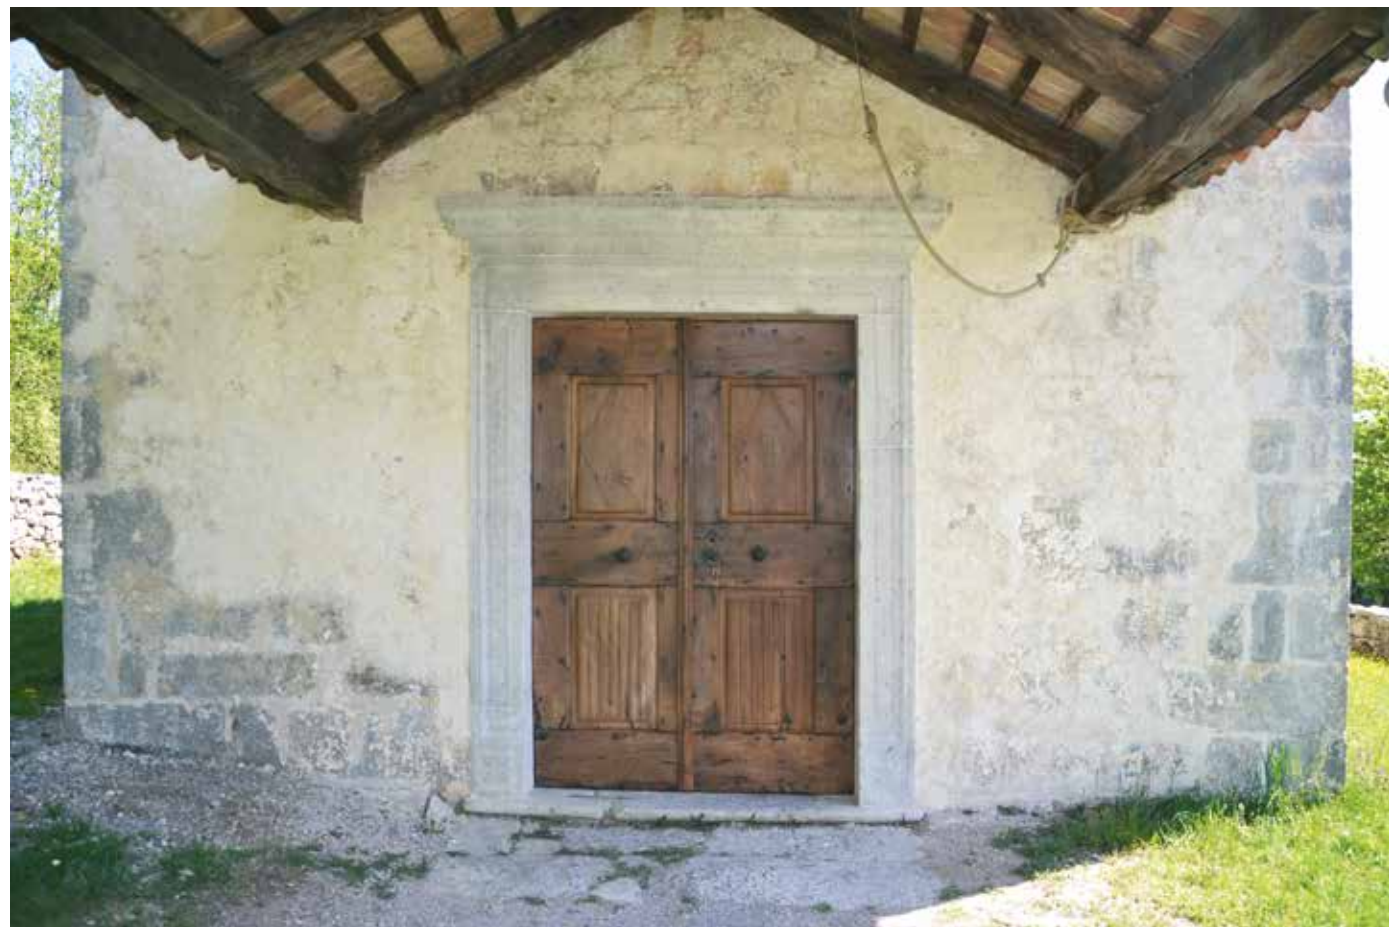
Slika 6: Spodnji del zahodne fasade (foto: Minka Osojnik, 2023).
Fig. 6: Lower part of the west façade (photo: Minka Osojnik, 2023).

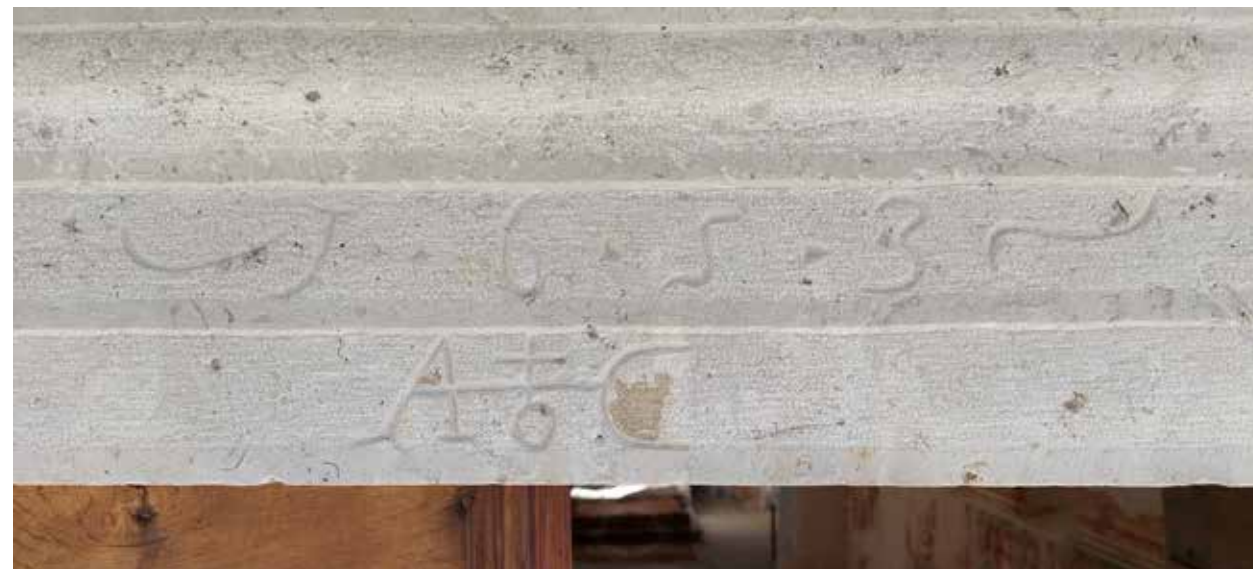
Slika 7: Detajl kamnitega portala (foto: Majda Kunst, 2013).
Fig. 7: Close-up of the stone portal (photo: Majda Kunst, 2013).

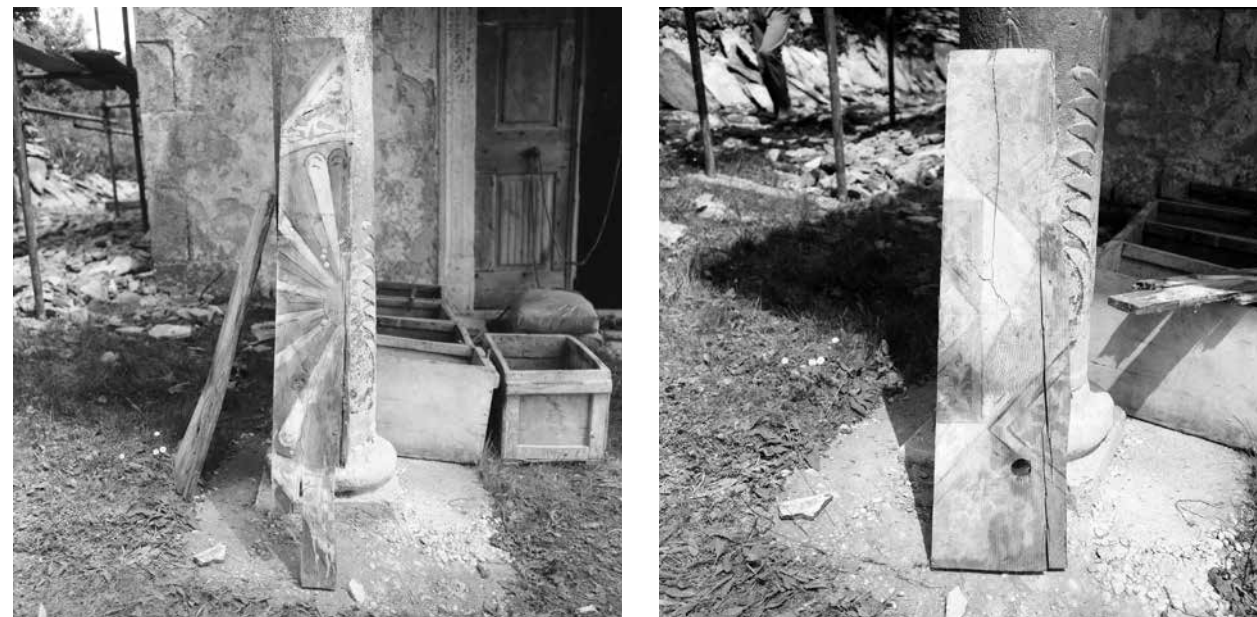
Sliki 10a in 10b: Ostanke lesenega poslikanega stropa, najdeni med obnovo kamnite strehe (foto: Robert Červ, 1987).
Figs. 10a and 10b: Remains of the painted wooden ceiling found during the reconstruction of the stone roof (photo: Robert Červ, 1987).

In 1753, a new stone floor was laid and ten years later the limestone tiled roof was renovated and the wooden roof structure repaired. At the same time, a new painted wooden ceiling was installed in the interior,¹⁰ the remains of which were found in the attic during the restoration of the stone roof in 1986 (Figs. 10a and 10b). A new door was made out of walnut planks and, like the stone pavement, it is still preserved today. The porch was repaired in 1761 and at that time it was most probably still covered with limestone tiles, similar to the ones we can see today on the church in Dolnje Ležeče.

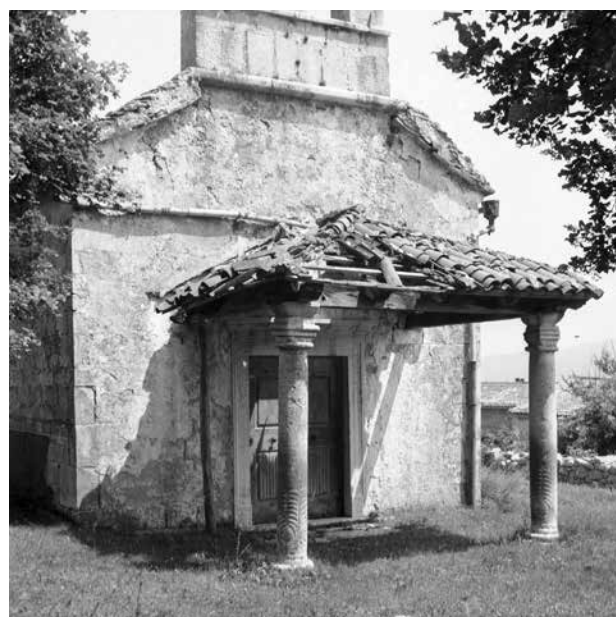
Slika 11: Poškodovana streha cerkvene lope (foto: Nada Osmuk, 1985).
Fig. 11: Damaged roof of the church porch (photo: Nada Osmuk, 1985).

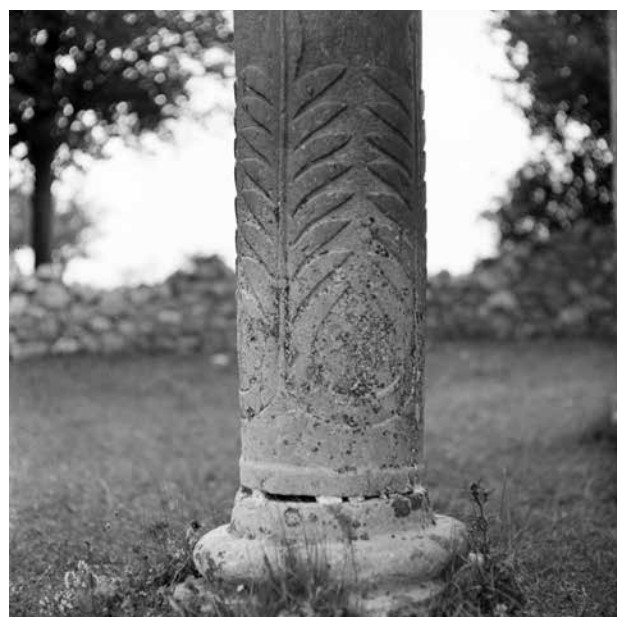
Slika 12: Detajl stebra lope (foto: Emil Smole, 1968).
Fig. 12: Close-up of the porch column (photo: Emil Smole, 1968).

In the 1980s, major renovation work began. Its aim was to gradually present the building in its entirety. First, the church porch was renovated in 1985. The dilapidated wooden structure was replaced, the foundations for the columns were built and the roof was covered with barrel tiles²⁰ (Figs. 11 and 12). However, the church of St Helen was undoubtedly marked most significantly by the renovation of the stone roof that followed. The roof was already leaking in the 1960s and makeshift repairs were carried out, as noted above, using limestone tiles taken from the roof of the church of St Thomas the Apostle in nearby Famlje. The roof was comprehensively repaired in the years 1986-87. During these years, the church of St Helen suffered some irreparable damage. In line with the conservation doctrine of the time, the probably rather dilapidated roof structure was removed and replaced by a reinforced concrete gable roof on which the limestone tiles were laid (Figs. 13 and 14). However, as the new concrete slab did not completely cover the top of the perimeter walls but ended in the middle, rainwater soon seeped into the walls. After the local residents

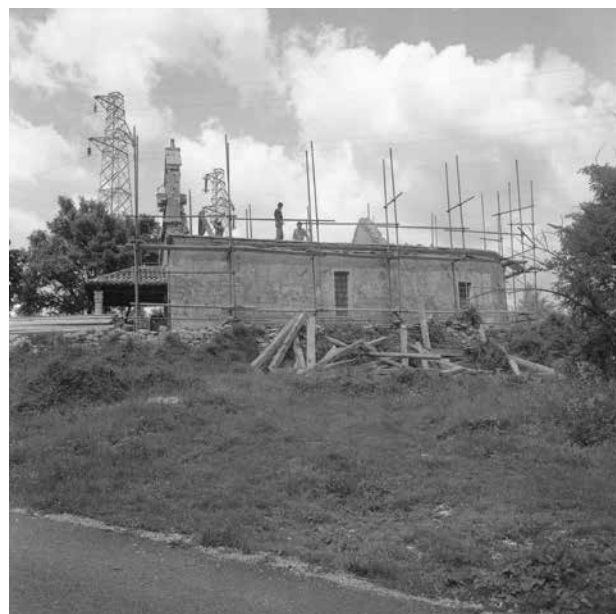
Slika 13: Pogled na cerkev po odstranitvi kamnite kritine in lesenega ostrešja (foto: Robert Červ, 1987).
Fig. 13: The church after the stone tiles and the wooden roof structure were removed (photo: Robert Červ, 1987).

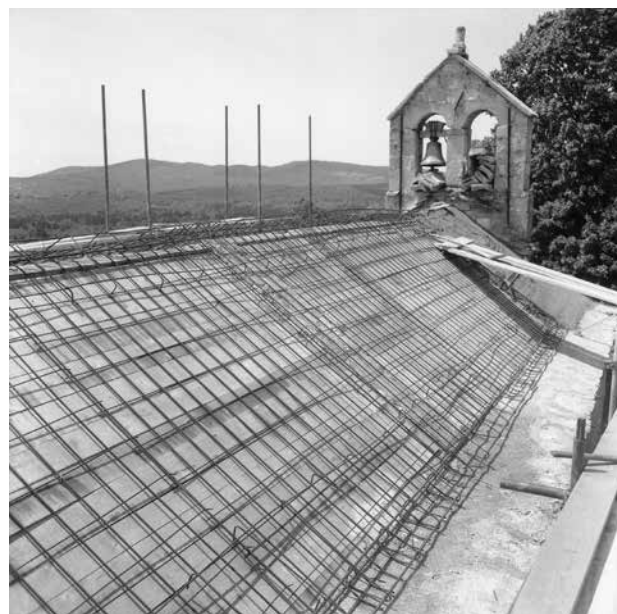
Slika 14: Izdelava armiranobetonske strehe (foto: Robert Červ, 1987).
Fig. 14: Reinforced concrete roof under construction (photo: Robert Červ, 1987).

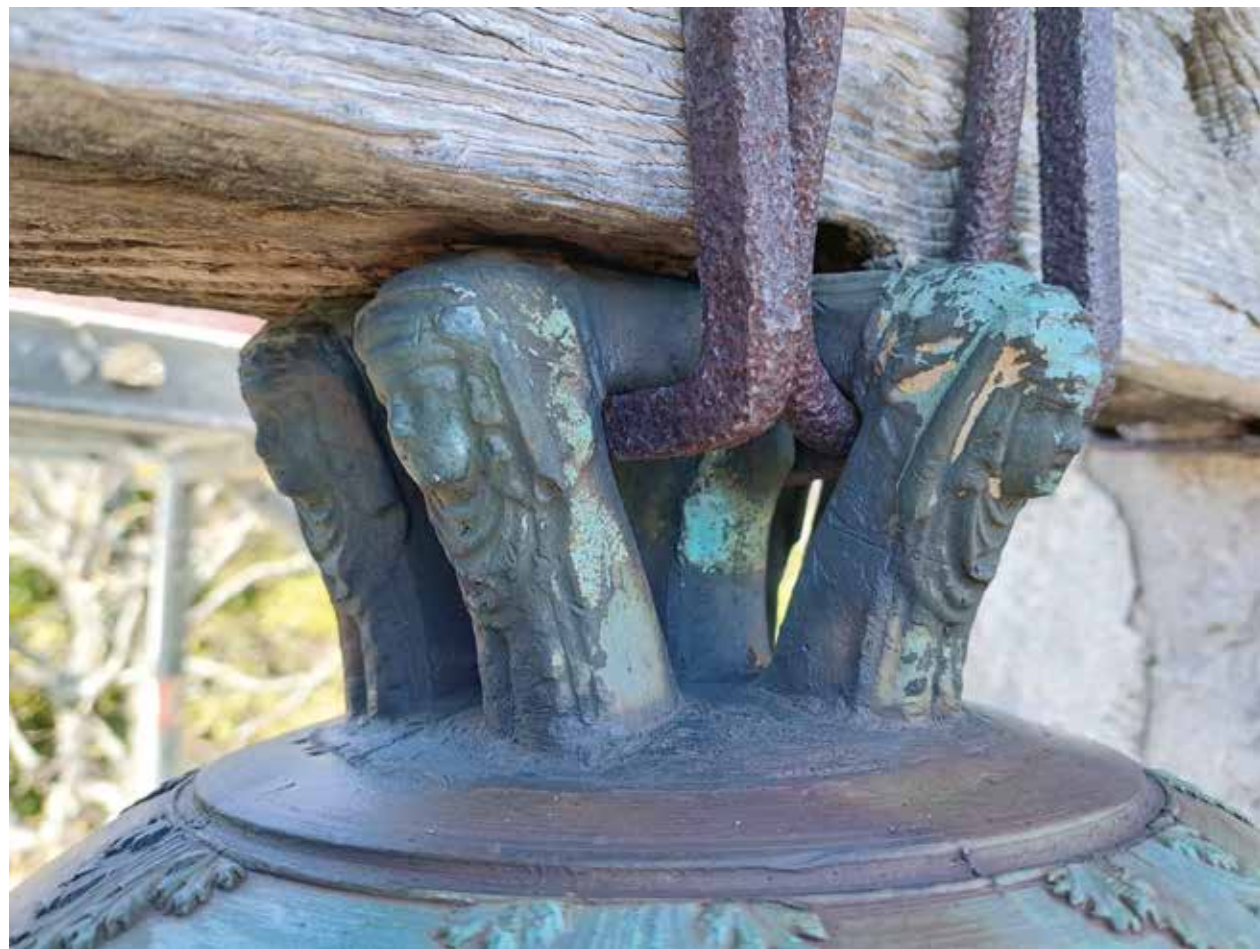
Slika 15: Detajl cerkvenega zvona (foto: Minka Osojnik, 2021).
Fig. 15: Close-up of the church bell (photo: Minka Osojnik, 2021).

In 2022, restoration work was completed on the exterior, which was fully conserved-restored. The church of St Helen had retained a significant part of its original lime plaster, prompting the IPCHS to determine that the exterior should be conserved-restored according to the principle of preserving its authentic appearance and materials to the greatest extent possible. All the high-quality lime plasters were preserved and consolidated, and the missing parts were replaced with new ones based on the original. The original lime whitewash was also preserved and strengthened. It was not covered with new whitewash – only the reconstructed sections were tonally adapted to the original. All the stone elements have been conserved-restored and the junctions between the bellcote and porch with the nave have been repaired, preventing further ingress of moisture into the building. In 2022 and 2023, the ceiling and plastered walls above the paintings in the nave were renovated, and the original wooden doors were conserved-restored. Finally, the church bell was restored in 2023. The yoke was completely dilapidated and it was unsafe to ring the bell. The funds for this restoration were raised by the locals who agreed with the sexton Rudi Cerkvénik that 'a church without a bell is like a tavern without wine!' (Fig. 15).

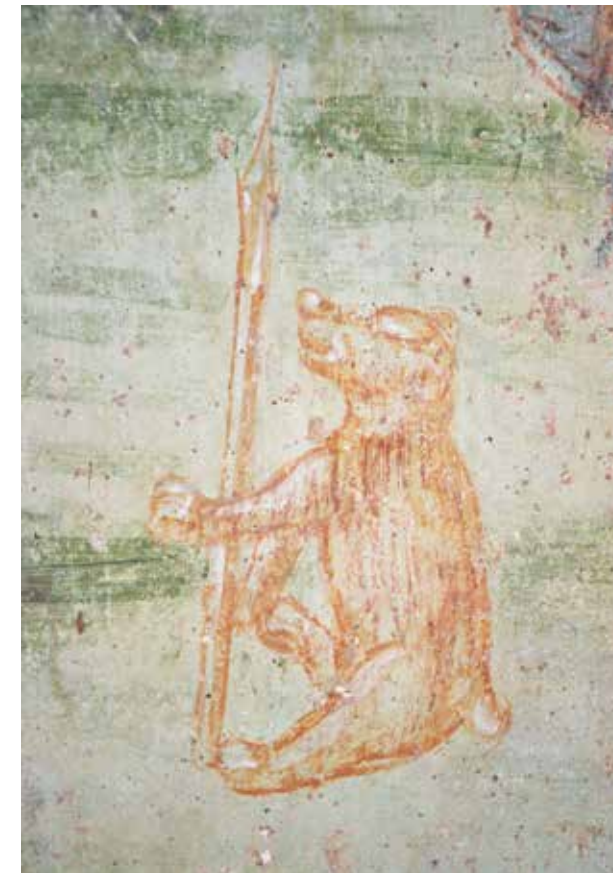
Slika 5: Srednji pas severne stene: detajl medveda s sulico, naslikanega v monokromni tehniki (foto: Marta Bensa, 2017).

Fig. 5: Central sequence on the north wall: close-up of the bear with spear, painted in monochrome (photo: Marta Bensa, 2017).

The figures in the central sequence are walking through a green meadow and are the secular, genre companions of the Journey of the Magi. Some of them are painted in a smaller format and in monochrome. Just outside the walls of Jerusalem, a small man wearing a dark headdress is standing facing left. He is holding something in one hand and reaching up to his nose with the other, as if smelling something. Then there is a court jester, adorned with bells and holding a cudgel below which there is a small monochrome painting of a man who is also holding something like a cudgel. The next in line is a hunter with a spear and his kill over his shoulder (a small white animal). To his right sits a very small, monochrome bear with a spear (Fig. 5). Then comes a man making a long stride. He is wearing a white cape and extremely short trousers – perhaps he is not even wearing any trousers at all. He is looking back and holding an indefinable, monochrome animal on a leash. Next in the procession is a bearded man with a cudgel, which he might use to hit the naked bottom of the man in front of him who is bending forward, without any trousers, holding a large wooden spoon. A white dog runs in front of him, looking back and apparently sticking its tongue out at the man. Ahead of the mischievous dog walks a man in a dark suit, holding his hat with one hand, a large knife at his waist, and a white bundle hanging from a stick slung over his shoulder. A white dog is leaping in front of him, trying to reach the cauldron being carried by a cook on a long wooden spoon slung over his shoulder. The cook also has a large knife at his waist. On the floor, to the right of the cook, there is a white lion (or lioness, as it has no mane). An examination with UV-light found that it is holding a mouse in its paws. To the right of the lion, only the lower part of a person in a white robe has been preserved. They are the only bare-legged person in the procession, who has a small purse attached to their waist and is carrying a basket. A careful observer will see a large crayfish in the basket, which probably explains why the person has no shoes on – they were fishing for crayfish in the water (Fig. 6). This scene brings the sequence of secular figures to an end and the Adoration scene begins. Below this figure a small four-legged animal (perhaps a fox or a weasel) with a long tail and a white belly was depicted in the grass.

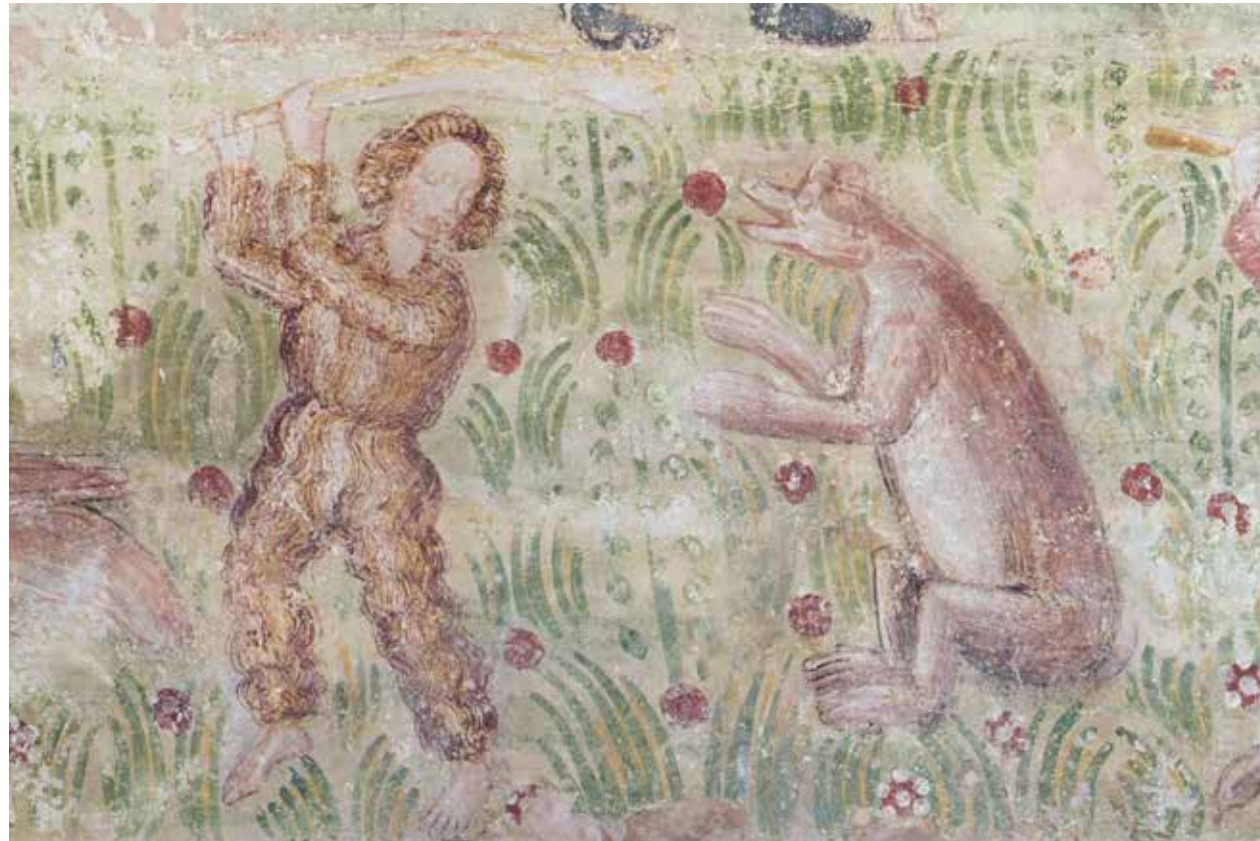
Slika 7: Spodnji pas severne stene: divji mož v boju z medvedom (foto: Marta Bensa, 2017).
Fig. 7: The lower sequence on the north wall: a wild man fighting a bear (photo: Marta Bensa, 2017).

canopies are as tall as the blades of grass, but their shape leaves no doubt that they are trees. The sequence starts on the left with a hunter who is carrying a spear on his shoulder and sounding his hunting horn to summon his big dog to join the hunt. The dog is chasing an even bigger hare in front of him. The next figure in the sequence is a man carrying a stick on his shoulder. A bird is hanging from the stick with its head raised so that it appears to be still alive. Here the painting's lower part is damaged, so the figures are missing their legs. The procession continues with a bald man who has a darkened face and is drinking from a flask. He is holding a dog on a leash and the dog is chasing a large bird with a long beak – a northern bald ibis. To the right of the bird we can see a wild man fighting a bear. The fur-clad, bare-footed man is swinging a cudgel above his head with which he will strike an open-mouthed bear resting on its hind paws and behind (Fig. 7). The last hunting scene shows a hunter standing with his legs spread wide apart, attacking a wild boar with a spear, and being assisted by a dog. We can clearly tell it is a wild boar by its snout, hooves and distinctive curled tail. The sequence ends with two scenes from fables. In the first one, set in the middle of the forest, we can see a pelican feeding two chicks in a nest with its blood, followed by a scene from the fable of the fox and the crane (or stork). The latter is again set in tall grass with a low table set between the two figures. On the table rests a plate, three loaves of bread, and a jug with a long neck, into which the bird is sticking its slender beak.

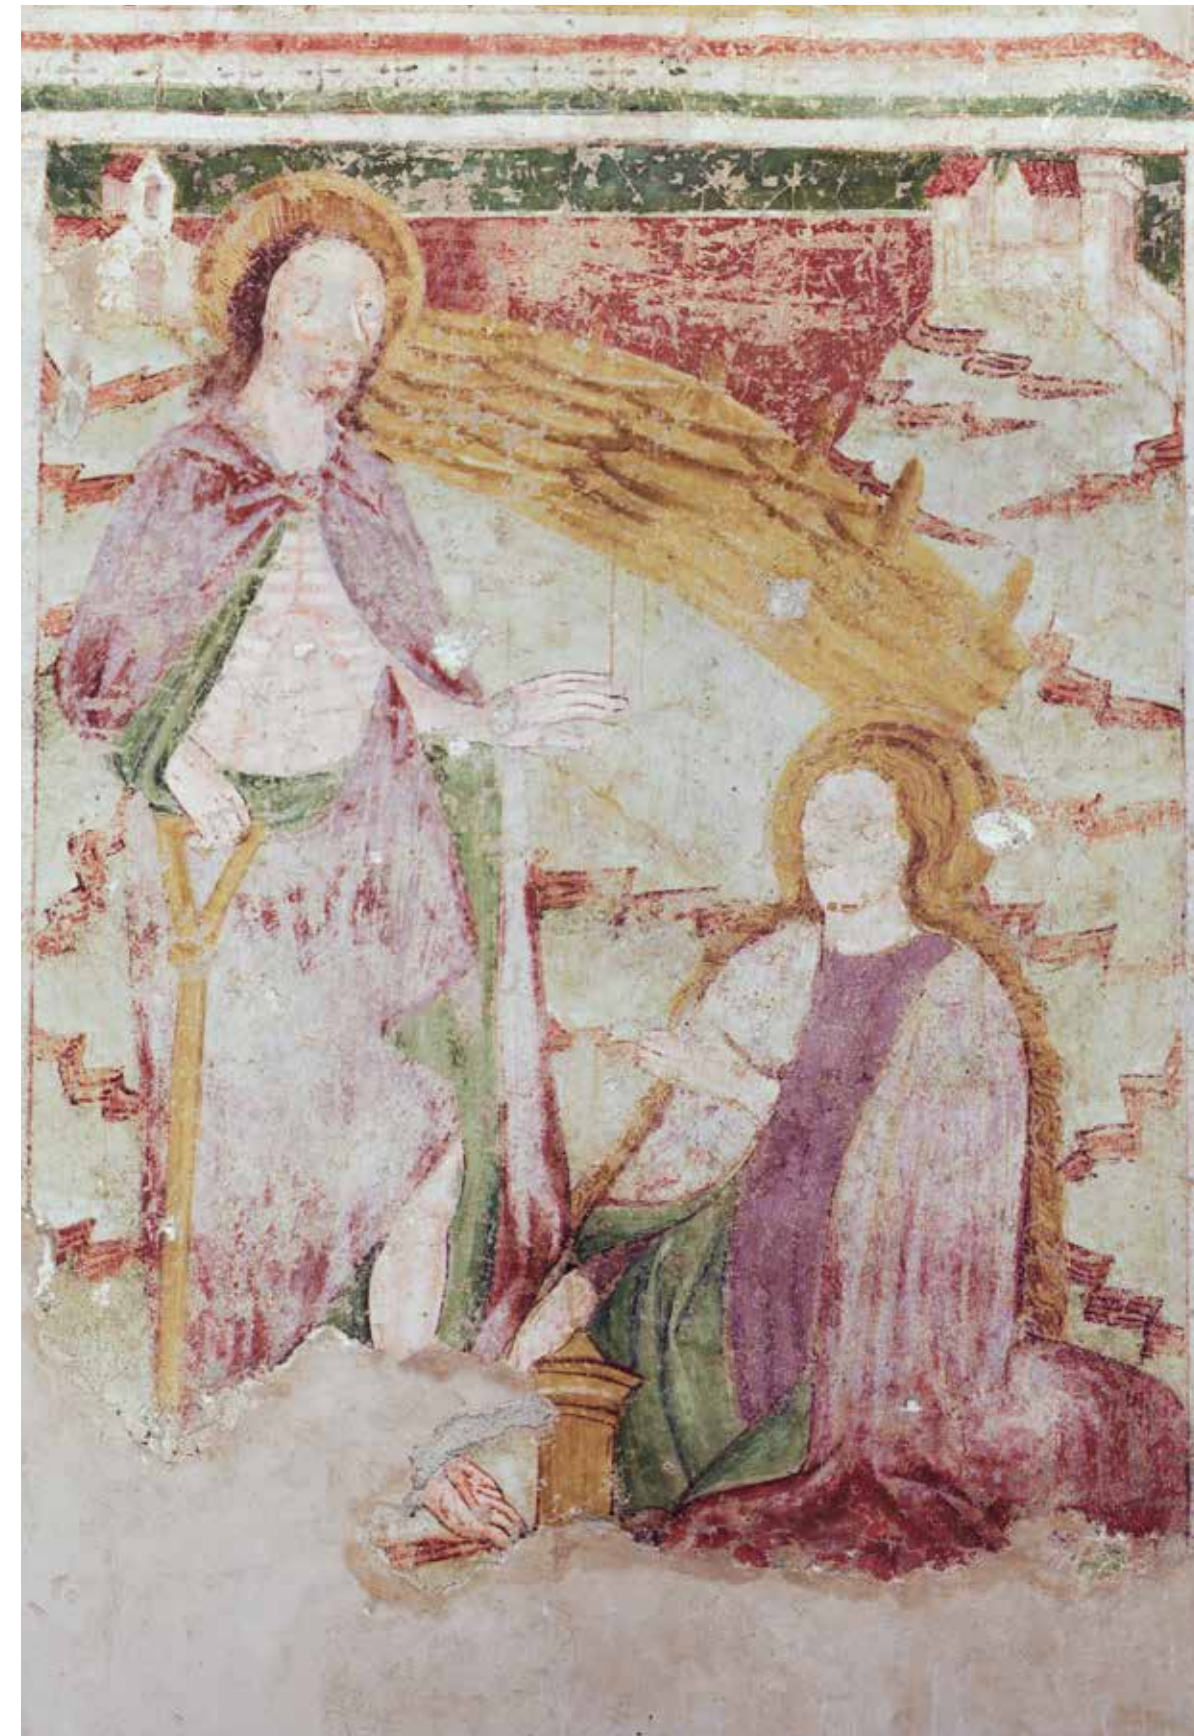
Slika 8: Južna stena, prizor *Noli me tangere* z veduto manjše cerkvice z zvončnico levo zgoraj (foto: Andrej Jazbec, 2023).
Fig. 8: South wall, *Noli me tangere* scene; there is a small church with a bellcote at the top left (photo: Andrej Jazbec, 2023).

The paintings on the south wall of the nave are less well preserved, as they were badly damaged in the past. The scenes depicting the *Passion of Christ* appear chronologically in two horizontal sequences. The three Gothic windows (one of which was rebuilt and enlarged in the Baroque period) were also incorporated into the painting in an interesting way. The painting continues seamlessly into the window jambs, as if there was no interruption in the wall. The scenes mainly have neutral backgrounds with a flat spatial composition, and are separated by tricolour borders similar to those on the north wall. The story begins on the right side in the upper sequence, where we can expect to see the scene of the *Arrest of Christ*. However, with the exception of the upper right-hand corner, where the fortified building with towers and part of Christ's halo are painted, it is mostly destroyed. The scene once reached to the middle of the Gothic window, so that the painting continued into its right jamb, while the left jamb is reserved for the next scene, *Christ before Pilate*. In the jamb there is a bearded man with a sword and a soldier in armour. The rest of the scene has only been preserved in the lower part. The *Flagellation* follows, although its upper section is destroyed. Herod is the best preserved figure in the right jamb of the next Gothic window.¹⁶ In the left jamb of the same window, the painting continues with the *Crowning with Thorns* scene, which is much better preserved, so we can see the suffering Christ up to neck height. The story continues with the scene of *Christ Carrying the Cross*. However, only a fragment on the far right with some spectators, and a small piece of the cross in the lower corner have survived. This scene also extended into the jamb of the third Gothic window, which was later largely destroyed to make way for the larger window. The left jamb of the old window has partially been preserved, together with part of the *Christ is Nailed to the Cross* scene, which continues towards the left. Above this scene, in the upper left-hand corner, the lower layer of an older painted plaster can be seen, but the fragment is too small for it to be possible to determine its content. The last scene in the upper sequence is the almost entirely preserved *Crucifixion* with Mary and John the Evangelist, then the story moves to the lower sequence and continues with the *Descent from the Cross* and continues towards the right with the *Entombment of Christ*. Only a fragment of this scene – part of the sarcophagus and Christ's feet – is preserved. This is followed by the scene of *Christ in Limbo*, with an interesting depiction of the devil kneeling on the ground, looking towards Christ above him with an air of defeat. To the right a group of souls is apparently rejoicing at their salvation. The upper portion of the scene is severely damaged so the whole upper part of Christ's body is missing. The following three scenes are very well preserved. The first one is the *Resurrection*, in which we can see the sleeping guards and

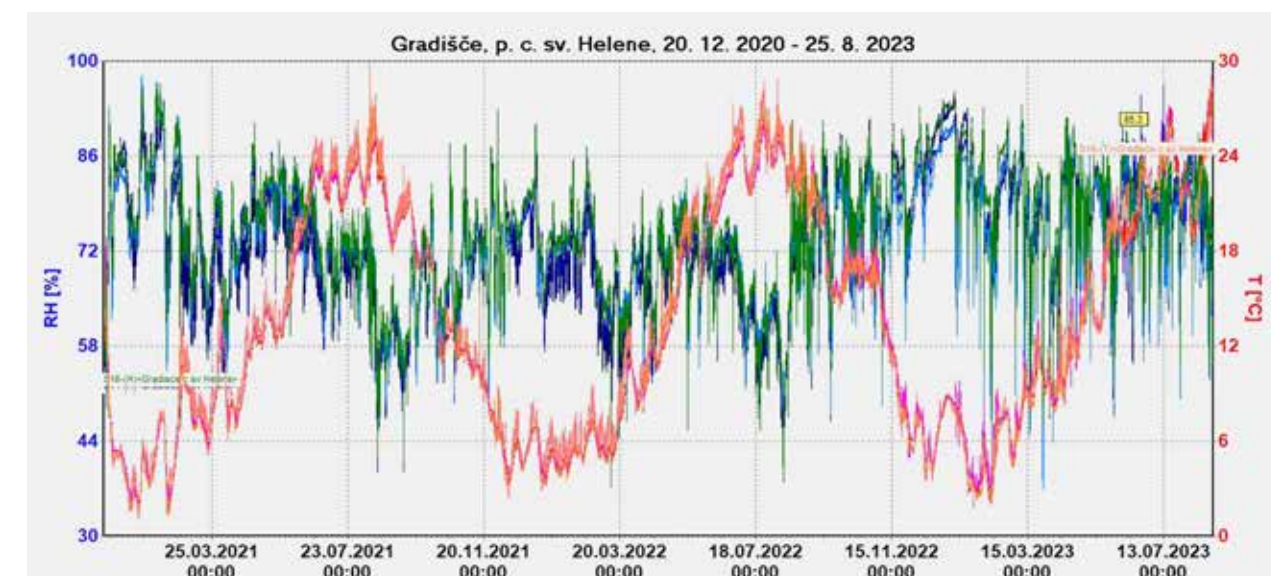
Slika 1: Graf mikroklimatskih pogojev v cerkvi v merjenem obdobju. Rdeči in oranžni spektri prikazujejo temperaturo ter modri in zeleni relativno vlažnost (foto: Katja Kavkler, 2023).

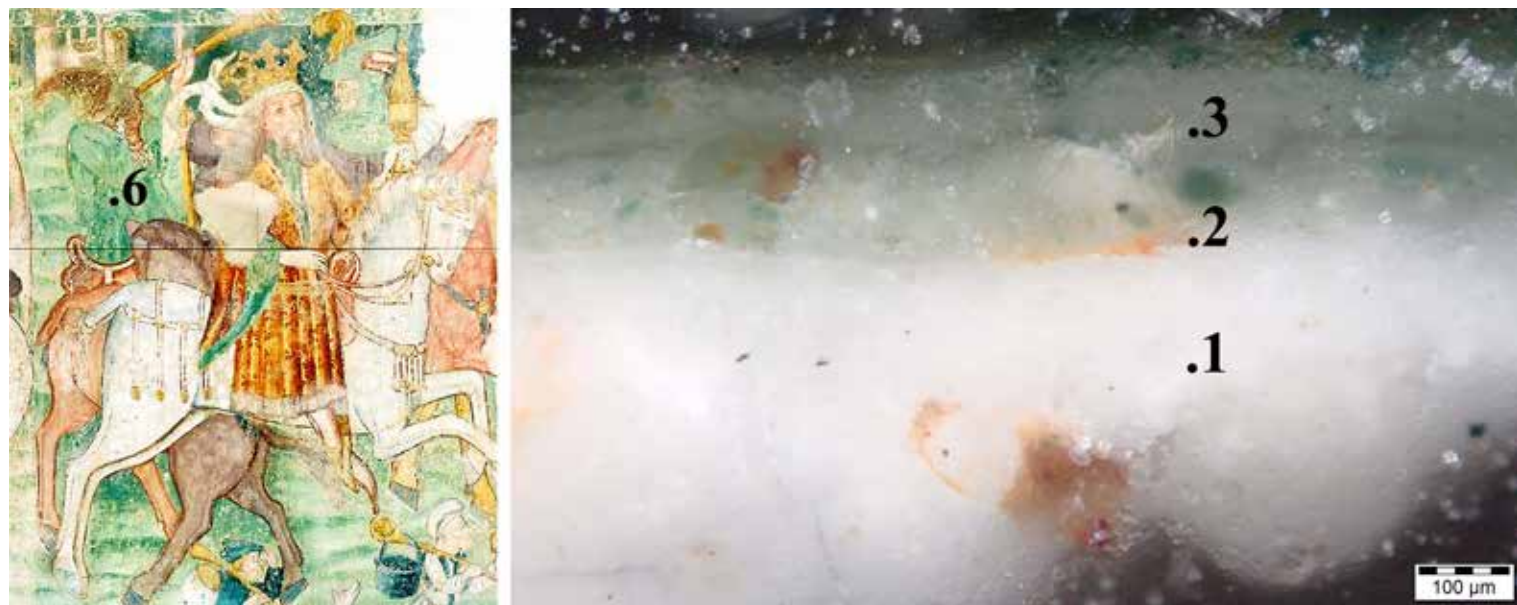
Slika 2: Fotografija prečnega preseka vzorca zelene obleke moškega z instrumentom s severne stene v vidni svetlobi (desno, 200-kratna povečava, številke označujejo različne sloje). Na levi fotografiji je označena lokacija vzorčenja na temnejši gubi oblačila moškega z instrumentom (foto: Katja Kavkler, 2024).

Fig. 2: Photograph of a cross-section of a sample of the green dress of the man with an instrument from the north wall in visible light (right, 200x magnification, numbers indicate different layers). On the left photograph, the sampling location is marked on the darker fold of the man's garment with the instrument (photo: Katja Kavkler, 2024).

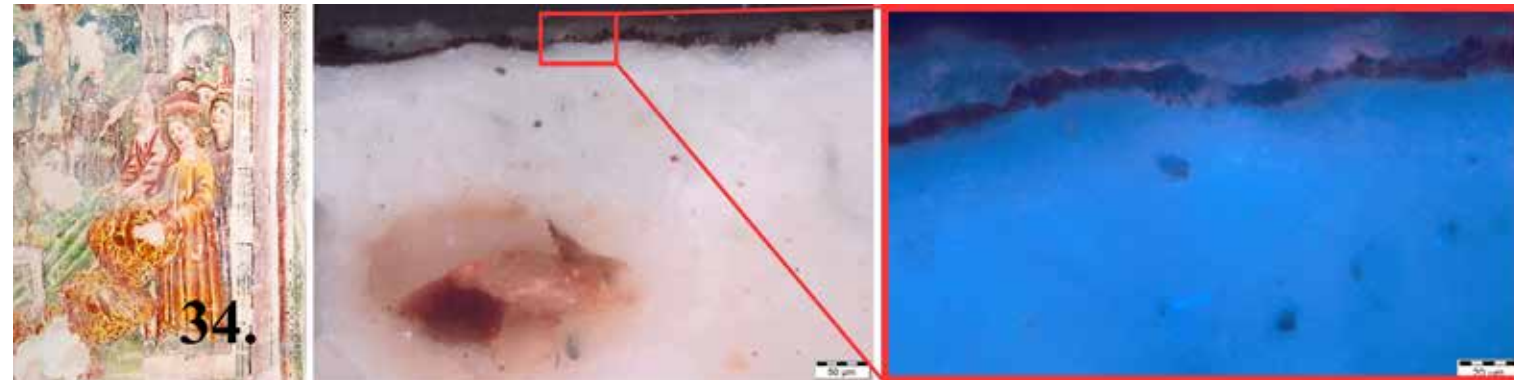
Slika 3: Fotografiji prečnega preseka vzorca črne barvne ploskve z oranžno fluorescenco z okna na zahodni steni v vidni (sredina, 200-kratna povečava) in UV-svetlobi (desno, 500-kratna povečava), kjer je viden material z oranžno fluorescenco. Na levi fotografiji je označena lokacija vzorčenja (foto: Katja Kavkler, 2021).

Fig. 3: Photographs of a cross-section of a black coloured window with orange fluorescence from the west wall in visible (centre, 200x magnification) and UV light (right, 500x magnification), showing the orange fluorescent material. The left photo shows the sampling location (photo: Katja Kavkler, 2021).

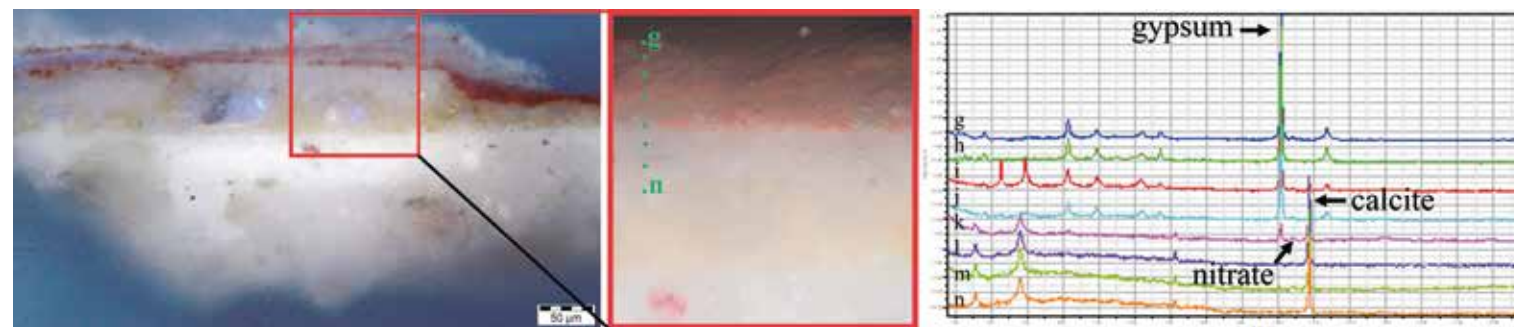
Slika 5: Mikrofotografija vzorca z inkrustacijo na površini v UV-svetlobi (levo, 200-kratna povečava), označene točke vzorčenja na izbranem območju preseka (sredina, 500-kratna povečava) in ramanski spektri, ki ustrezajo posameznim točkam (desno). Vidimo, da je na površini prisotna le sadra, njen delež se z globino zmanjšuje, medtem ko v posameznih analiziranih točkah opazimo tudi prisotnost nitratov (foto: Katja Kavkler, 2022).

Figure 5: Microphotograph of the sample with encrustation on the surface under UV light (left, 200x magnification), the marked sampling points in the selected cross-sectional area (centre, 500x magnification) and the Raman spectra corresponding to each point (right). It can be seen that only gypsum is present on the surface, its amount decreases with depth and the presence of nitrates is also noticed in the individual points analysed (photo: Katja Kavkler, 2022).
