CERKEV SV. HELENE NA GRADIŠČU PRI DIVAČI

Mednarodna poletna šola konserviranja-restavriranja stenskih poslikav
– Gradišče Summer School 2021–2023

THE CHURCH OF ST HELEN IN GRADIŠČE PRI DIVAČI

International Summer School for the Conservation-Restoration
of Wall Paintings – Gradišče Summer School 2021–2023

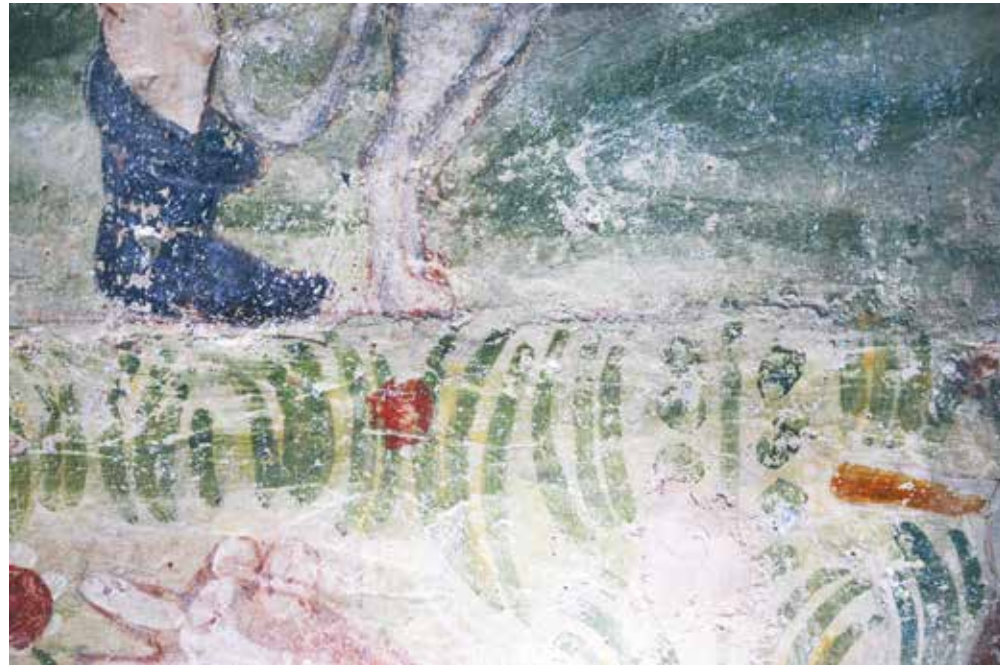
Fig. 1: Joint of two *pontate* on the north wall; the overlap indicates the lower *pontata* was applied after the upper one (photo: Neva Pološki, 2024).

When they wanted to paint *a fresco*, painters applied *intonaco* on surfaces they estimated could be painted in one day while the plaster was still damp. The shape and size of the *giornate* depended on many factors. The one that most commonly influenced the decision was the subject of the painting, connected with the composition's level of difficulty and the master's painting skills.⁵ Layers of fresh *intonaco* could be divided into large horizontal bands known as *pontate*⁶ or into smaller *giornate*⁷ that usually divided the *pontate* into smaller sections. Only relatively large *pontate* were observed in St Helen's church, and they are symmetrical and rectangular in shape. There are seven *pontate* in total, three on the north wall and two on the south and west walls each. One can clearly see the difference in plasters from one *pontata* to another. Even the way they were laid differs and can be seen. The overlapping of plasters at the juncture point of two *pontate* informs us of the order of painting. The west wall and triumphal arch⁸ were painted first, followed by the north and south walls. The detected joints indicate that plaster was applied from top to bottom, as was the custom (Fig. 1). On the north wall, which bears the *Adoration of the Magi* scene, *intonaco* was first applied on the right, where we can see one King and the Virgin Mary with Child.⁹ A splendid cavalcade with the other two Kings goes from the left towards the Holy Family, and it is painted on the second *pontata*. At the bottom, where the fable scenes are painted, including a bear fighting an uncivilized man and Aesop's tale of the fox and the stork,¹⁰ the third *pontata* stretches along the whole wall (Fig. 2). The scenes from the *Passion of Christ* on the south wall are painted on two long *pontate*, the upper one followed by the lower one, coinciding with the division into registers. After the plaster was applied, the painters looked for ways to set up the scenes on the large wall surfaces. They would start by dividing the space into large segments and marking the scene frames, and only then would they mark details like halos and outlines of figures. In this manner they could see the effect of the whole cycle in the interior. This

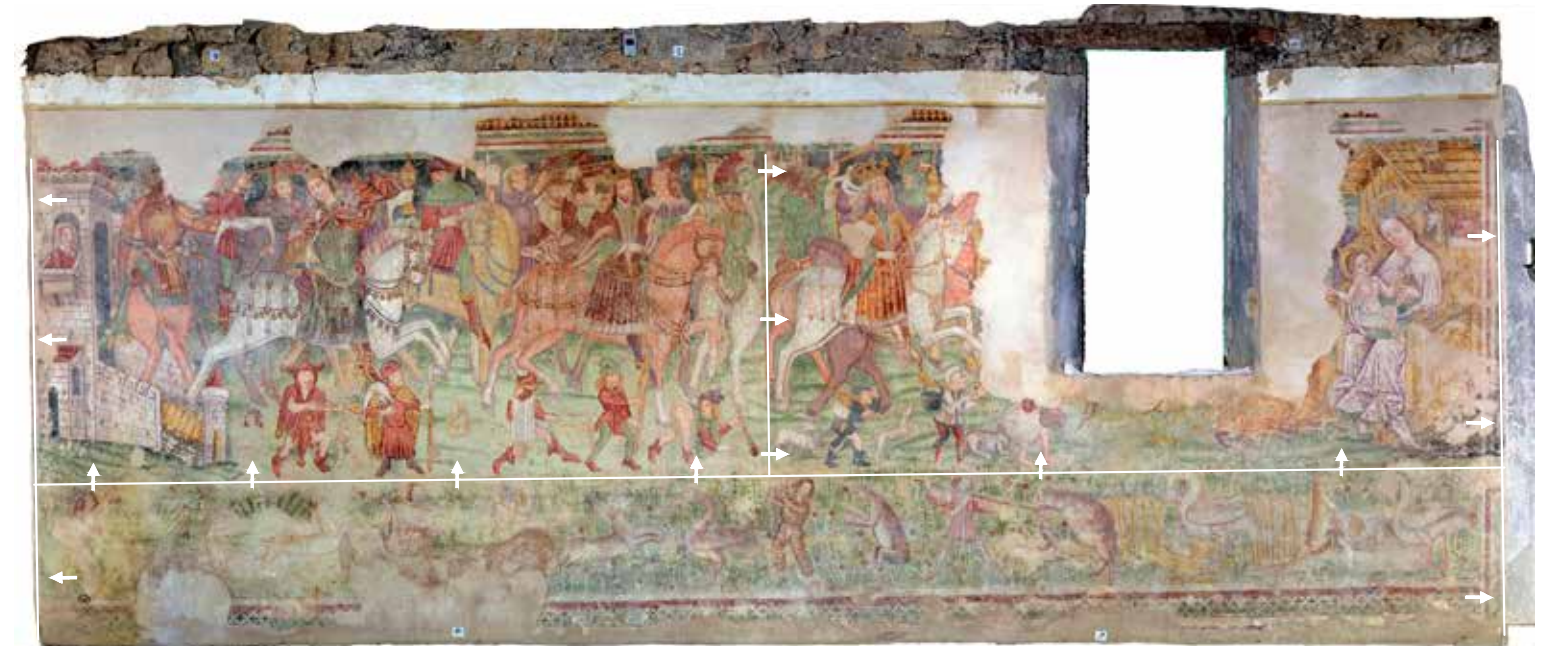
Fig. 2: Graphic presentation of *pontate* on the N wall (image: Summer School archive, 2021).

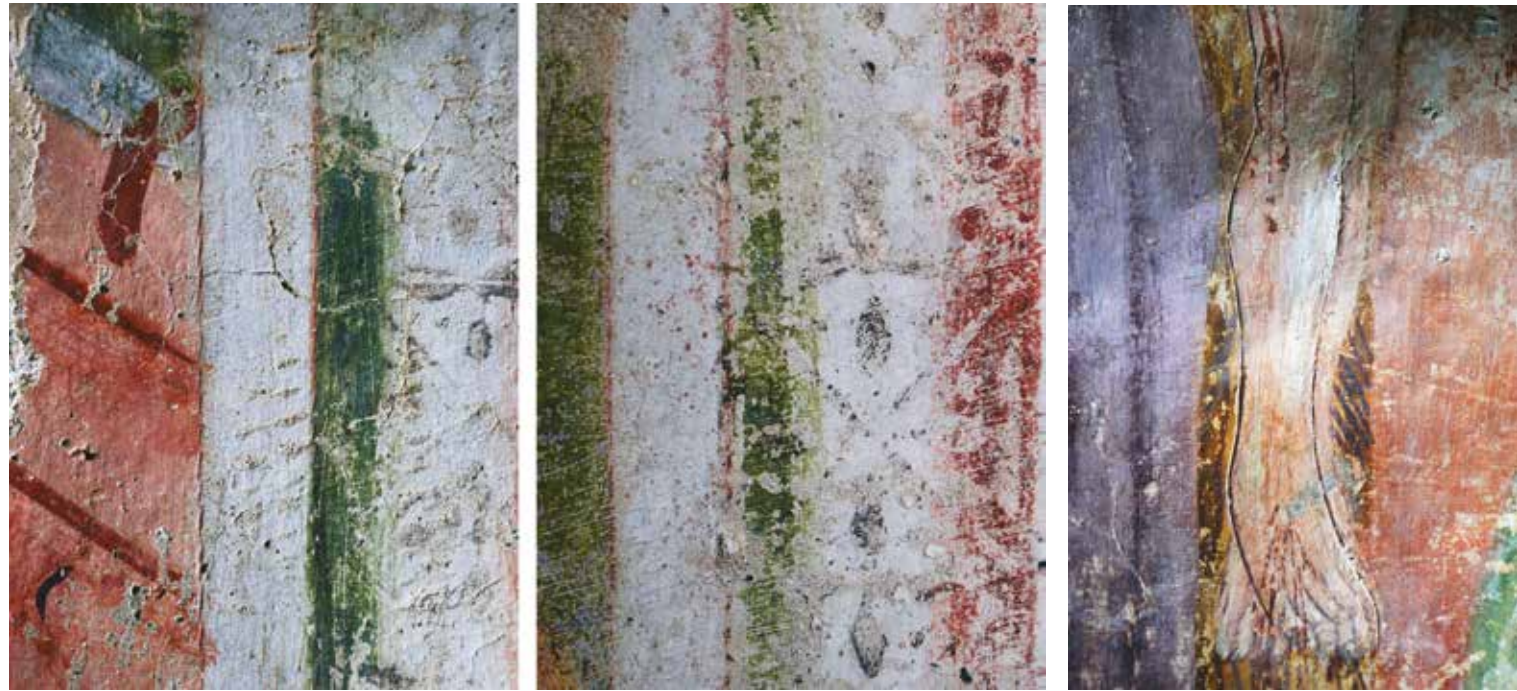
Fig. 3: Imprint of a cord in plaster (left), red lines and drops as a result of snapping the coloured cord (right) (photo: Andrej Jazbec, 2024).

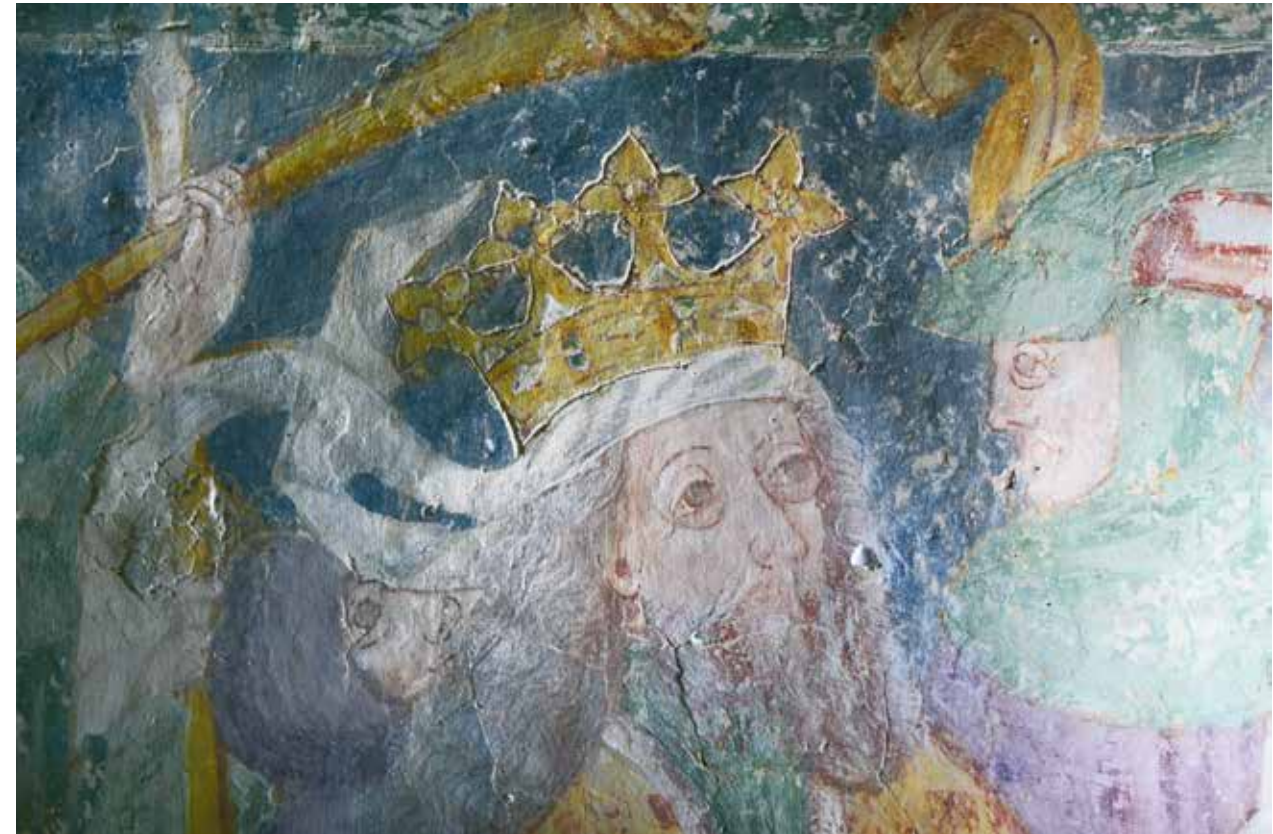
Fig. 5: King Melchior's crown accentuated by direct incisions (photo: Neva Pološki, 2024).

helped them to divide their work, while also enabling them to make corrections that were not possible later on when painting on fresh plaster.¹¹ Different techniques were developed in the course of history. We encounter some that were frequently used in the art of wall painting, in St Helen's church. Painters used a snapped line to mark the boundaries of a scene.¹² The twisted imprint of a cord is visible where it was used when the plaster was still fresh. Sometimes they coloured the cord red before snapping it, so we can also notice a thin red line and small drops of splashed colour (Fig. 3). The south wall contains the inner green scene border – on wall paintings from the Kastav workshops,¹³ they are probably customary.¹⁴ Here and there they are marked by direct incisions, most likely made with a ruler. Direct incisions are also noticed on Christ's legs in the *Crucifixion* scene, and they are most often present on halos. Sharp incisions with pieces of plaster accumulated at the edges indicate that they were made directly on the fresh plaster (Fig. 4). In the first case the painters made incisions by hand with a sharp instrument, while the round halos were achieved with a compass. One can still distinguish the axis of rotation around which the compass turned. Direct incisions are also visible on the crowns of the Kings (Fig. 5), and the most elaborate example is found on the crown and halo of the Virgin Mary.

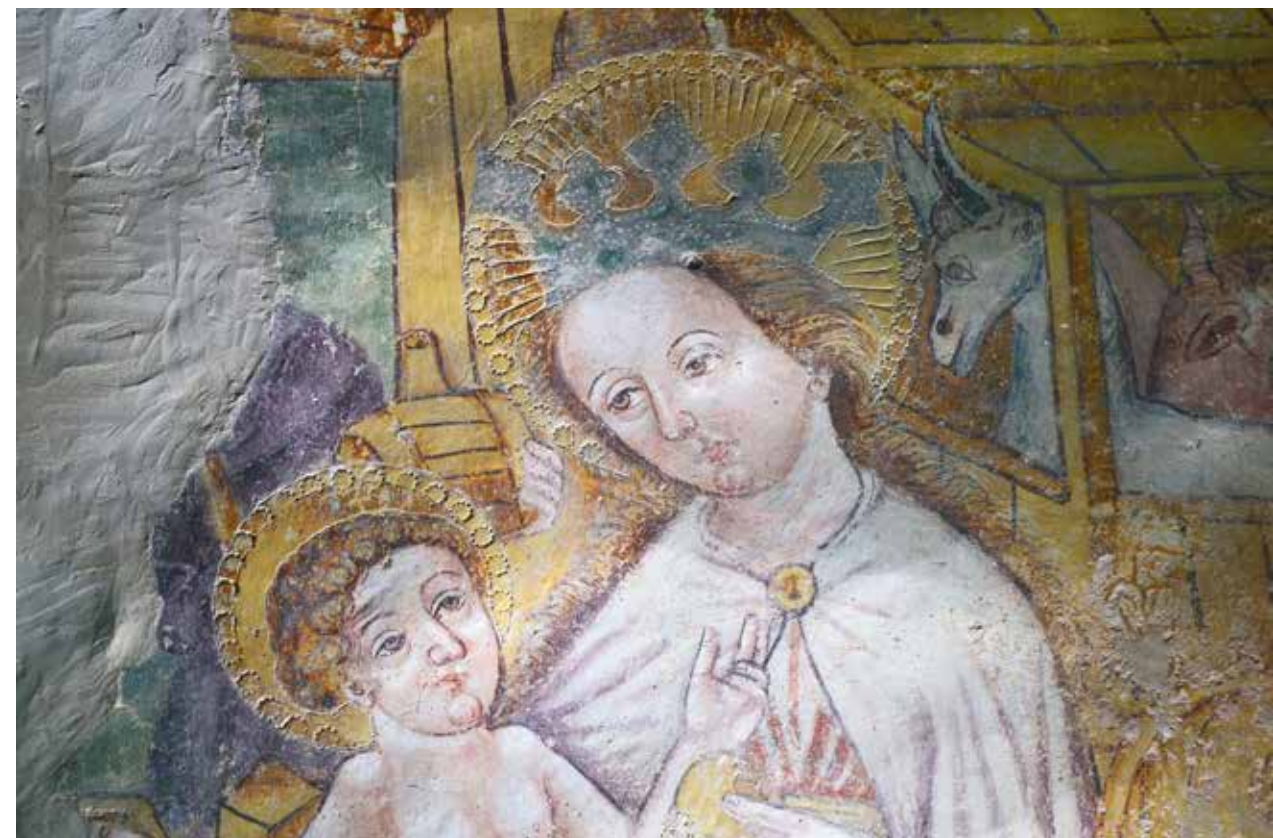
Fig. 6: *Punzonatura* and direct incisions decorating the halos of Jesus and the Virgin Mary (photo: Neva Pološki, 2024).

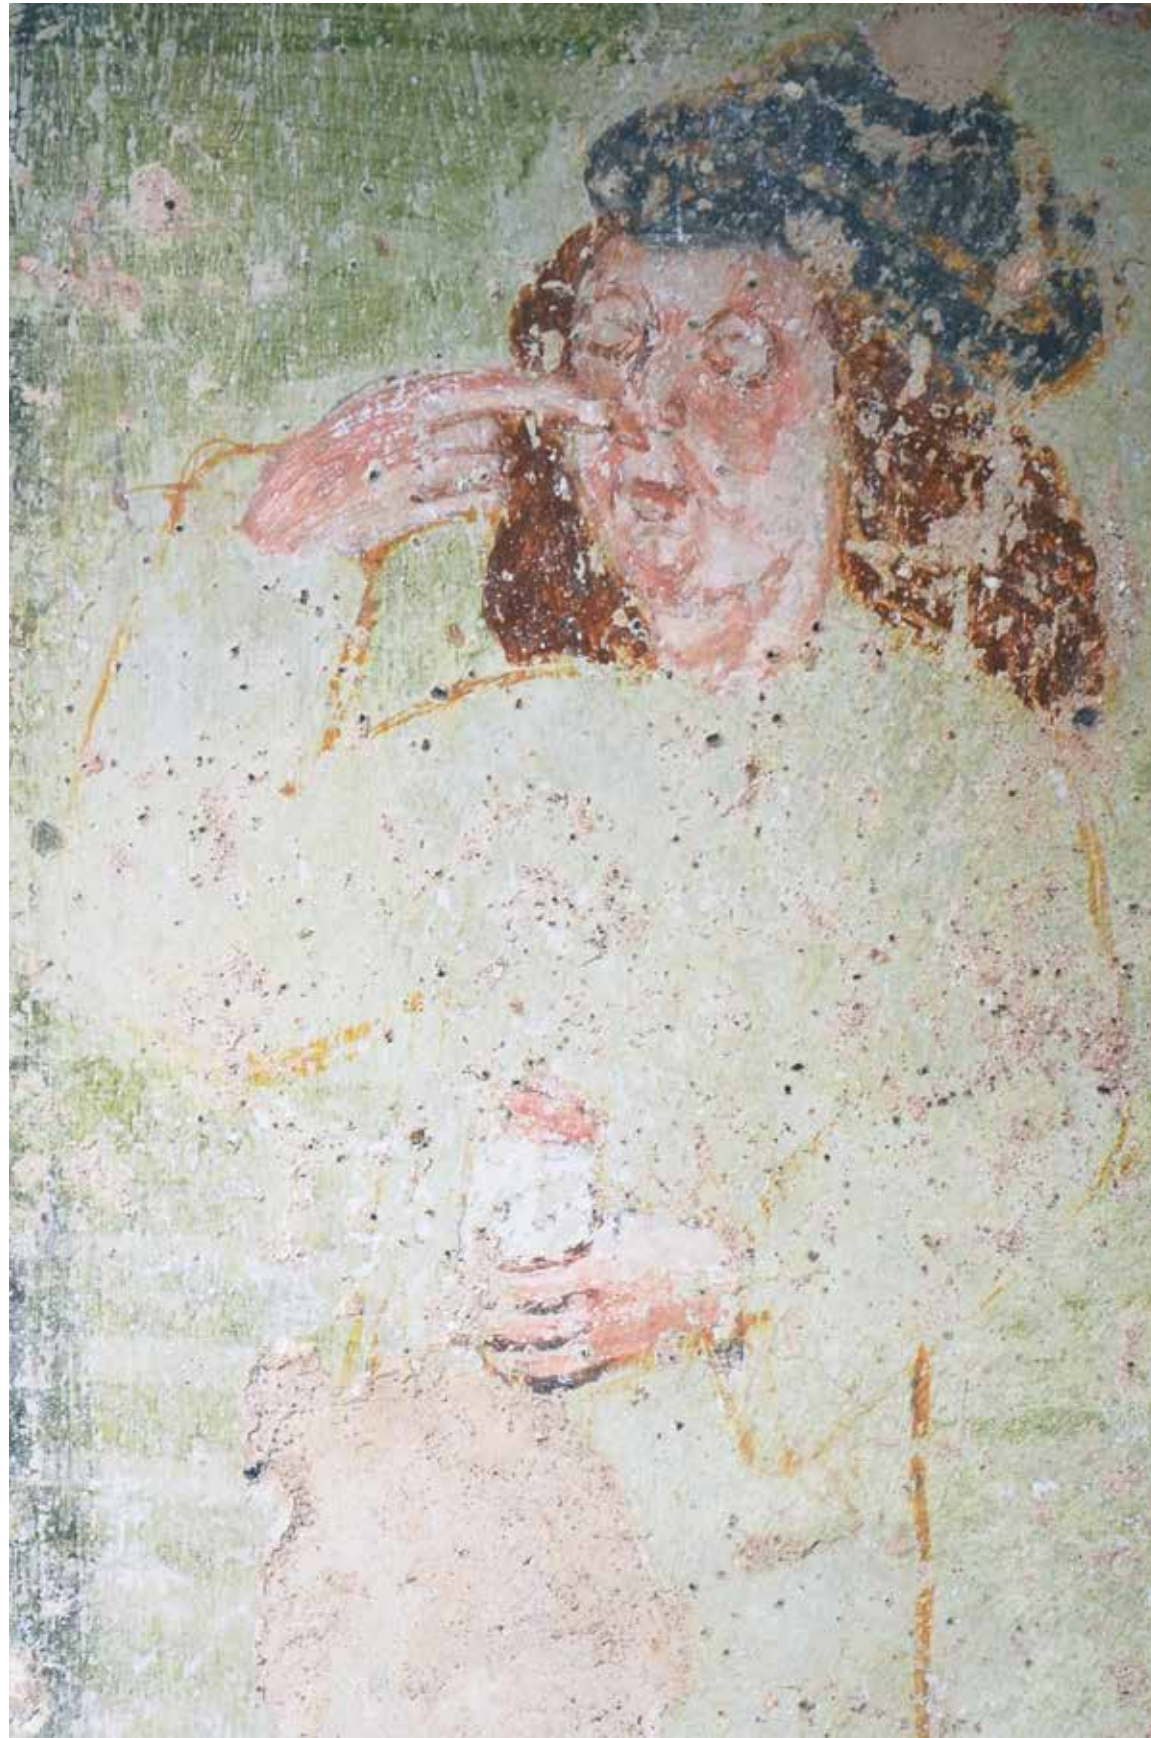
Fig. 7: Preparatory drawing made with yellow ochre, visible as outlines of the robe where the paint layer has fallen off (photo: Andrej Jazbec, 2024).

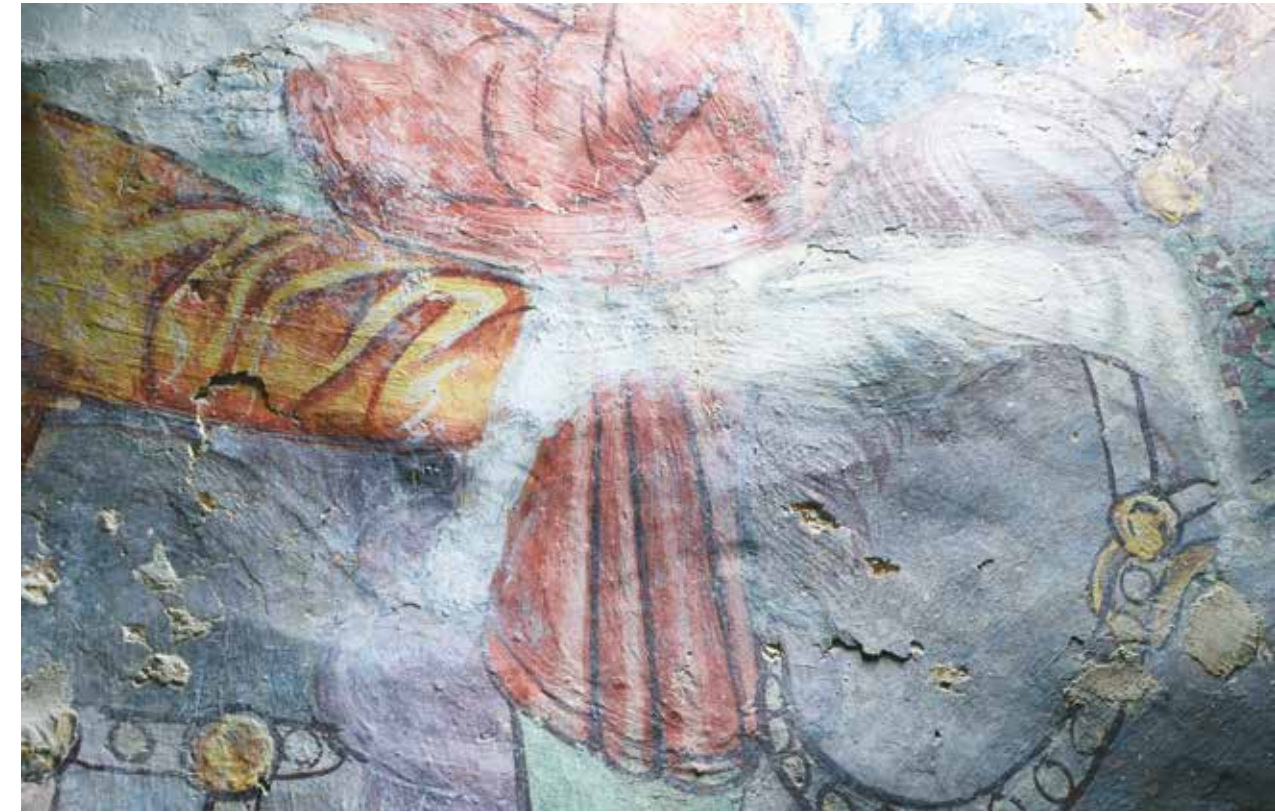
Fig. 8: Visible brushstrokes which suggest the use of lime milk (sometimes tinted) as an under-coating (photo: Andrej Jazbec, 2024).

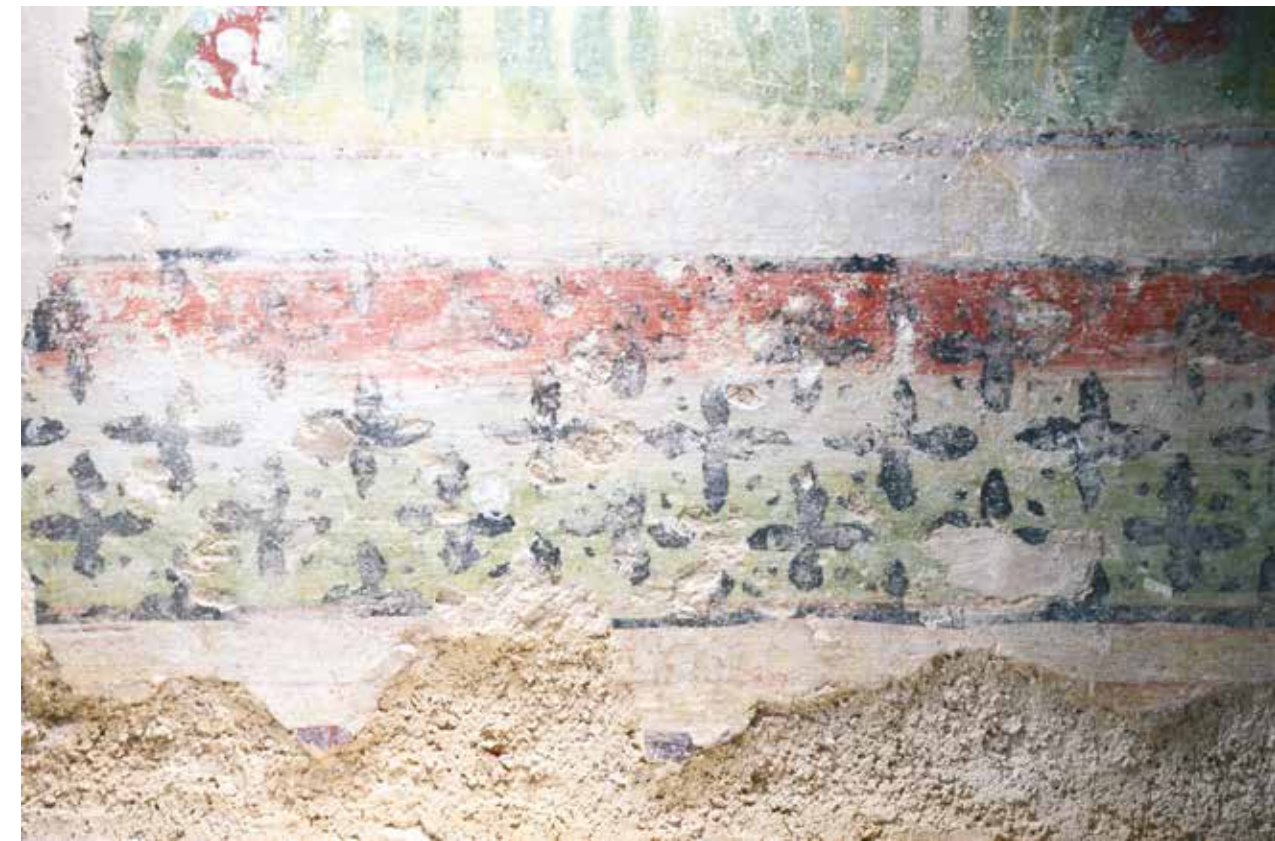
Fig. 9: Frames with an ornamental pattern; lime milk as the white base for red and green stripes (photo: Neva Pološki, 2024).

white and red stripes filled with ornamental patterns, which the painters from Kastav seem to have used most often¹⁹, also have lime milk as the base, serving as white colour (Fig. 9). Finally, the painters used thin brushes to paint details, such as eyes and hair curls, to accentuate the outlines and to add highlights (*lumeggiature*) with lime milk. Paintings were most probably finished *a secco*, using organic binder.

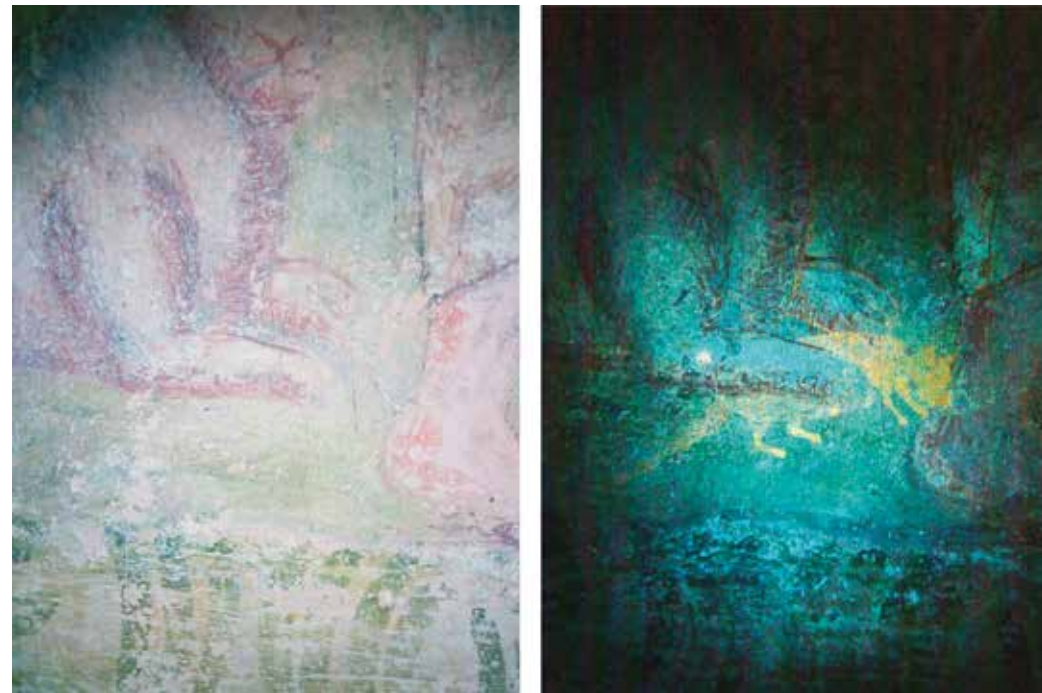
Fig. 10: Detail of lion's paws under visible light (left) and under UV light, which reveals the depiction of a mouse (right) (photo: Summer School archive, 2021).

Orange fluorescence is noticed under UV light, mainly in places where black pigment was used for ornamental patterns on frames and some elements of painted architecture, and it might be caused by organic binder, but the interpretation is still questionable. Observations with UV light showed the depiction of a mouse between the paws of a lion in the *Adoration of the Magi* scene that was completely invisible with standard light (Fig. 10).²⁰ It is therefore a detail that was executed *a secco* and has lost most of its paint layer. Residues of binder and pigment remained, favouring the phenomenon of UV light-induced fluorescence. Immunofluorescence microscopy (IFM) detected egg protein²¹ in two samples, which can indicate painting with egg tempera, but this finding is not unequivocal, as consolidation material can also be a source of protein. Research has found that all the pigments used are compatible with the *a fresco* technique – red and yellow ochre, cinnabar, green earth and carbon black.

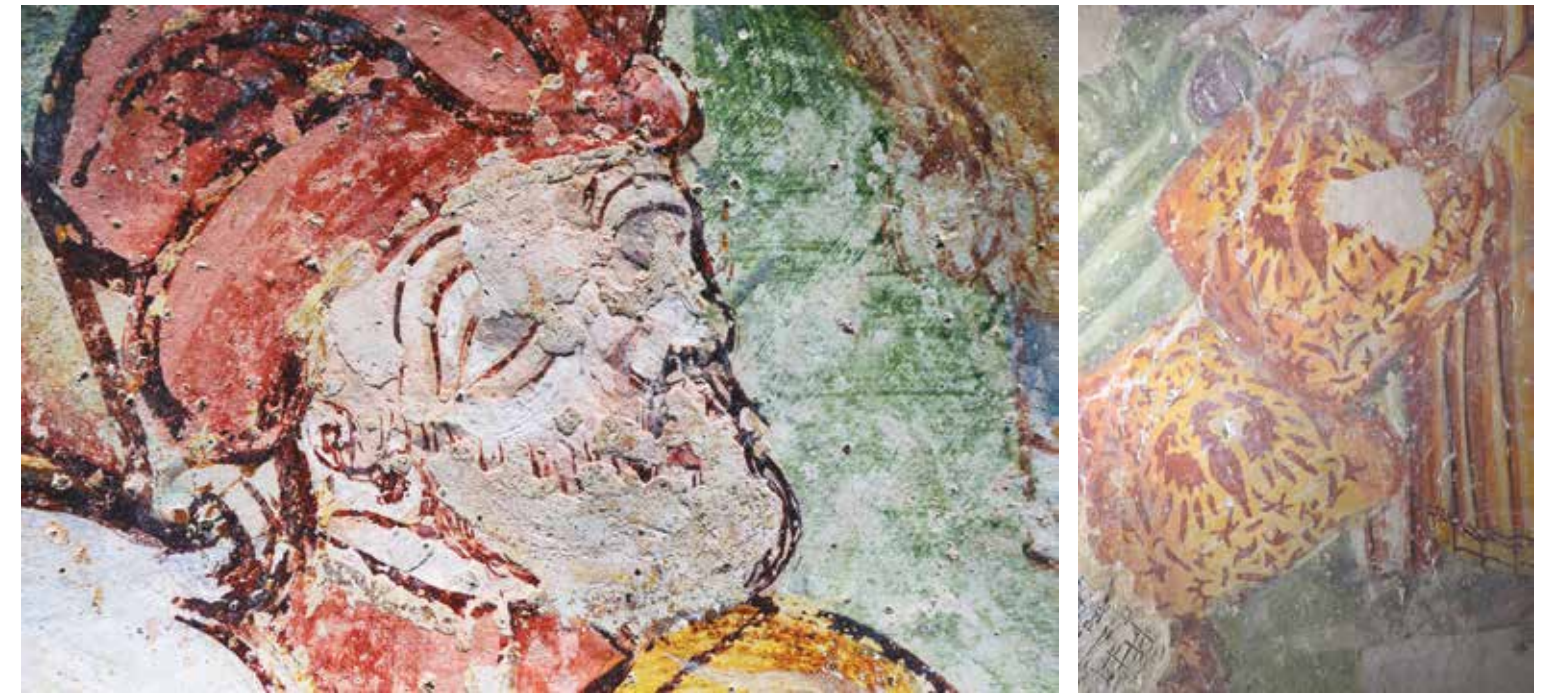
Fig. 11: Damage on the character's face reveals the complex stratigraphy of the paint layer (photo: Andrej Jazbec, 2024). **Fig. 12:** Decoration of the robe representing a bird, made using a stencil (photo: Neva Pološki, 2024).

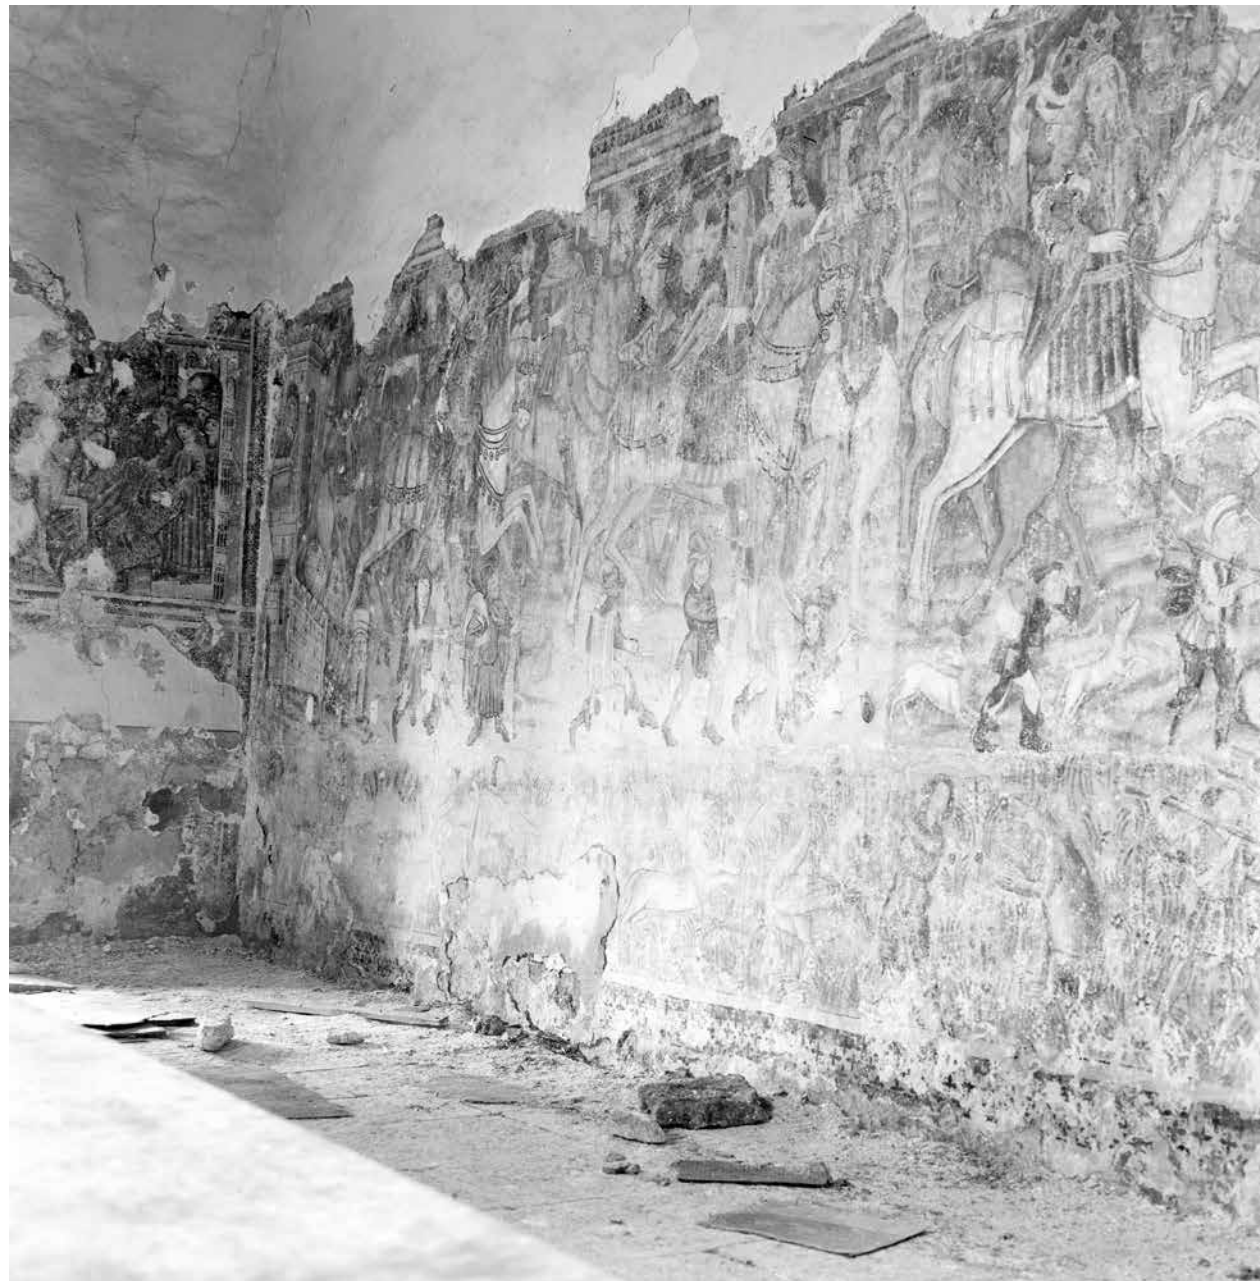
Slika 2: Fotografska dokumentacija stanja poslikav na severni in zahodni ladijski steni ob odkritju v 60. letih 20. stoletja (foto: Emil Smole, 1968).
Fig. 2: Photographic documentation of the condition of the paintings on the north and west walls of the nave at the time of their discovery in the 1960s (photo: Emil Smole, 1968).

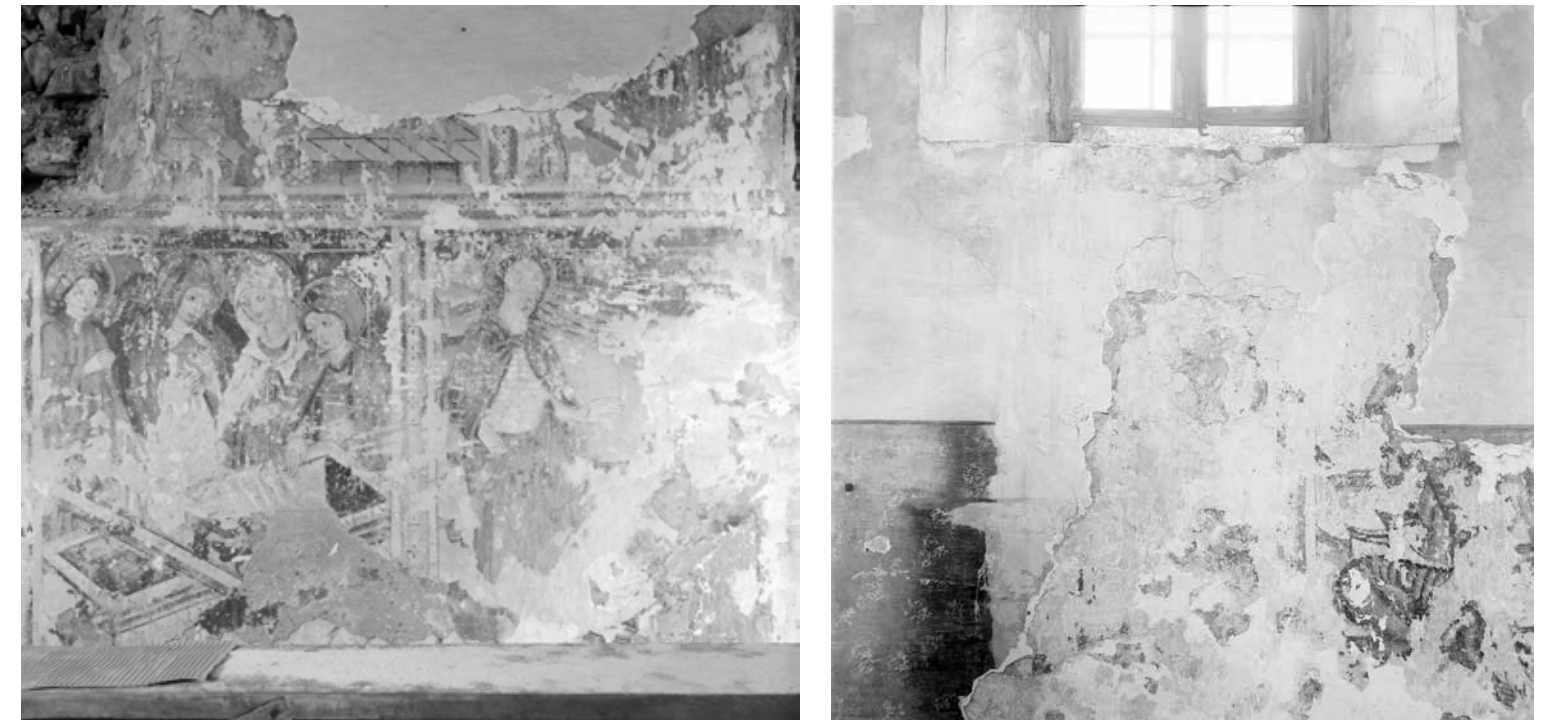
Sliki 3 in 4: Fotografska dokumentacija stanja poslikav na južni ladijski steni ob odkritju v 60. letih 20. stoletja (foto: Emil Smole, 1968).
Figs. 3 and 4: Photographic documentation of the condition of the paintings on the south wall of the nave at the time of their discovery in the 1960s (photo: Emil Smole, 1968).

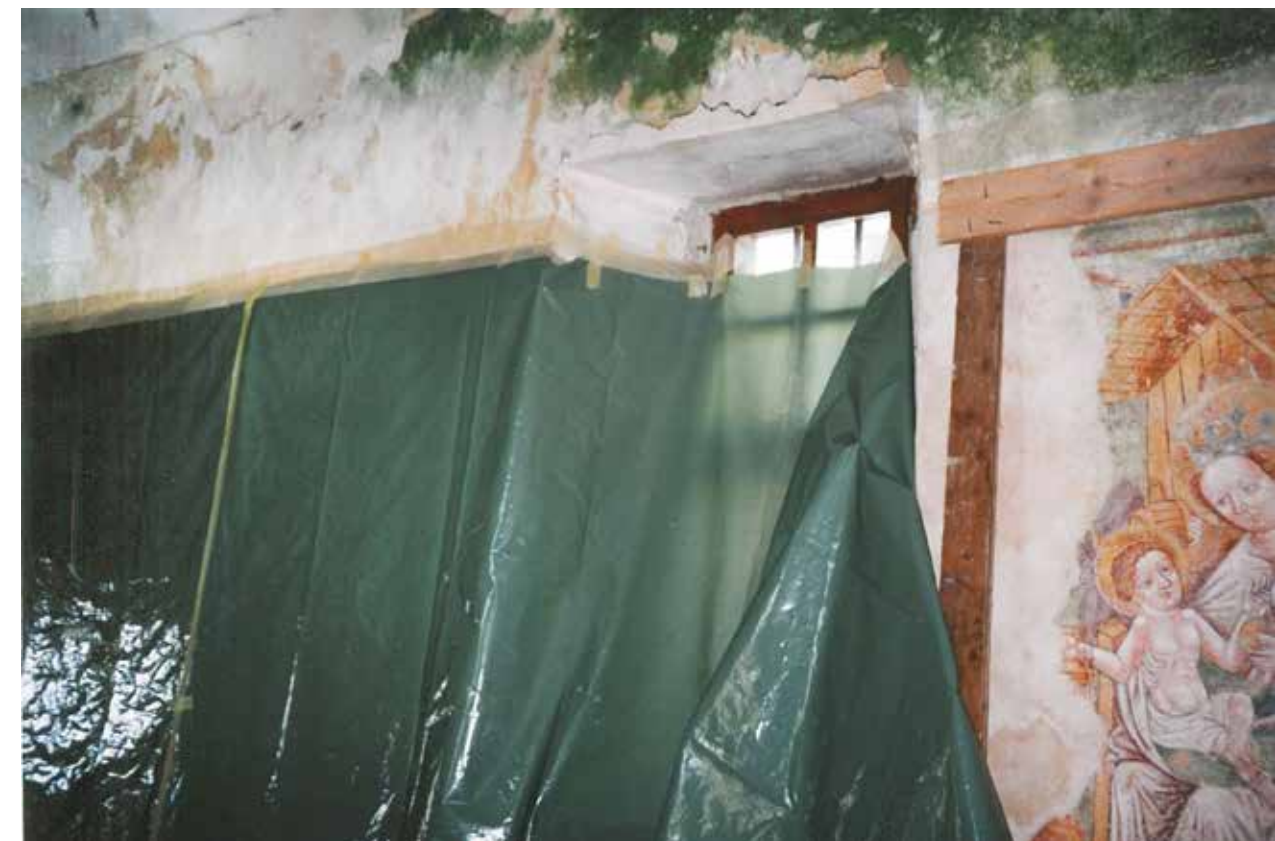
Slika 5: Stanje ostenja v cerkvi oktobra 2001; posnetek dela severne stene ladje (foto: Beta Benko-Mächtigt, 2001).
Fig. 5: The state of the church walls in October 2001; part of the north wall of the nave (photo: Beta Benko-Mächtigt, 2001).

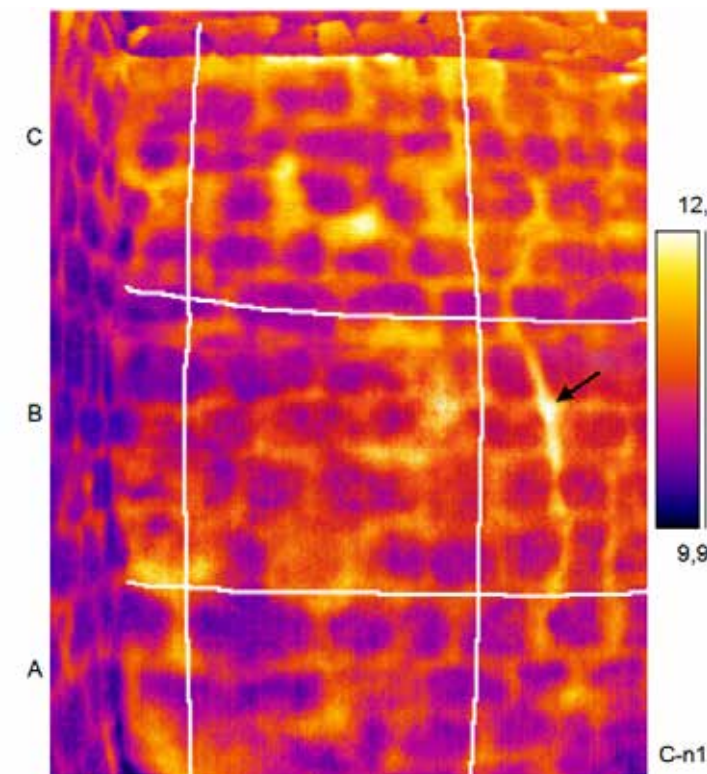
Slika 6: Termografski posnetek levega roba severnega zidu, kjer je opazna večja razpoka (foto: Bojan Težak, 2020).

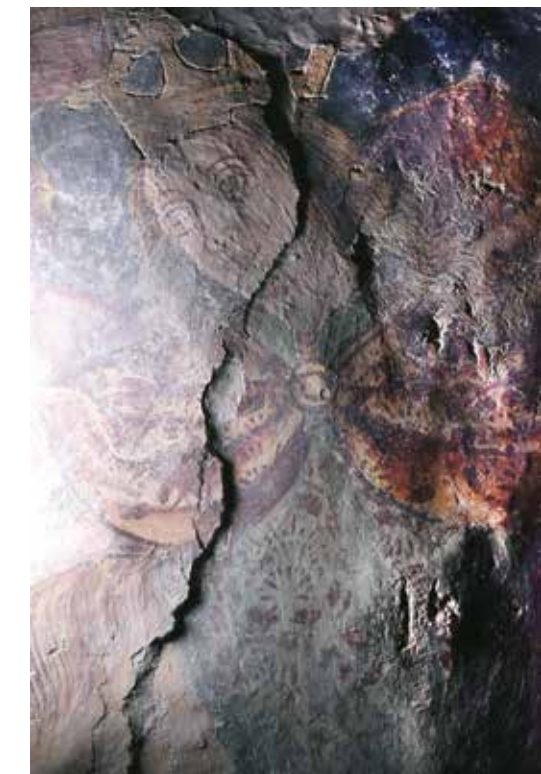
Slika 7: Fotografija razpoke na levem robu severnega zidu ladje pri stranski osvetlitvi (foto: arhiv Poletne šole 2021, 2021).

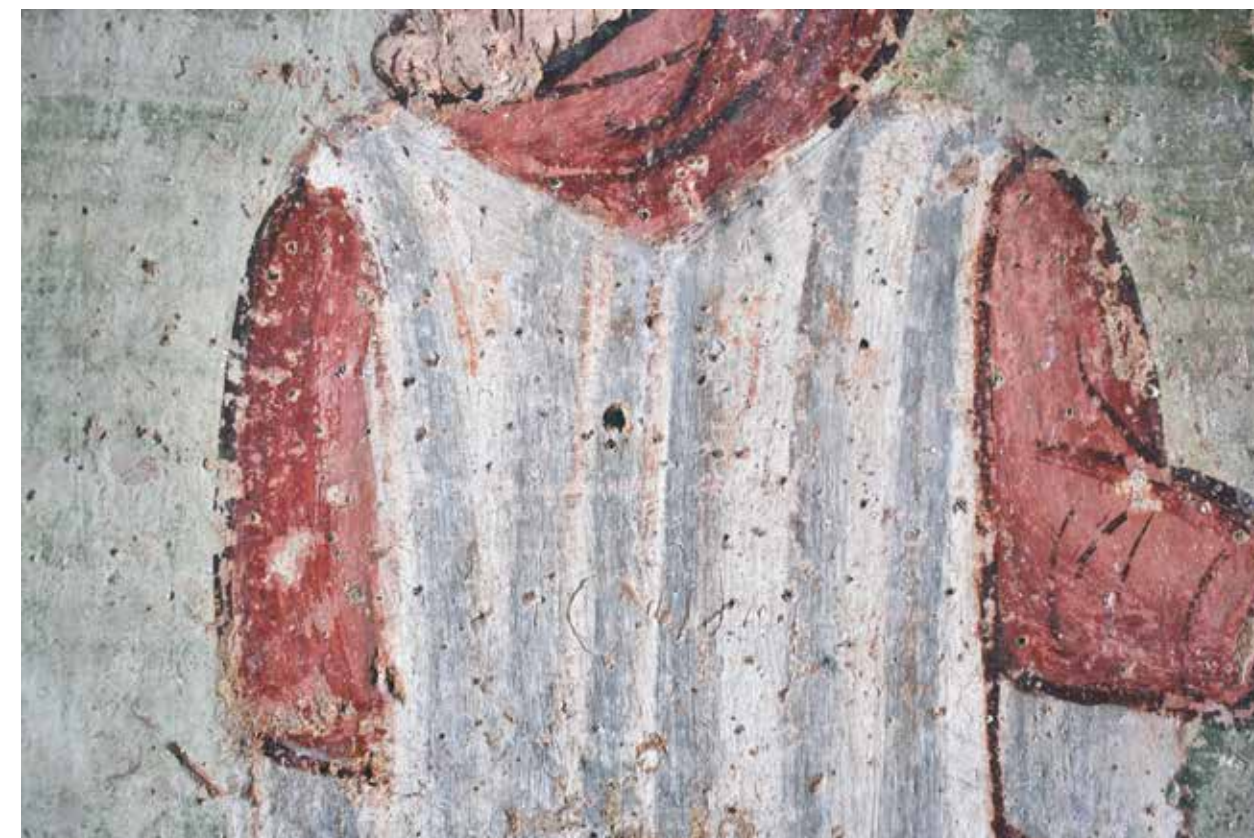
Slika 9: Dobro viden pojav jamičastega razpadanja (*pitting*), luščenje barvne plasti in sledovi grafitov; podrobnost s severne ladijske stene (foto: arhiv Poletne šole 2021).

Fig. 9: Clearly visible pitting, flaking of the paint layer and traces of graffiti; close-up of the north wall of the nave (photo: Summer School archive, 2021).

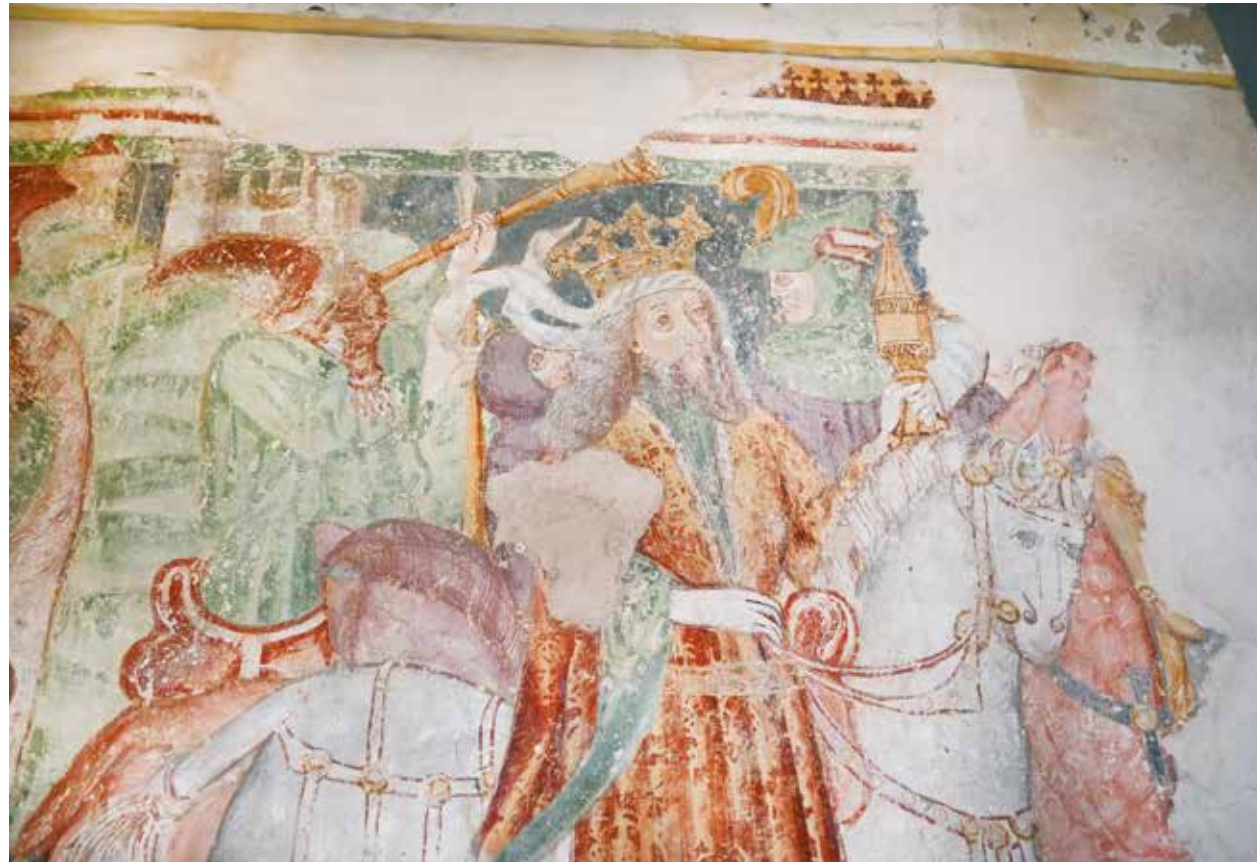
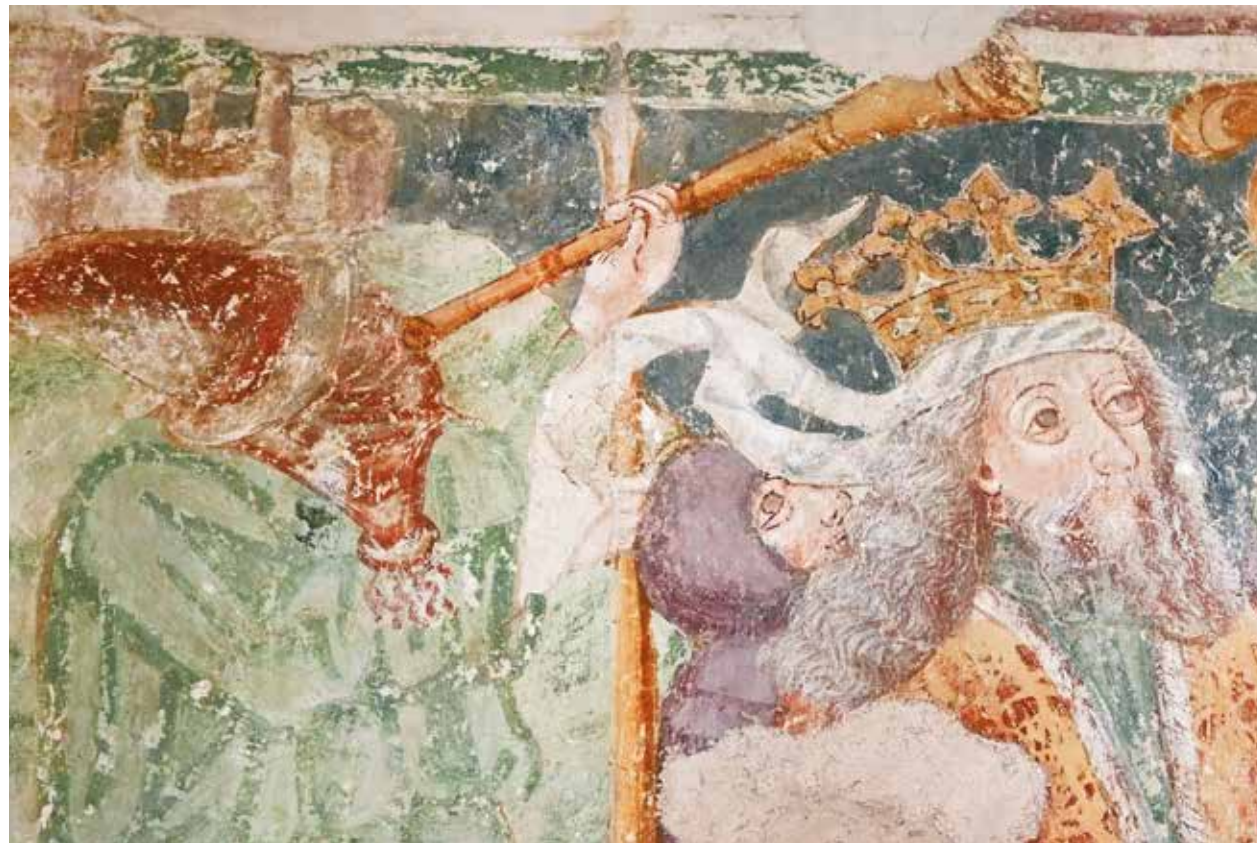
Slika 10: Spremembe barvne plasti, potemtnjenost; podrobnost s severne ladijske stene (foto: Anka Batič, 2023).
Fig. 10: Changes in the paint layer, darkening; close-up of the north wall of the nave (photo: Anka Batič, 2023).

wool when the surface was lightly rubbed with it (swab test). The paintings also showed other localised visual changes in the paint layer, such as saturation of the paint, which could be the result of moisture acting on the surface or the use of binders in previous restoration work. Small areas where the paint layer is slightly darkened (Fig. 10) can be seen on the upper part of the north wall. This may be the result of chemical changes in the organic binder that may have been used in previous restoration work.¹⁵ There are also localised dark or black stains on the north wall, probably due to burning candles.¹⁶ In some places, shiny areas of the paint layer are visible under raking light, but their origin is not clear. Some of the paint layer has yellowed over the years, again probably due to several factors (Fig. 11). Below the windows on the north and south walls there are visually very disruptive traces of water seepage, both in the plastered areas and on the paintings. The streaks and changes in the paint layer are due to an increased amount of water.

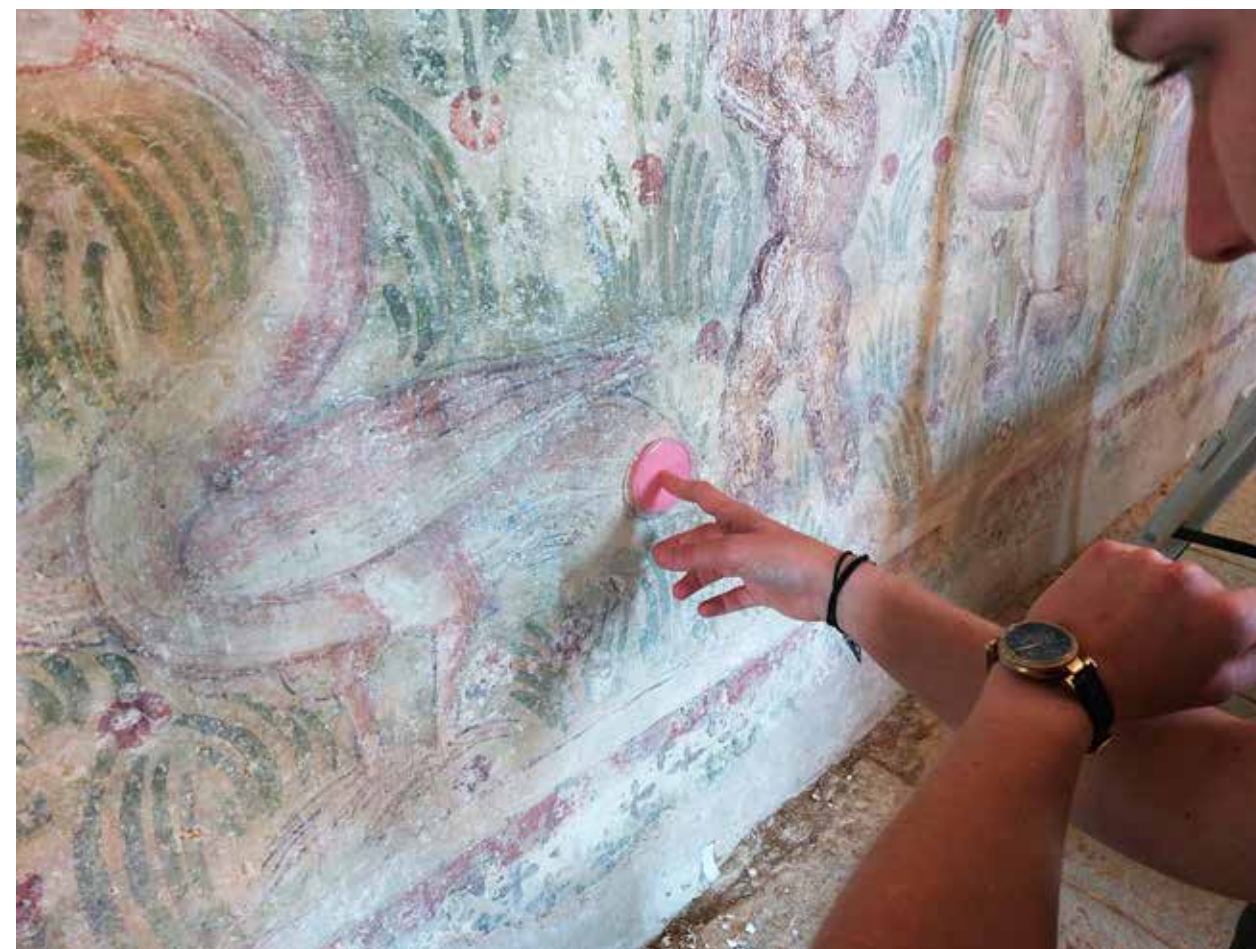
Foto 1: Parete nord, prove di assorbimento dell'acqua (foto: Katarina Bartolj, 2021).
Fig. 1: North wall, water-absorption tests (photo: Katarina Bartolj, 2021).
