CERKEV SV. HELENE NA GRADIŠČU PRI DIVAČI

Mednarodna poletna šola konserviranja-restavriranja stenskih poslikav
– Gradišče Summer School 2021–2023

THE CHURCH OF ST HELEN IN GRADIŠČE PRI DIVAČI

International Summer School for the Conservation-Restoration
of Wall Paintings – Gradišče Summer School 2021–2023

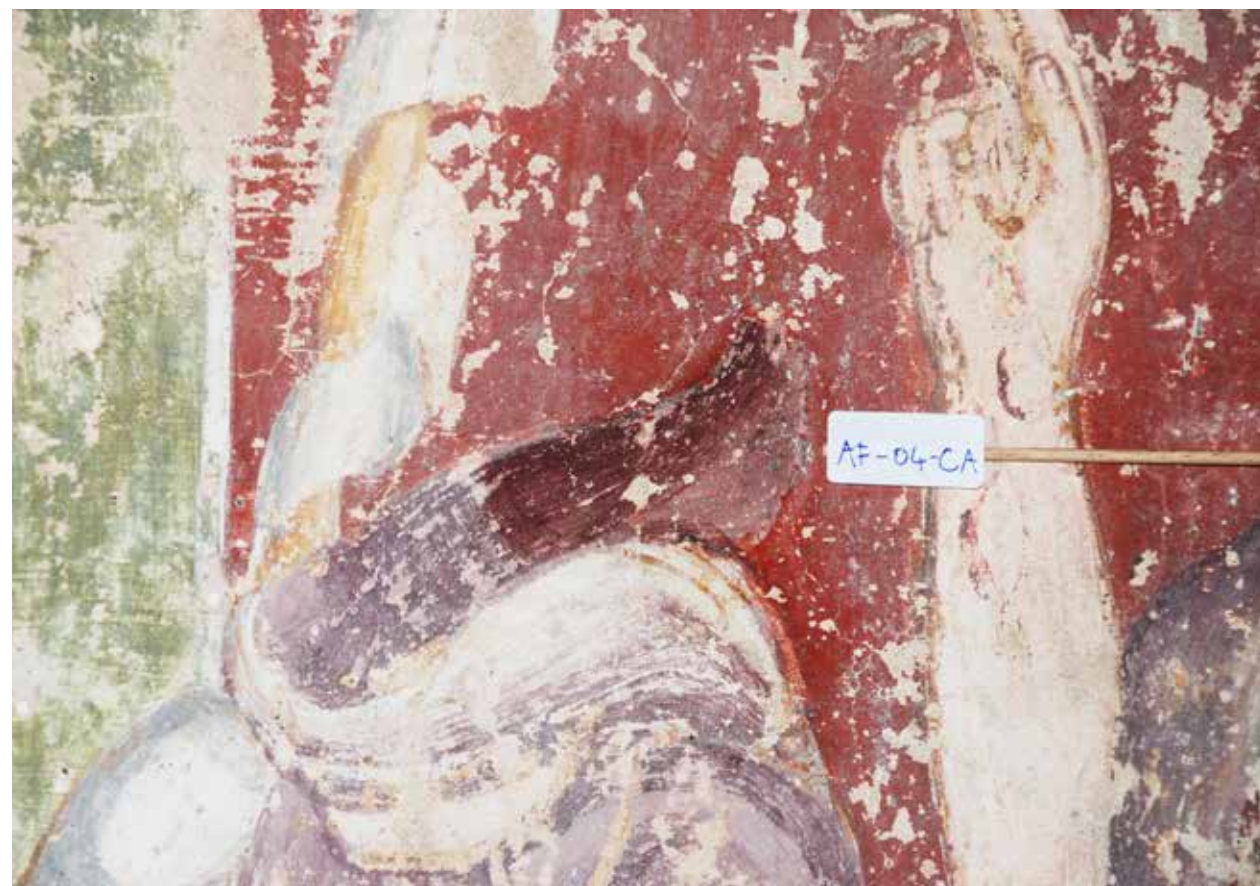
Foto 2: Parete sud, prove di coesione tramite tamponcini di cotone inumiditi di acqua (foto: Alberto Felici, 2021).
Fig. 2: South wall, cohesion tests using cotton swabs moistened with water (photo: Alberto Felici, 2021).

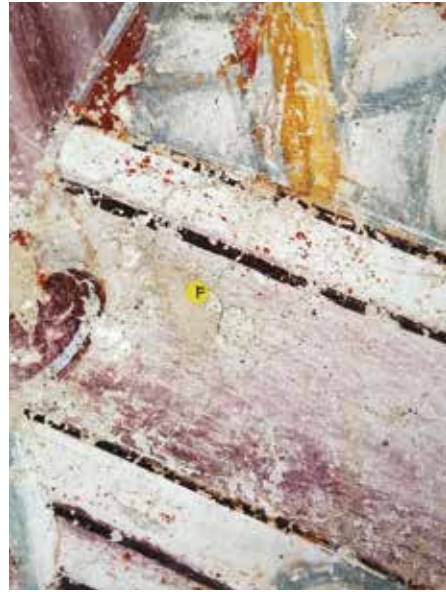
Foto 3a: Parete sud, scena della *Resurrezione*, GDC 35, campione F (foto: Katja Kavkler, 2021).
Fig. 3a: South wall, *Resurrection* scene, GDC 35, sample F (photo: Katja Kavkler, 2021).

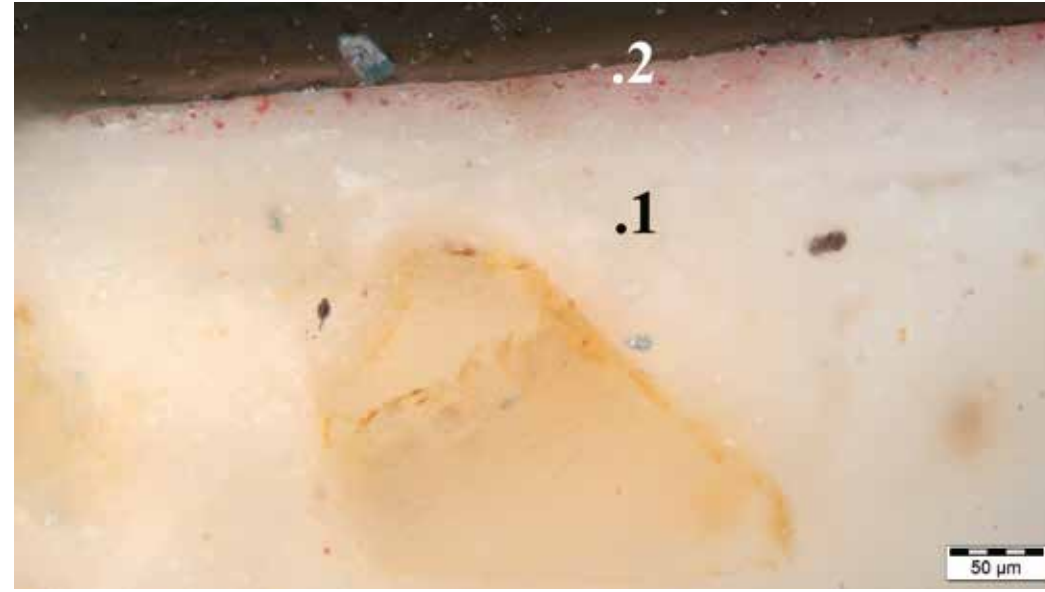
Foto 3b: Parete sud, GDC 35, campione F, applicazione di resine anioniche, 30 minuti di contatto, sezione lucida osservata al microscopio ottico a luce visibile (foto: Katja Kavkler, 2021).
Fig. 3b: South wall, GDC 35, sample F, application of anion resins, 30-minute contact, glossy section observed under a visible-light optical microscope (photo: Katja Kavkler, 2021).

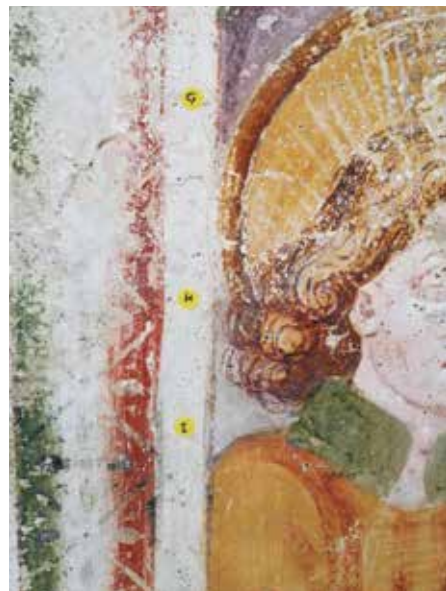
Foto 4a: Parete sud, cornice bianca, scena delle *Tre Marie al sepolcro*, GDC 36, campioni G, H, I (foto: Katja Kavkler, 2021).
Fig. 4a: South wall, white frame, scene of the *The Three Marys at the Tomb*, GDC 36, samples G, H, I (photo: Katja Kavkler, 2021).

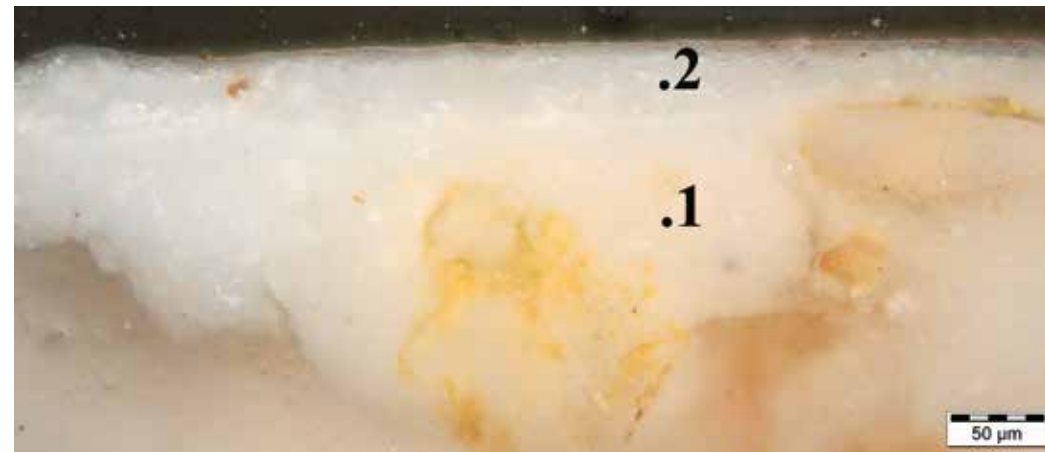
Foto 4b: Parete sud, cornice bianca, scena delle *Tre Marie al sepolcro*, GDC 36, campione G: sezione lucida osservata al microscopio ottico a luce visibile (foto: Katja Kavkler, 2021).
Fig. 4b: South wall, white frame, scene of the *The Three Marys at the Tomb*, GDC 36, sample G: glossy section observed under visible-light optical microscope (photo: Katja Kavkler, 2021).

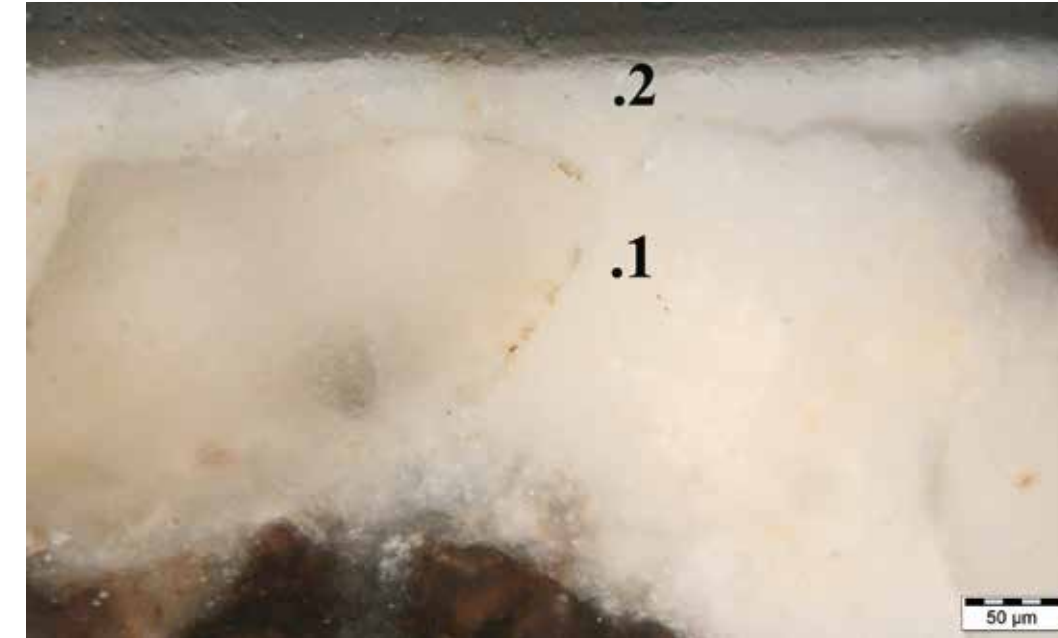
Foto 4c: Parete sud, cornice bianca, scena delle *Tre Marie al sepolcro*, GDC 37, campione H: sezione lucida osservata al microscopio ottico a luce visibile (foto: Katja Kavkler, 2021).
Fig. 4c: South wall, white frame, scene of the *The Three Marys at the Tomb*, GDC 37, sample H: glossy section observed under visible-light optical microscope (photo: Katja Kavkler, 2021).

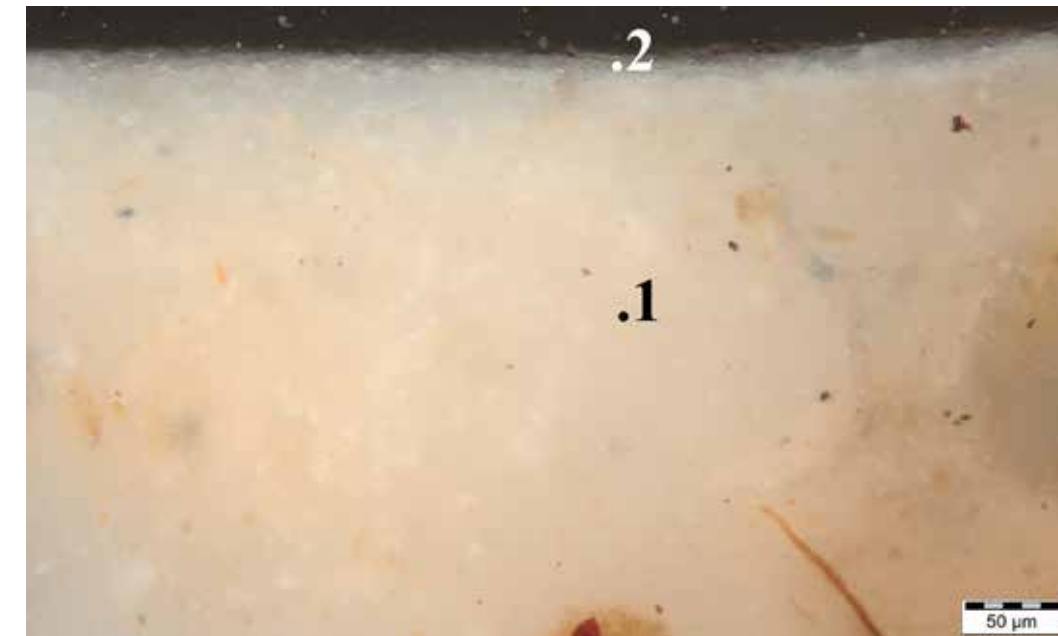
Foto 4d: Parete sud, cornice bianca, scena delle *Tre Marie al sepolcro*, GDC 38, campione I: sezione lucida osservata al microscopio ottico a luce visibile (foto: Katja Kavkler, 2021).
Fig. 4d: South wall, white frame, scene of the *The Three Marys at the Tomb*, GDC 38, sample I: glossy section observed under visible-light optical microscope (photo: Katja Kavkler, 2021).

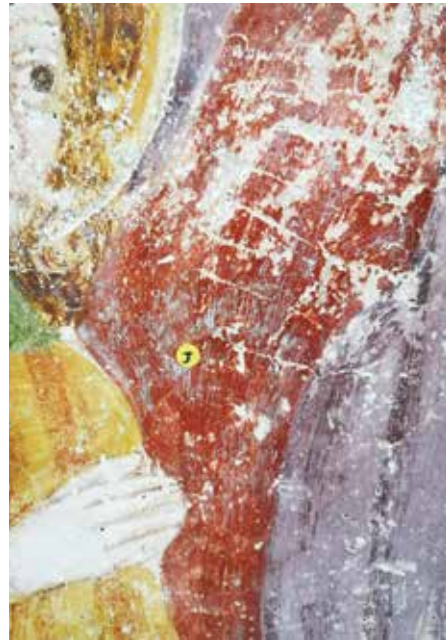
Foto 5a: Parete sud, drappo rosso, scena delle *Tre Marie al sepolcro*, GDC 39, campione J (foto: Katja Kavkler, 2021).

Fig. 5a: South wall, red drape, scene of the *The Three Marys at the Tomb*, GDC 39, sample J (photo: Katja Kavkler, 2021).

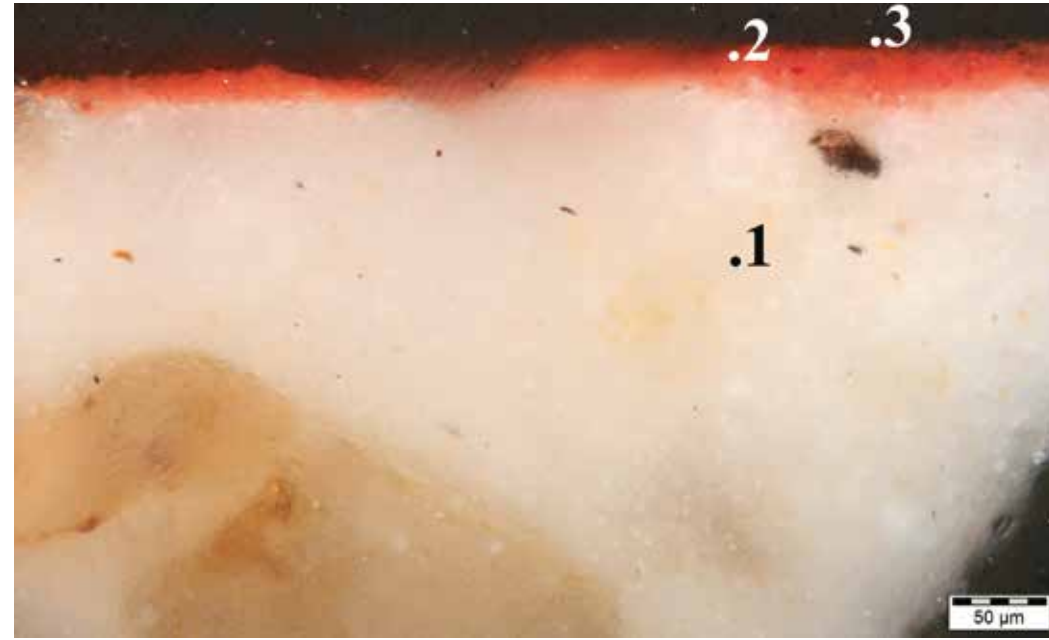
Foto 5b: Parete sud, drappo rosso, scena delle *Tre Marie al sepolcro*, GDC 39, campione J: sezione lucida osservata al microscopio ottico a luce visibile (foto: Katja Kavkler, 2021).

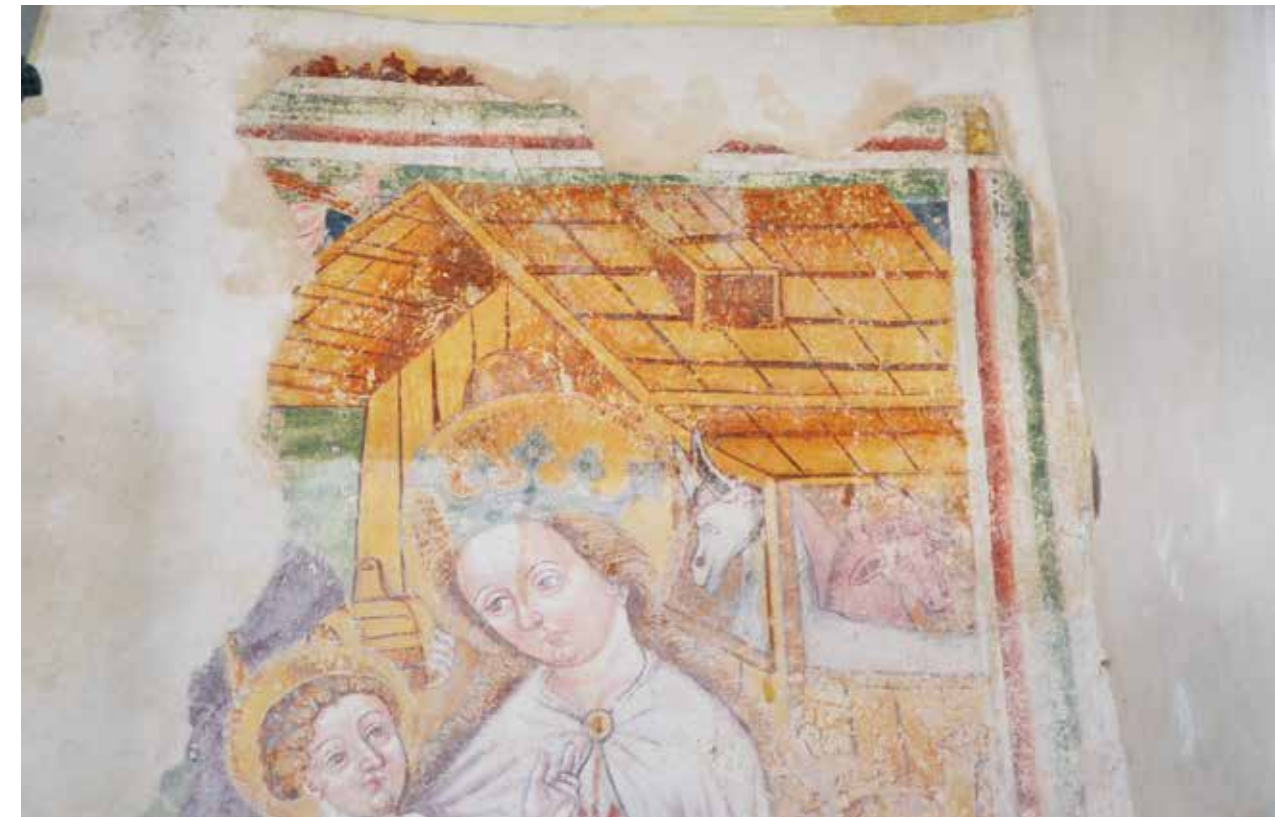
Slika 2: Med postopkom čiščenja z destilirano vodo in gobicami (foto: Nataša L. Jazbec, 2021).

Fig. 2: Painting being cleaned with distilled water and sponges (photo: Nataša L. Jazbec, 2021).

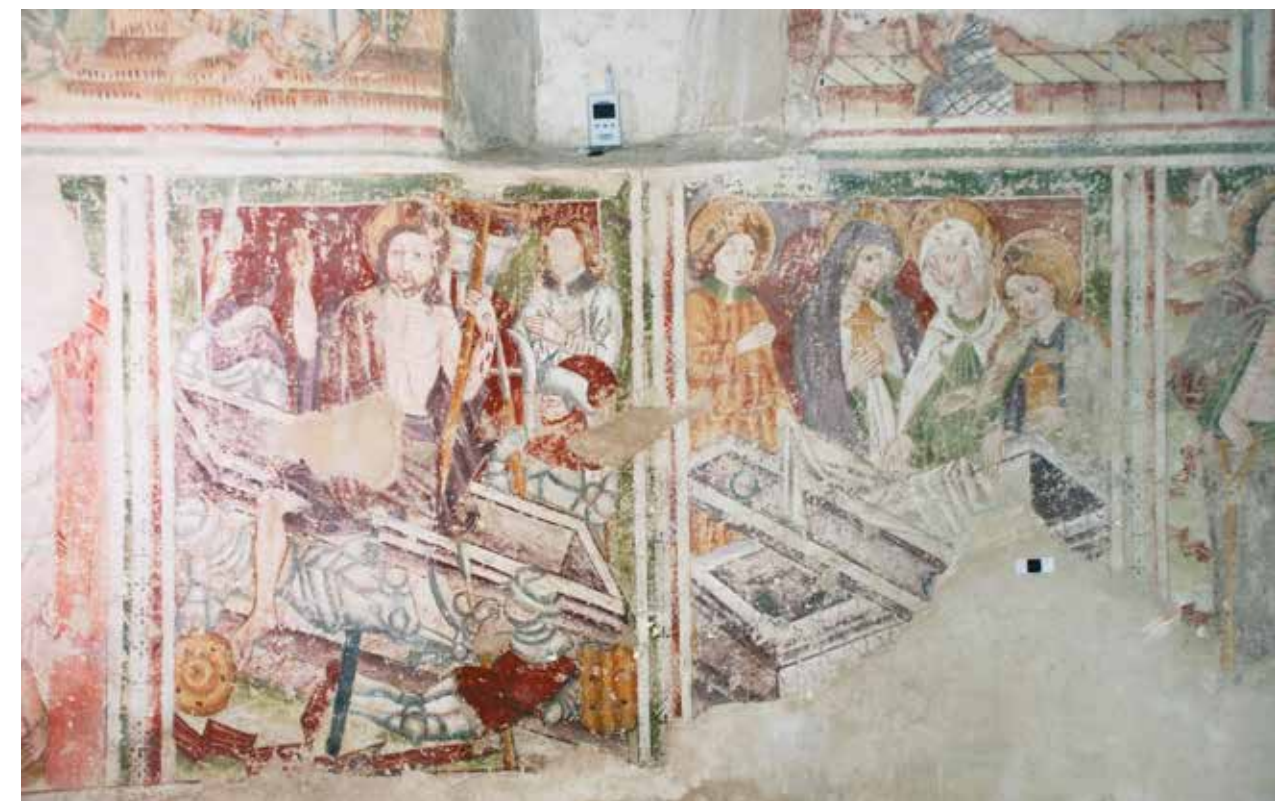
Slika 3: Razlika med očiščeno in neočiščeno površino na južni steni (foto: Anka Batič, 2021).

Fig. 3: The difference between a cleaned and an uncleaned surface on the south wall (photo: Anka Batič, 2021).

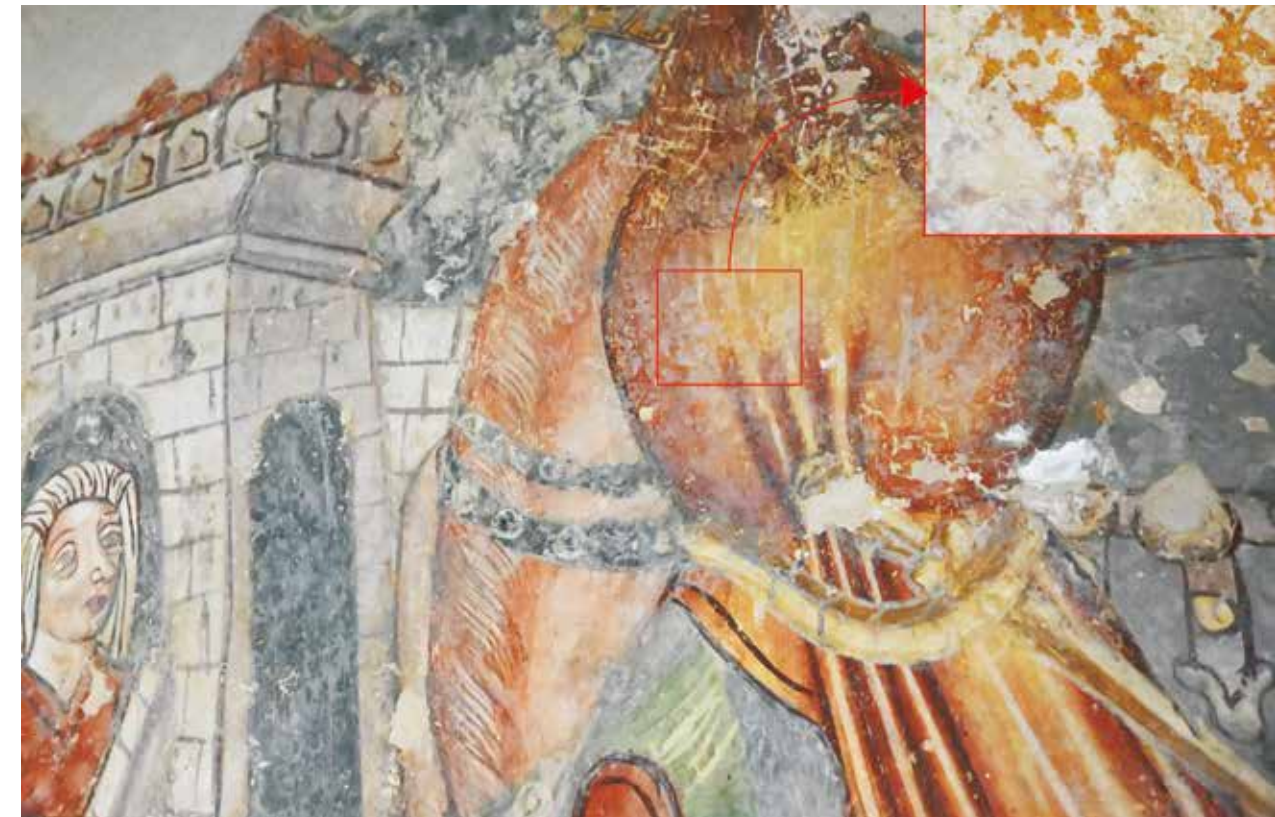
Slika 4: Pojav beljenja po čiščenju z vodo. Zgoraj desno povečava prizadetega dela (foto: Anka Batič, 2021).
Fig. 4: White veil after cleaning with water. Above right, close-up of the affected area (photo: Anka Batič, 2021).

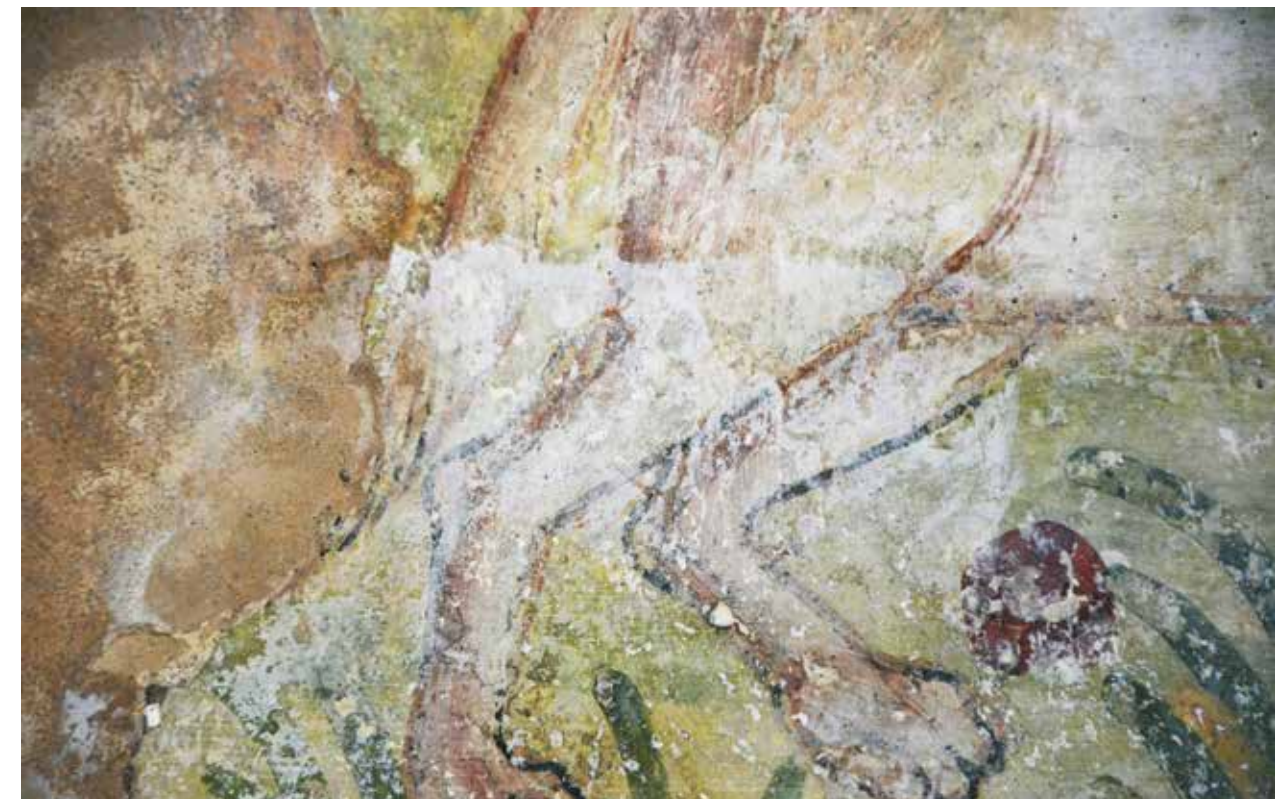
Slika 5: Pojav beljenja na severni steni po čiščenju z amonijevim bikarbonatom (foto: Anka Batič, 2022).
Fig. 5: Whitening on the north wall after cleaning with ammonium bicarbonate (photo: Anka Batič, 2022).

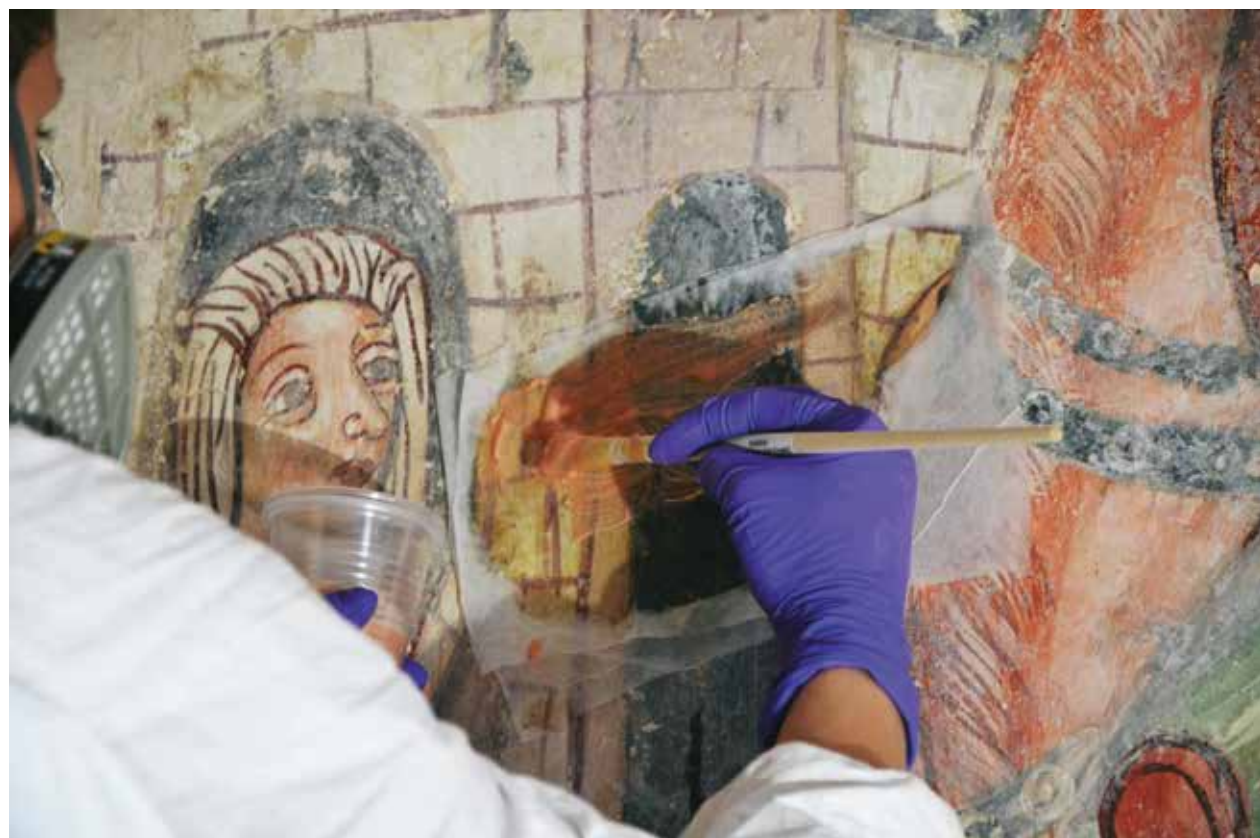
Slika 6: Nanos anionskih smol (foto: Nataša L. Jazbec, 2022).
Fig. 6: Application of anionic resins (photo: Nataša L. Jazbec, 2022).

The cleaning trials also included the use of anion-exchange resins, which promote the surface decontamination from the sulphates and, thanks to their slight alkalinity, facilitate the removal of undesirable substances present on the paint film. To make the treatment more effective and at the same time limit the presence of residual resins grains, the resins were applied using two sheets of Japanese paper, with a contact time varying from 10 to 30 minutes, during which they were moistened with water to facilitate the extraction of the sulphate ions. The results of these trials are comparable to the results of the tests performed with ammonium salts.

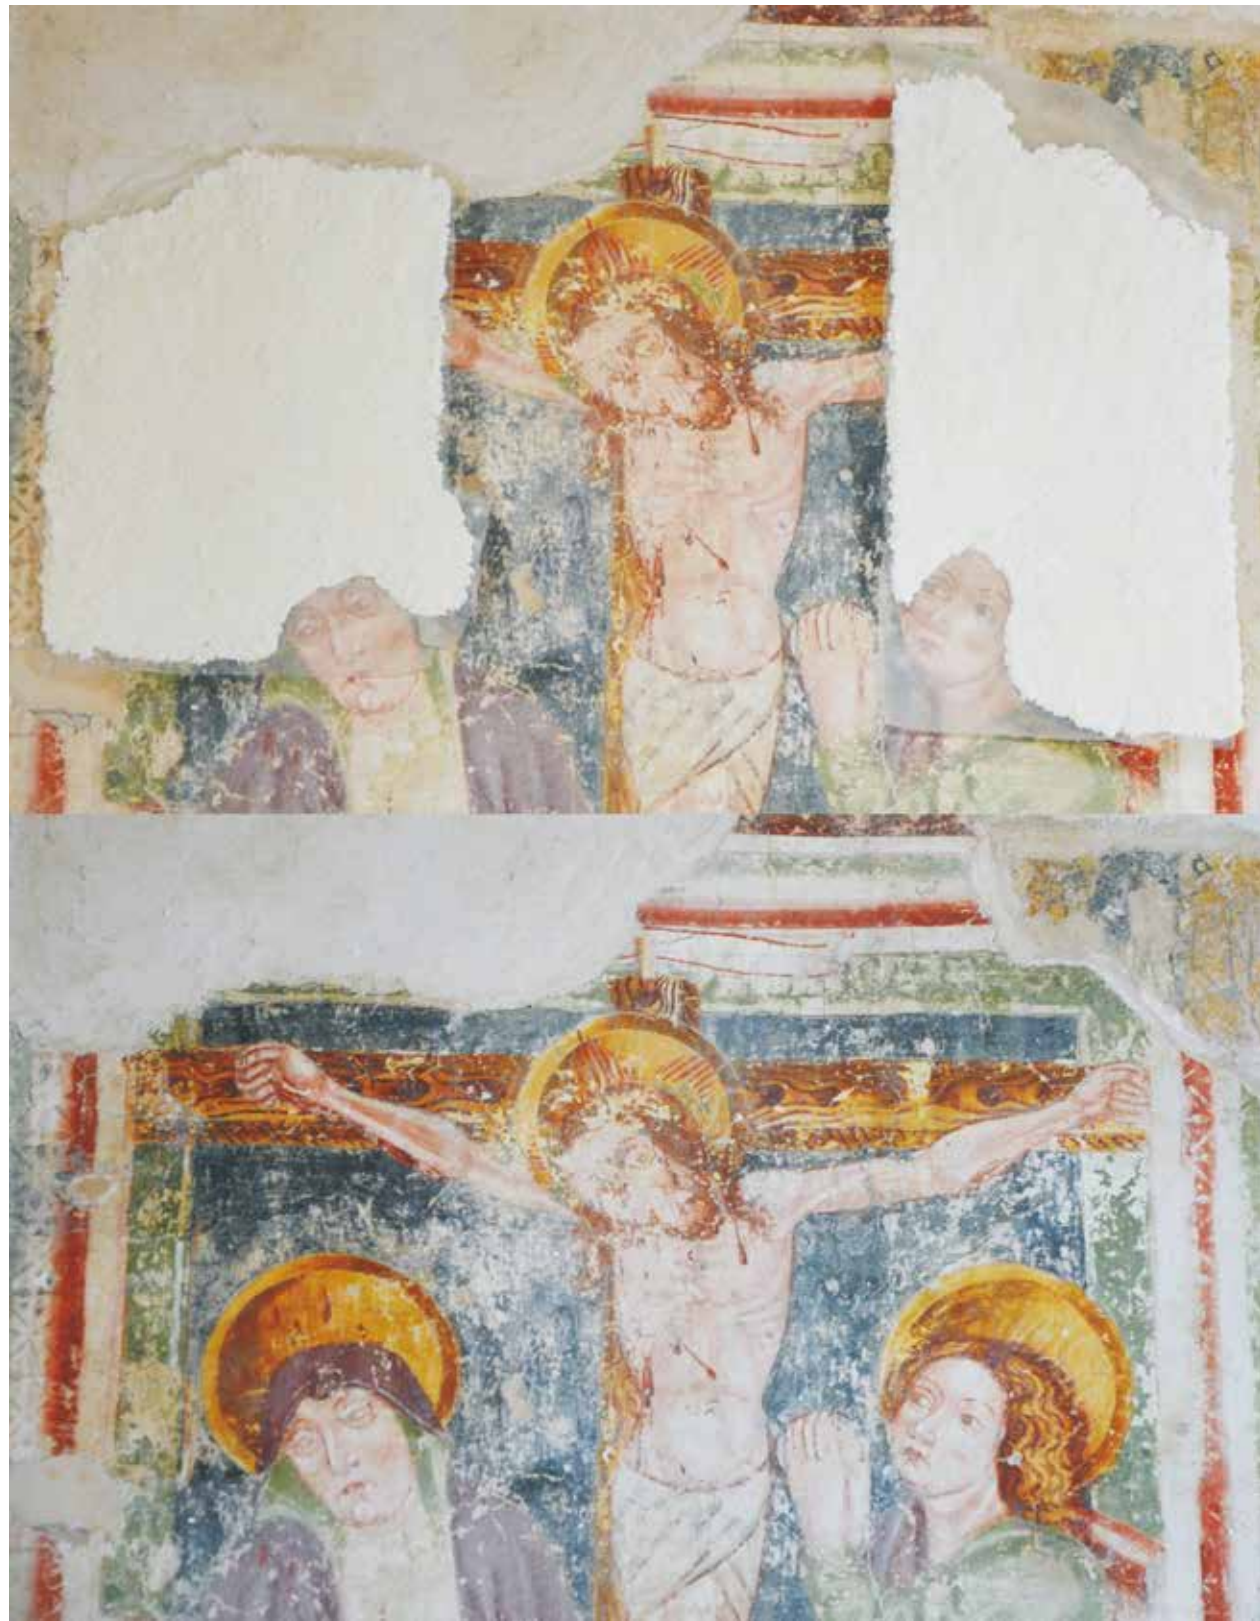
Slika 8: Poskusno utrjevanje z barijevim hidroksidom na prizoru *Križanje*. Zgornja slika: levo enojna in dvojna aplikacija 10-odstotne koncentracije, desno enojna in dvojna aplikacija 6-odstotne aplikacije. Spodnja slika: na mestu 10-odstotne koncentracije je opazna povečana nasičenost barv (foto: Andrej Jazbec, 2023).
Fig. 8: Trial consolidation with barium hydroxide in the *Crucifixion* scene. Image above: at left a single and double application of 10% concentration, at right a single and double application of 6% concentration. Image below: the area with 10% concentration shows an increase in colour saturation (photo: Andrej Jazbec, 2023).

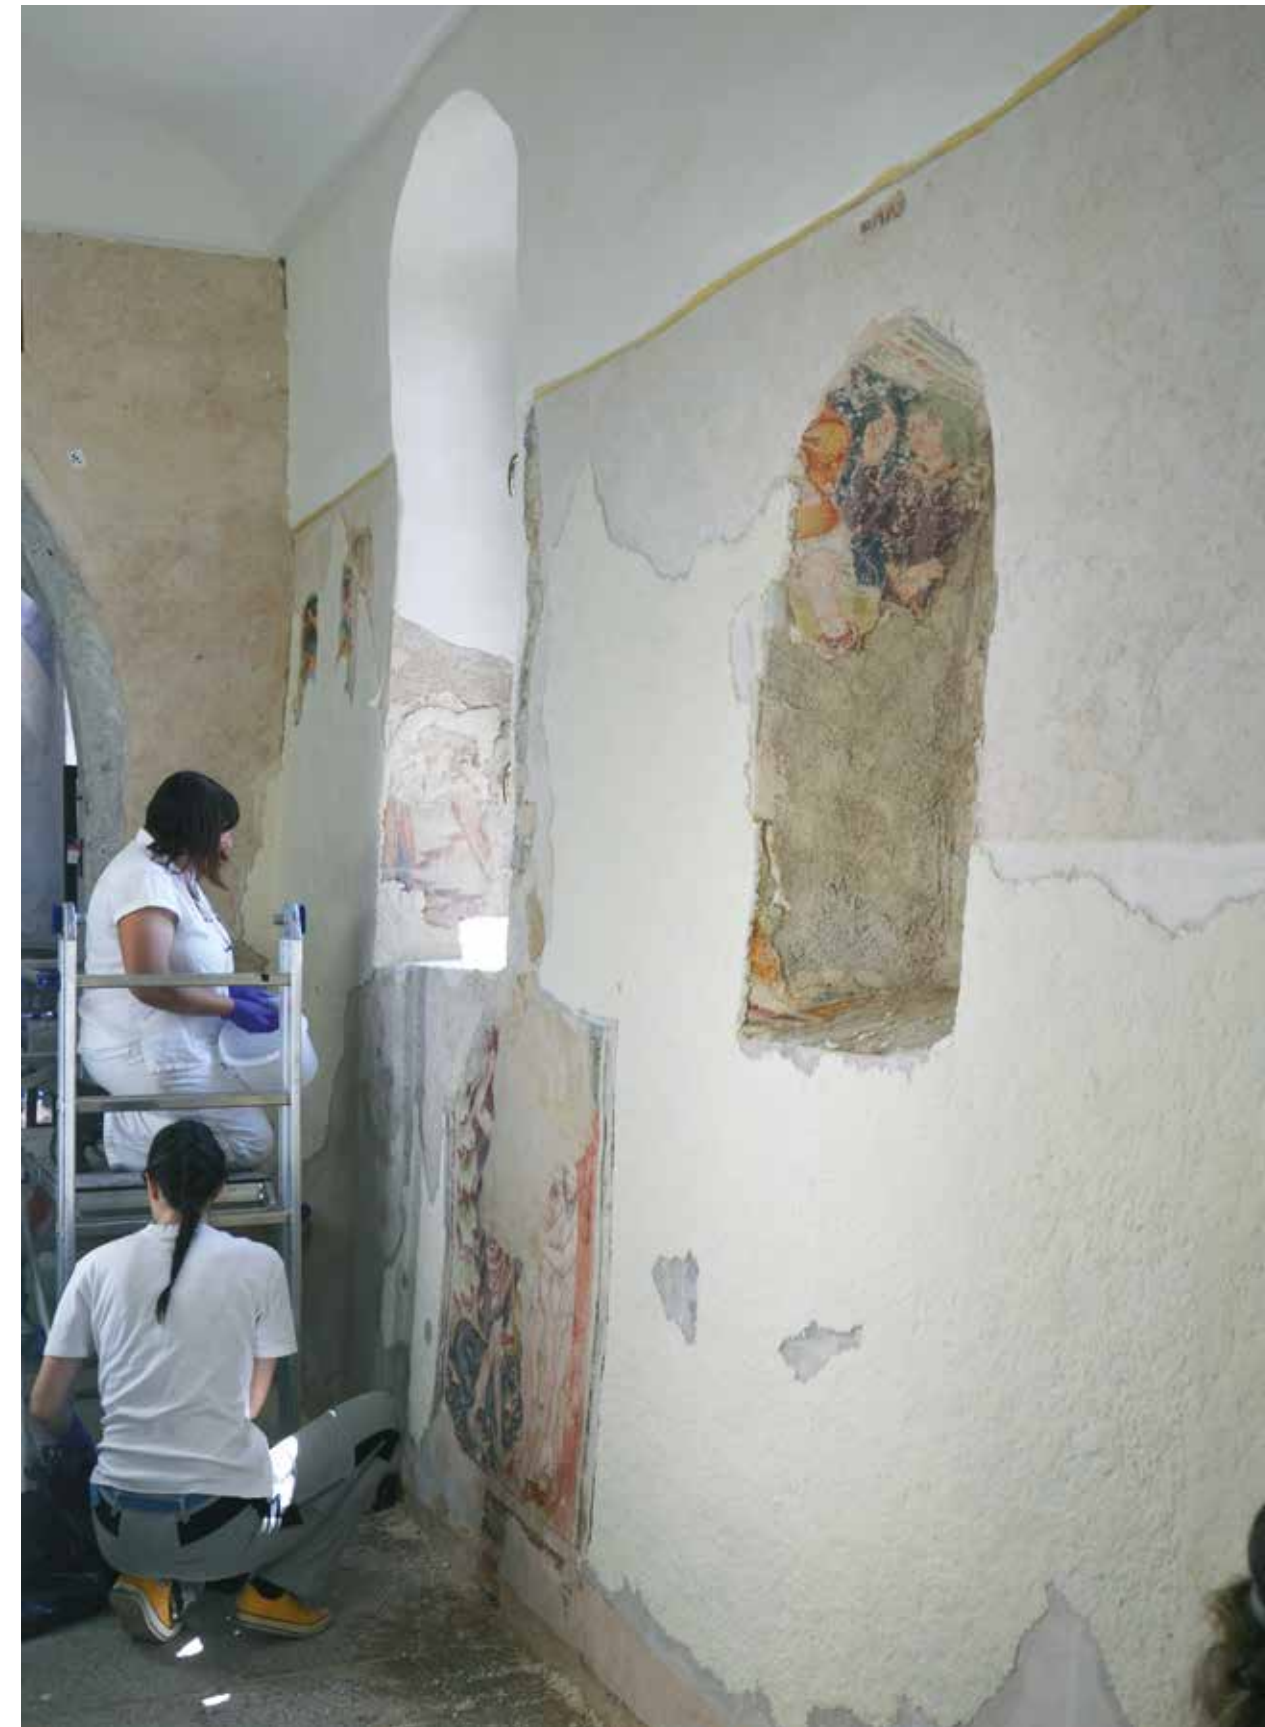
Slika 9: Nanašanje obloge z barijevim hidroksidom (foto: Andrej Jazbec, 2023).
Fig. 9: Applying a barium hydroxide poultice (photo: Andrej Jazbec, 2023).

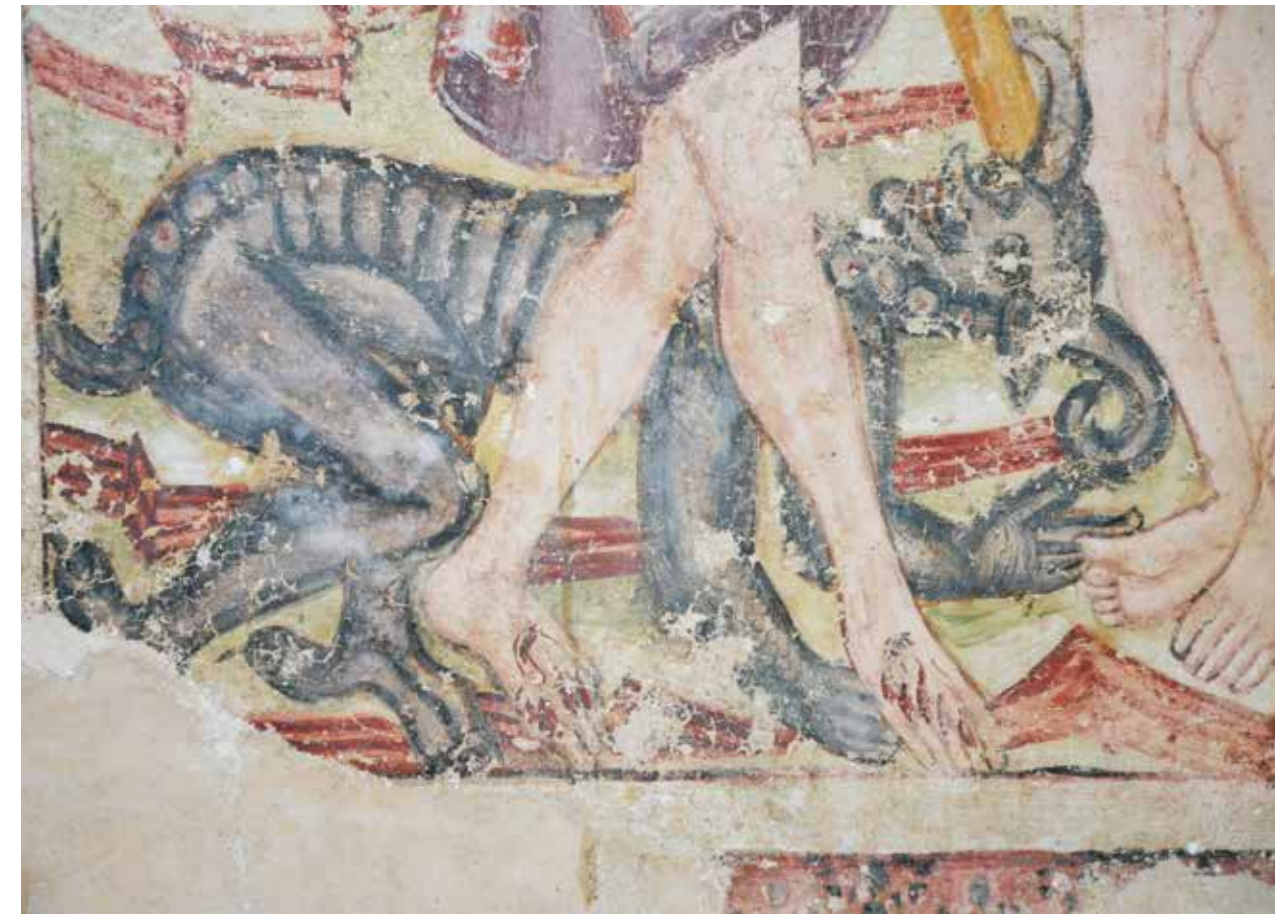
Slika 11: Bele koprne na hudičevem stegnu, ki so se mestoma pojavile po utrjevanju z barijevim hidroksidom (foto: Andrej Jazbec, 2023).
Fig. 11: White veils on the devil's thigh which appeared in places after consolidation with barium hydroxide (photo: Andrej Jazbec, 2023).

A double application of 6% then 10% barium hydroxide did an excellent job of consolidating the paint layer (Fig. 10). The colours have become more vivid and saturated, the paintings are more homogeneous in colour, and there are no longer major tonal variations due to different states of preservation. The porosity of the paintings has also been significantly reduced. The only unwelcome result of this consolidation are the as yet unexplained white stains that have appeared on Christ's white robe in the *Crowning* scene, on Mary's robe in the *Crucifixion* scene, on several of the green robes, and on Satan's thigh in the scene of Christ descending to hell. However, with repeated rinsing these stains also lost their intensity (Fig. 11).

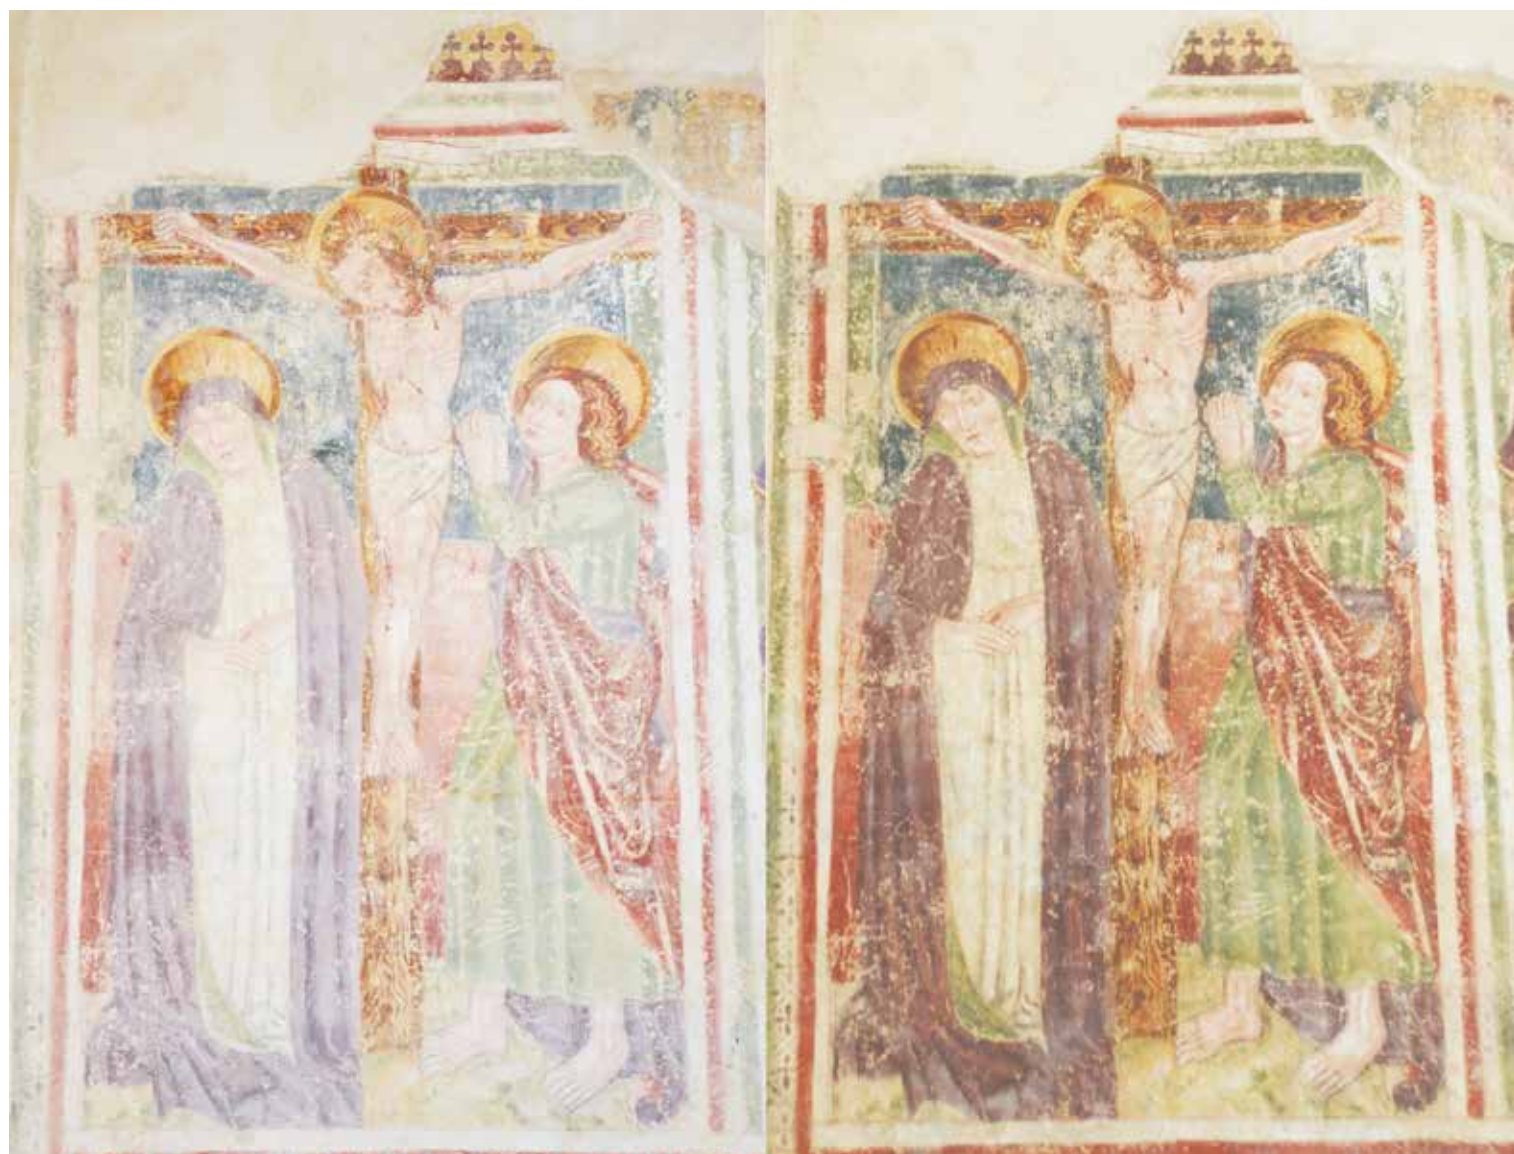
Slika 12: Prizor *Križanje* pred posegi (levo) ter po čiščenju in utrjevanju z barijevim hidroksidom (desno). Na tem prizoru so bile barvne spremembe po utrjevanju z barijevim hidroksidom najopaznejše (foto: Andrej Jazbec, 2023).

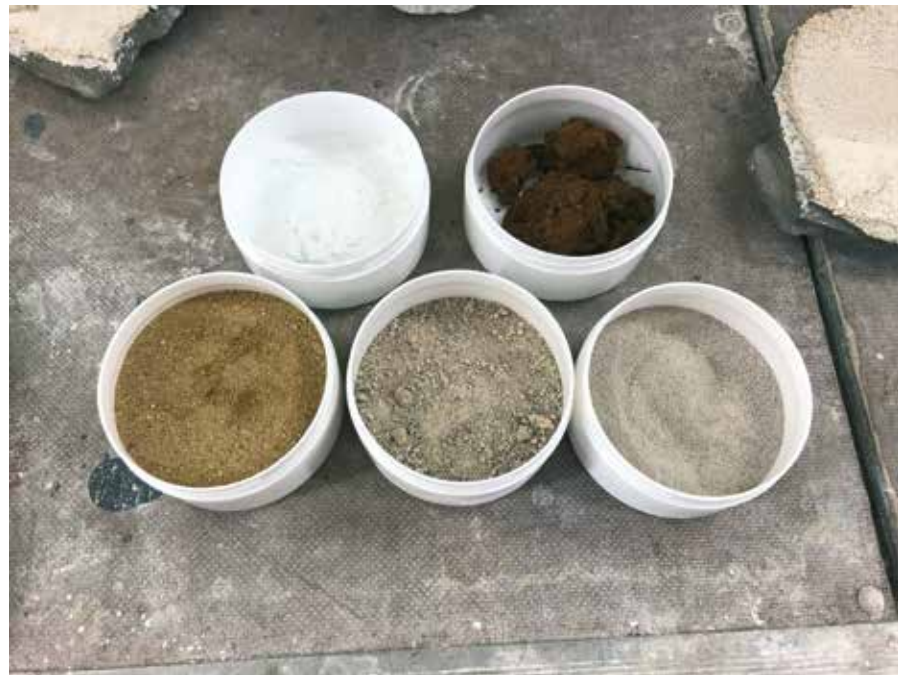
Fig. 1: Materials used to produce plaster mock-ups at the 2023 Summer School; from upper left: lime putty binder, local red earth as an additive and three different aggregates (silicate and carbonate) (photo: Carmen Hiltbrunner, 2023).

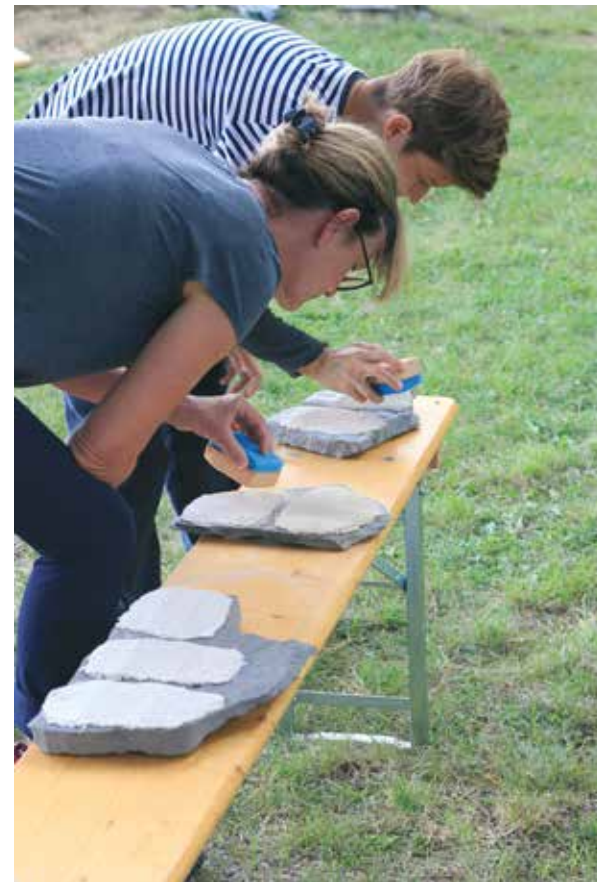
Fig. 2: Surface treatment of mock-ups using Wishab sponges to expose aggregate grains (photo: Blaž Šeme, 2023).

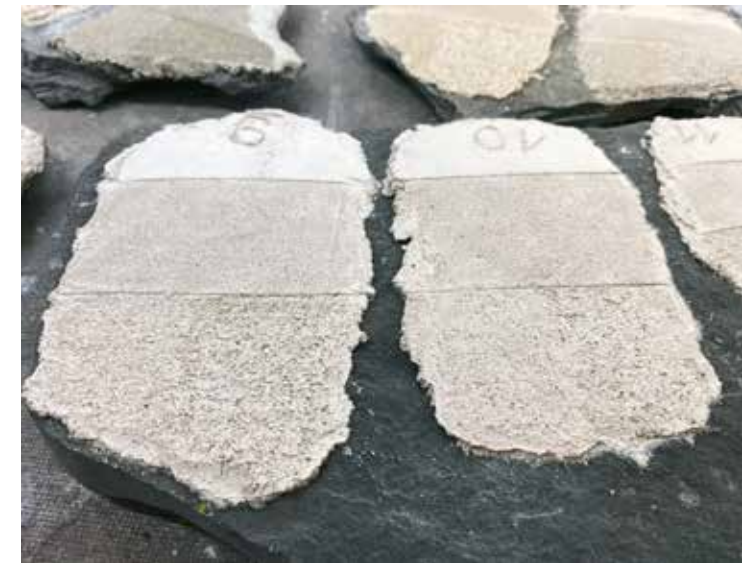
Fig. 3: Each mock-up, made using one specific plaster recipe, resulted in four different appearances because of various application procedures and surface treatments (photo: Alessia Grandoni, 2023).

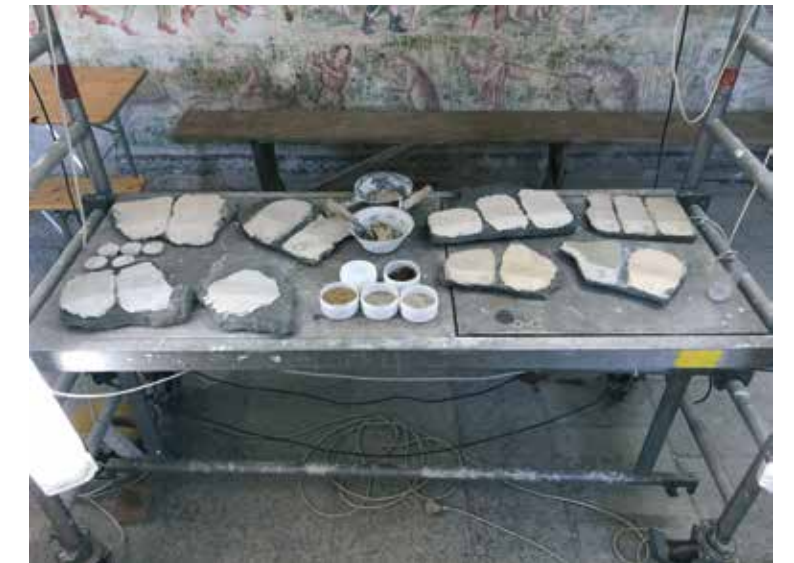
Fig. 4: Plaster mock-ups produced during the 2023 Summer School (photo: Carmen Hiltbrunner, 2023).

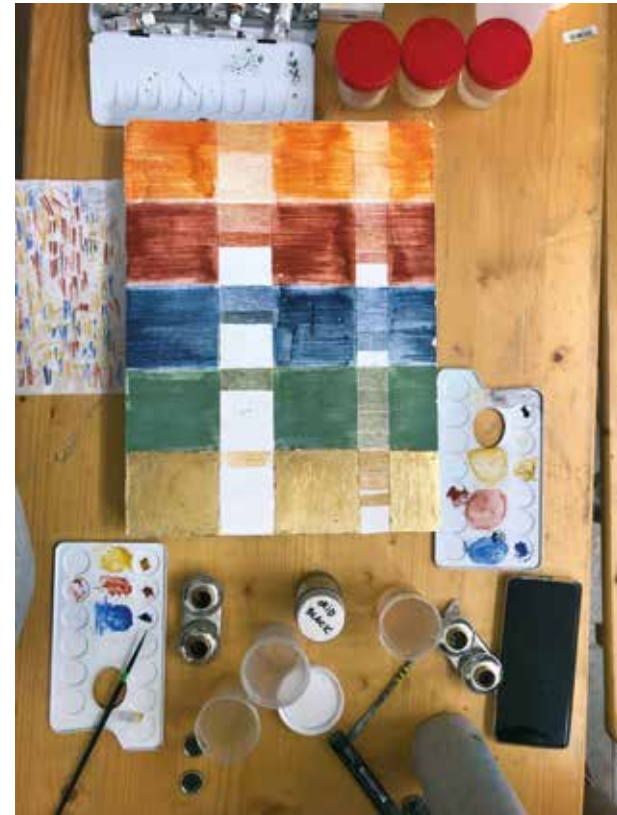
Fig. 6: Students practicing the *selezione cromatica* method (photo: Blaž Šeme, 2023).

beauty in relation to natural ageing with the traces of time.” He declares: ‘*Restoration consists of the methodological moment in which the work of art is recognized, in its physical being, and its dual aesthetic and historical nature, in view of its transmission to the future.*’⁶ To learn more about the history and methods of aesthetic reintegration, as well as the differences in their practical implementation between countries in recent decades, the students read selected publications on the subject in the run-up to the on-site campaign.⁷ During the preceding online week, they shared their findings. This exchange was further reinforced and expanded by several online lectures covering both the topic in general as well as specific case studies from the various participating countries. To familiarize the participants with one of the many methods and thereby deepen their understanding of the approaches from the past century following Riegl, the students were able to practice the *selezione cromatica*⁸ (colour selection) method on mock-ups (Figs. 6-7).
