CERKEV SV. HELENE NA GRADIŠČU PRI DIVAČI

Mednarodna poletna šola konserviranja-restavriranja stenskih poslikav
– Gradišče Summer School 2021–2023

THE CHURCH OF ST HELEN IN GRADIŠČE PRI DIVAČI

International Summer School for the Conservation-Restoration
of Wall Paintings – Gradišče Summer School 2021–2023

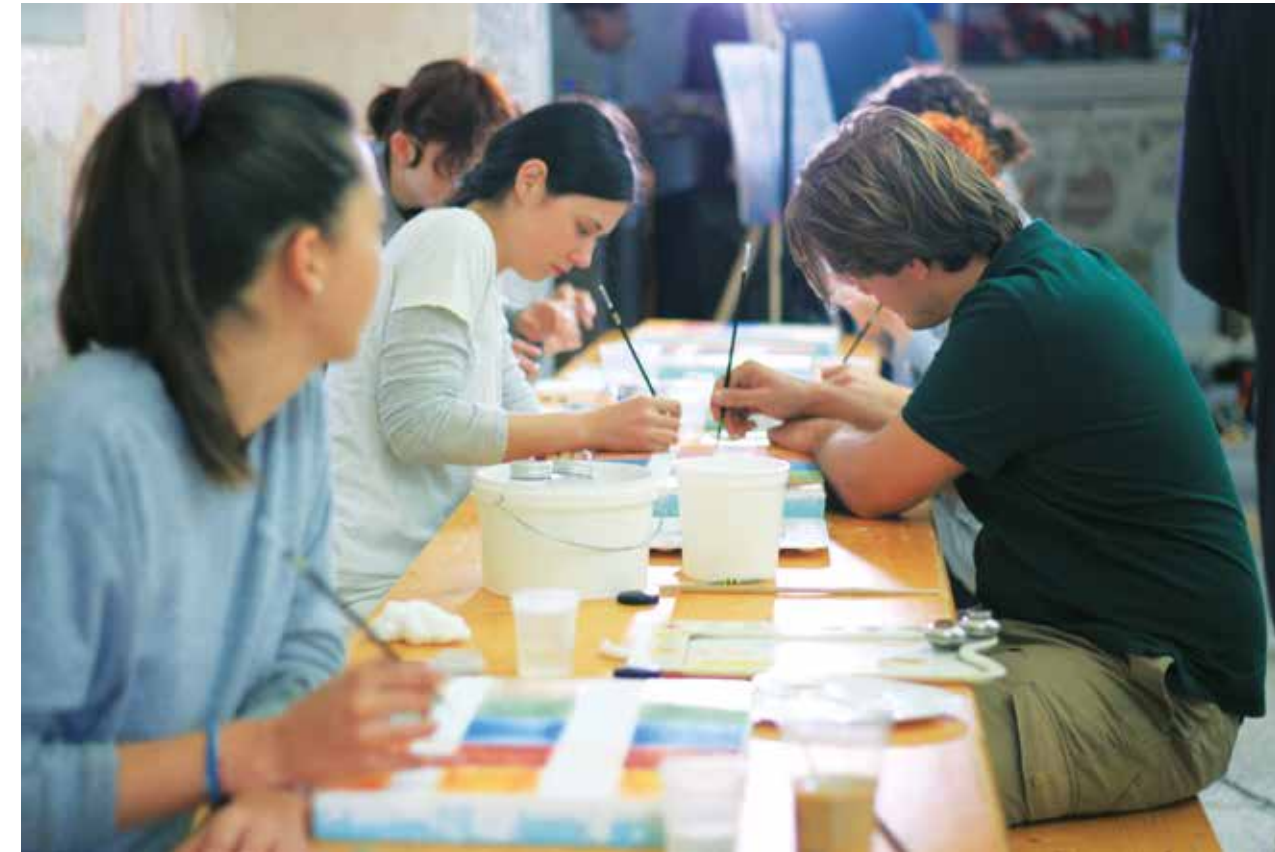
Fig. 7: Painted mock-up, pigments and binders used for practicing *selezione cromatica*; during the implementation of the method (photo: Carmen Hiltbrunner, 2023).

This method was developed by Umberto Baldini (1921–2006)⁹ and Ornella Casazza¹⁰ in the 1970s in the so-called ‘Florentine school’ of restoration. Another purpose of this exercise was to experiment with three different binders, allowing students to experience the working properties of different paint mediums. When the time came to work on the wall, each student was assigned a part of the wall paintings on the south wall, which had been cleaned and consolidated between 2021 and 2023. Their task was to retouch the paintings using the *abbassamento di tono* (tonal adjustment) method with watercolours (Fig. 8). This method involves applying paint to the original *intonaco* where there has been superficial alteration of the paint layer (or patina), due either to abrasion or to the loss of small flakes of paint. Such an alteration ‘...causes small light spots (sometimes even white spots when the rendering is exposed) to appear optically in front of the original pictorial plane.’¹¹ Therefore, the aim of the method is to consign damage to the background, which can be achieved by lowering the tone of the damaged surfaces. That way, the image is optically brought to the foreground, making the painting’s content more evident and chromatically more consistent.

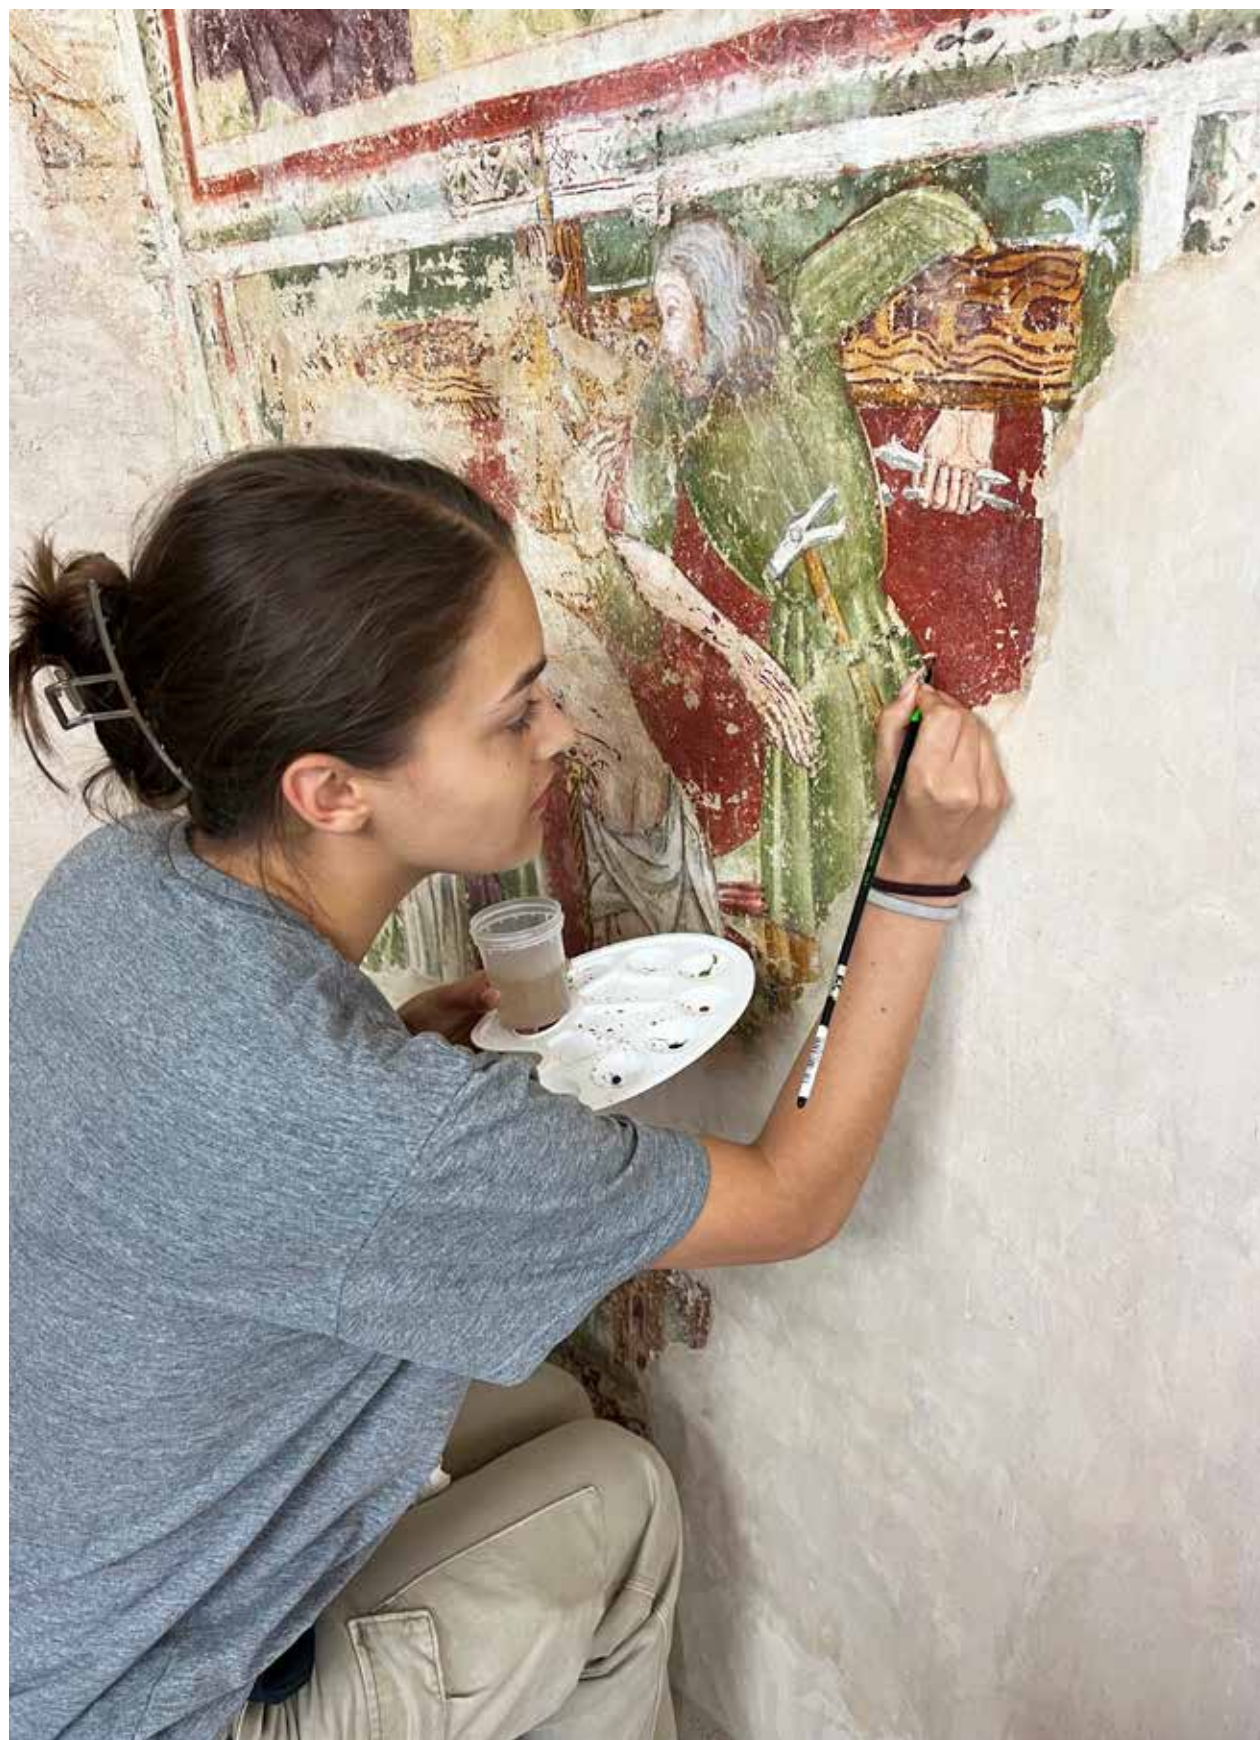
Fig. 8: Student retouching the upper part of the *Descent from the Cross* scene on the south wall, using the *abbassamento di tono* method (photo: Suzana Damiani, 2023).

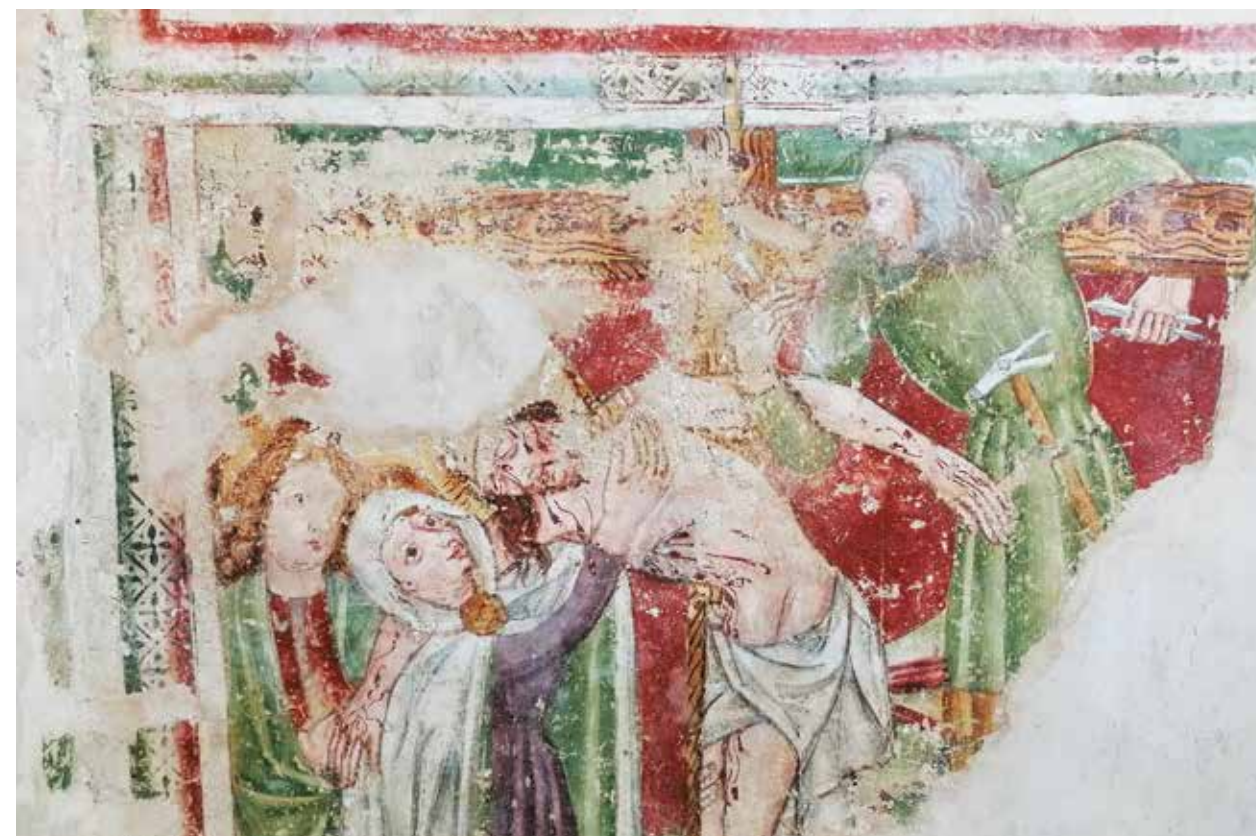
Fig. 9: Segment of the *Descent from the Cross* scene before retouching (photo: Karla Borenić, 2023).

The first step was to optically analyse a specific area. The aim of this visual inspection was to identify zones where, based on the subjective assessment of the person working on the image, the paint layer alterations (abrasions) were deemed non-disruptive because they were already integrated without the need for intervention. This subjective assessment could be balanced and verified in an intersubjective exchange in the group. Starting from this reference zone, the first colour field (coloured detail of a representation in close proximity) was visually harmonised. For this purpose, chromatic glazes were prepared to a 'neutral', darker, brownish hue made of red, blue and yellow *alla prima*¹² and applied with a pointed brush. Depending on the perceived colour temperature of the *intonaco*, the integration could be adjusted with a slightly modified colour temperature – warmer tones with red/yellow or colder with blue. Once the appearance of a colour field and the internal defects had been retouched satisfactorily, it was possible to continue with an adjacent colour area. It is important to note that the subsequent field may significantly impact the previously retouched colour zone. This influence in the sense of a simultaneous contrast required adjustment. Sometimes completed zones had to be treated again (Figs. 9-10).

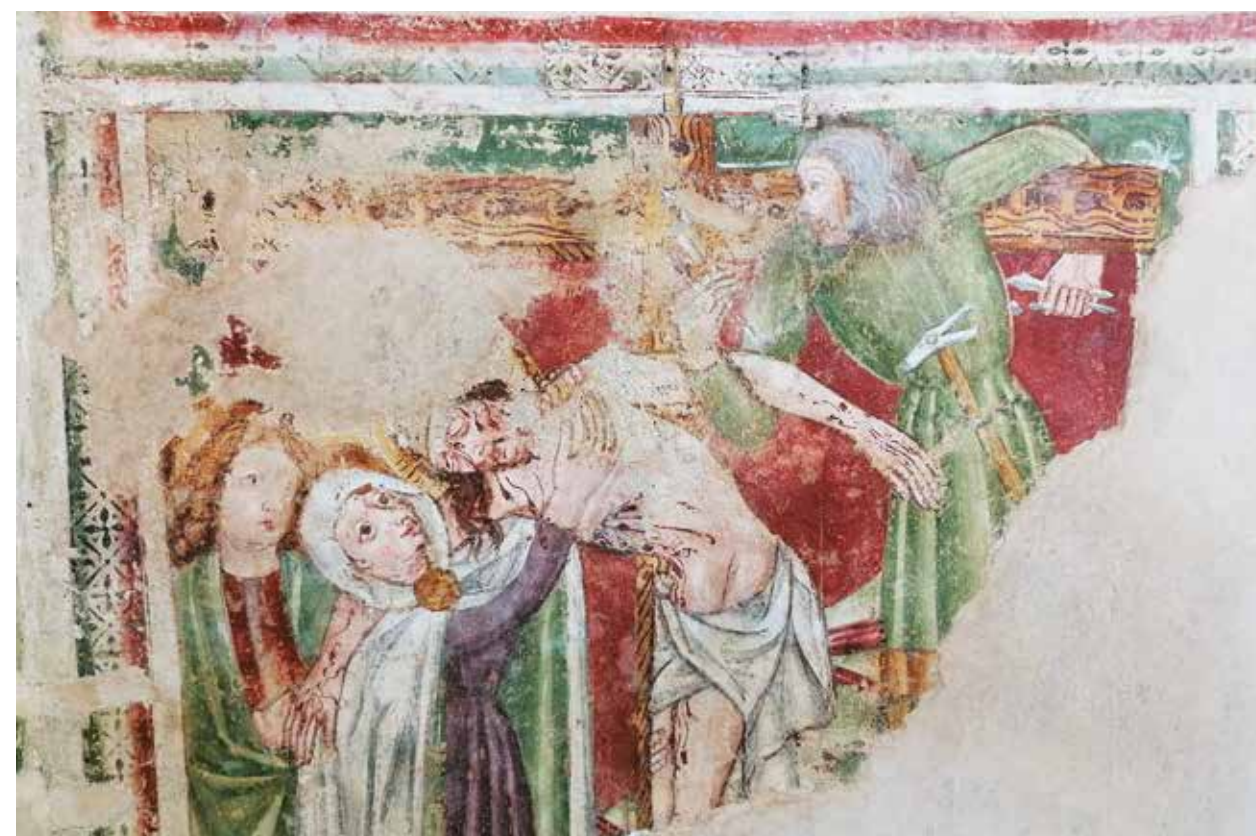
Fig. 10: Segment of the *Descent from the Cross* scene after retouching with the *abbassamento di tono* method (photo: Karla Borenić, 2023).
