REPORT: INTERNATIONAL 2021 SUMMER SCHOOL GRADIŠČE PRI DIVAČI (SLOVENIA)

CHURCH OF ST. HELEN
CONSERVATION-RESTORATION OF
WALL PAINTINGS

VOLUME 1 FINAL REPORT

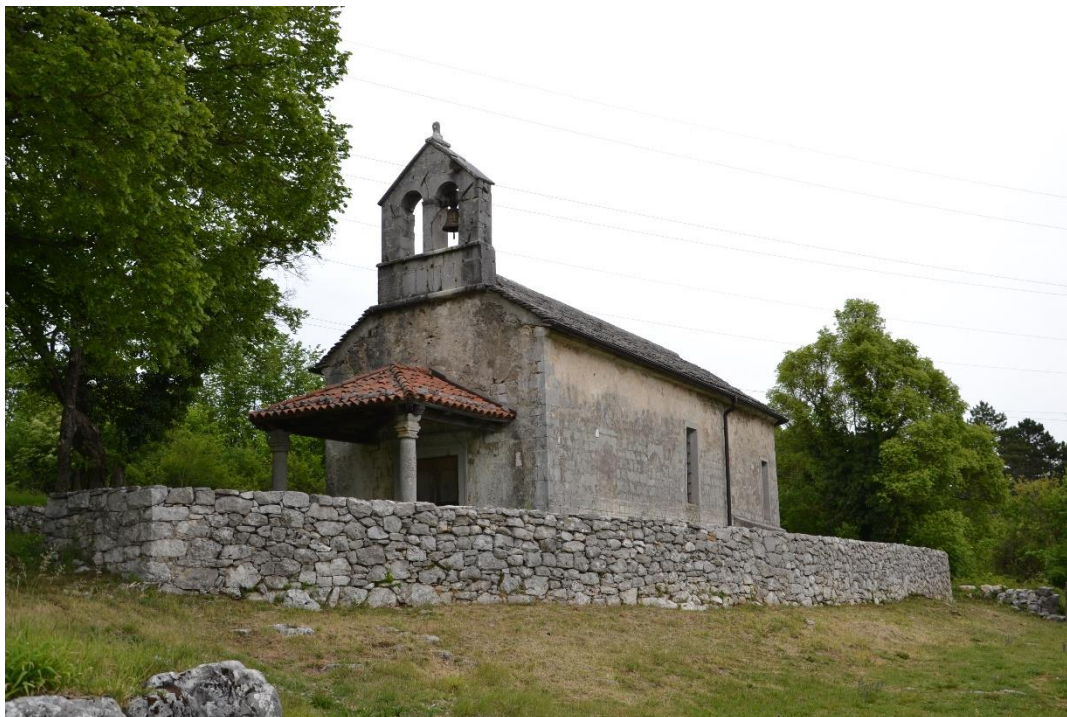
Photo 2: The exterior of the Church of Saint Helen in Gradišče (by: Minka Osojnik).

The church is a composite historical architecture with a rectangular nave and a presbytery with a termination forming three sides of a regular octagon, both covered with an uniform slated roof, with a bell-cote in the façade and a vestibule before it. The building is 14,63 m long and 5,54 m wide and is oriented towards east. At the junction with the nave the presbytery starts with the same width as the nave, towards east it slightly narrows down.

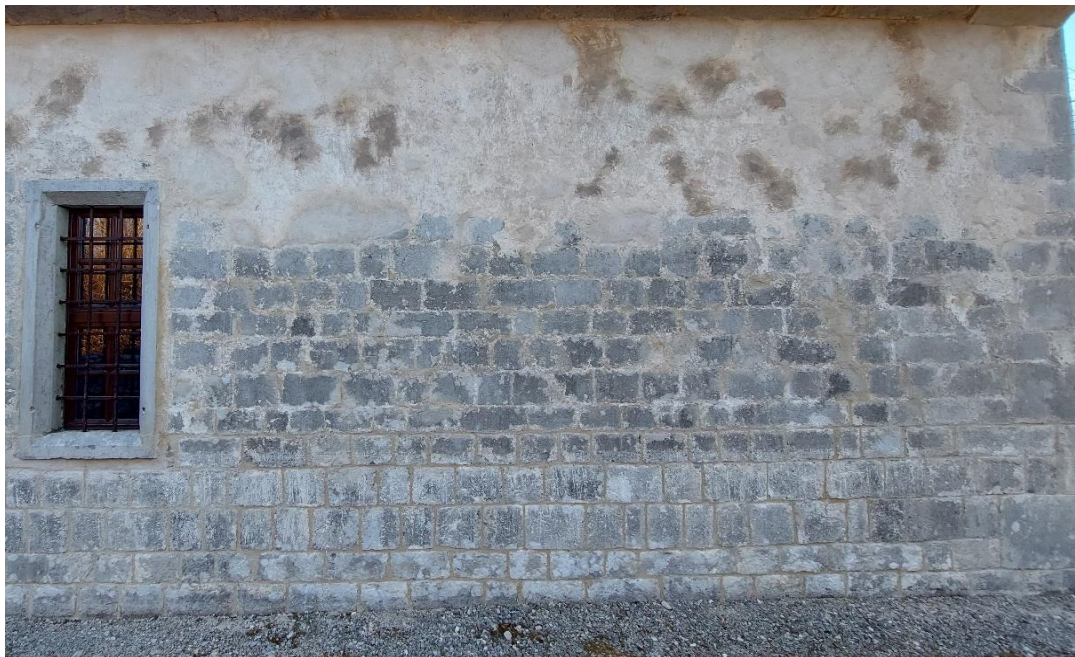
Photo 3: The ashlar masonry on the north wall of the Church of Saint Helen (by: Minka Osojnik).

At its core, the church of St. Helen is an example of early gothic architecture. Based on its preserved architectural tissue and various methods of building, different authors date the nave of the church in the early or the late 14th century, or maybe even in the beginning of the 15th century. By method of building we mean the so called ashlar masonry, where all the stones are cut and worked, so they have the same shape, size and surface texture. When building a wall, the ashlar blocks are laid in horizontal courses, or layers. The stones usually have smooth, parallel faces, and they fit together tightly with very little mortar. This kind of masonry we see on the nave of the church of St. Helen on the south and the north wall and it is the typical for early gothic period. In that period the church of St. Helen was smaller and so was its presbytery which was probably also narrower than the nave. Nevertheless the georadar investigations carried out in the year 2003 didn't show any further information about foundations of any older structures. The interior of the early gothic church, which had a rather long but not very tall nave with 3 small windows in the south wall, was probably decorated with frescoes as well for fragments can be seen in two cases on the south wall of the nave.

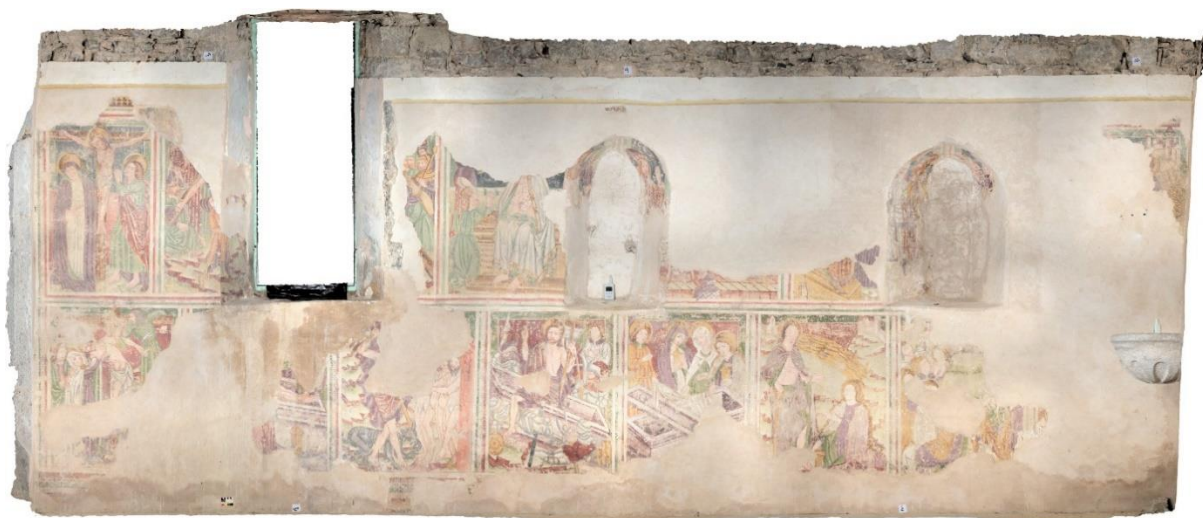
Orthophoto 6: Frescoes on the south wall of the nave depicting The Passion of Christ (by: Gašper Rutar).

On the nave's south wall there are scenes from the *Passion of Christ* arranged chronologically in two horizontal strips. The story starts on the right side of the upper part with the Arrest of Christ (mostly ruined), Christ before Pilate (mostly ruined), Flagellation (mostly ruined), Crowning with Thorns, Carrying of the Cross (fragment), Jesus is nailed to the cross (partly destroyed), Crucifixion, then on the far left shifts to the lower strip and continues to the right with Descent from the Cross, The Entombment (fragment), Christ in

Limbo (damaged), Resurrection, Three Marys at the empty Tomb, *Noli Me Tangere*, The Ascension. In the Passion of Gradišče there are three more scenes than in the Passion of Hrastovlje (Jesus nailed to the Cross, Descent from the Cross, Three Marys at the empty Tomb).

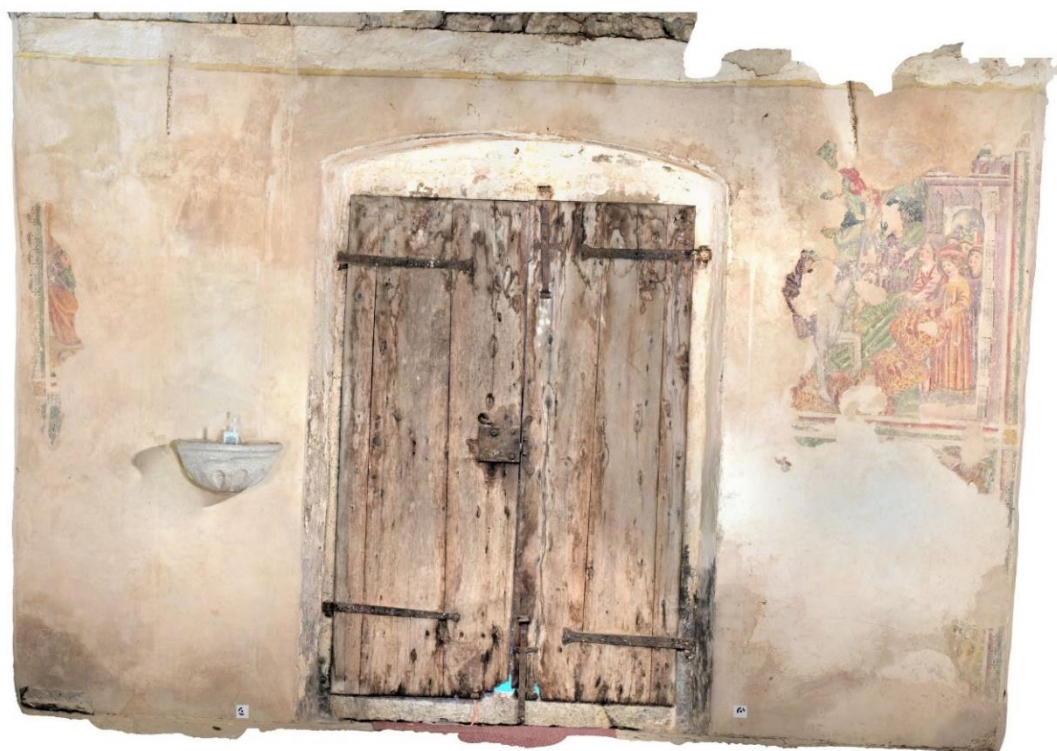
Orthophoto 7: Frescoes on the west wall of the nave depicting Jesus riding into the city of Jerusalem (by: Gašper Rutar).

On the west wall most of the frescoes are ruined, as a consequence of the later built-in portal. On the far right we see Jesus rides into the city of Jerusalem on a donkey, while on the far left only fragments of the Last supper are preserved.

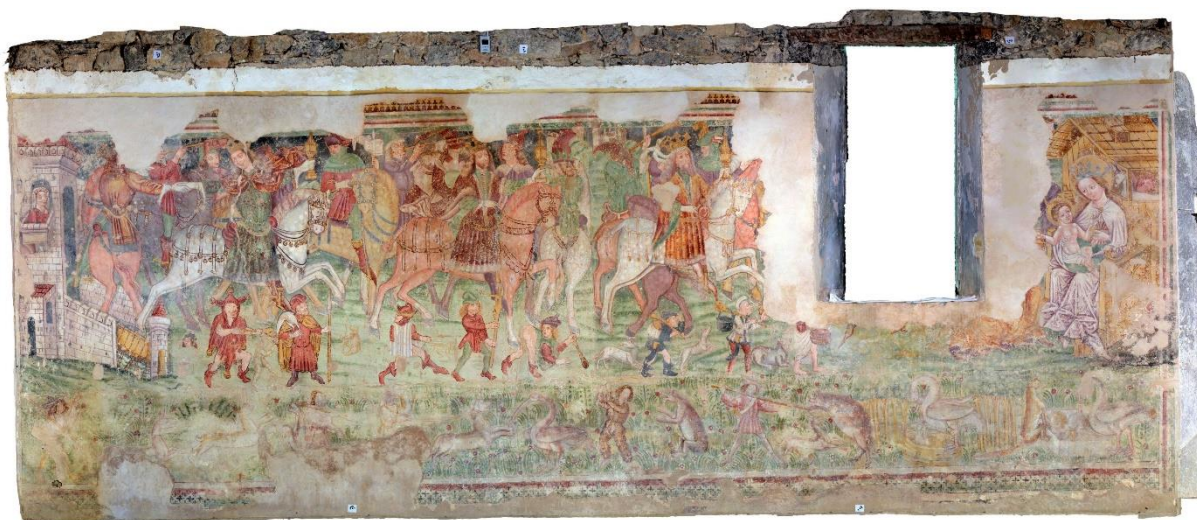
Orthophoto 8: Frescoes on the north wall of the nave depicting Adoration of the Magi (By: Gašper Rutar).

On the nave's north wall the *Adoration of the Magi* is depicted, supplemented by scenes of people's daily lives of the period as well as some animal anecdotal motives, such as Ezop's fable about the fox and a stork and a pelican feeding his offspring with his own blood. In the upper part of the painting there are actually two complementary scenes put together: the Journey and the Adoration. The Journey of the Magi starts with the reduced image of the city of Jerusalem on the far left and one of the Magi shaking the hand of Herod. The other scene is partly destroyed because of the later built window – only the Virgin Mary with baby Jesus are preserved, while the three magi from the Adoration are not. The painter paid special attention in depicting nobility dressed in their expensive precious garments and purebred horses. Especially this wall represents a treasure chest for variety of scientists from art historians, historians, sociologist, ornithologists, etc. Such an example is the scene of the hunt of the bird called the Northern Bald Ibis (KLAUVŽAR, Geronticus eremita) which was several times depicted by medieval painters (also in Hrastovlje), and lived in Istria and in Dalmatia as quite an ordinary bird, till it's extinction in Europe probably by the end of the 17th century. The cause for the extinction was hunting, mostly by nobility. After almost 400 years in 2006 three birds were spotted on the meadows near Postojna (20 minute drive from Gradišče) and also it was spotted in Ilirska Bistrica in the year 2021.

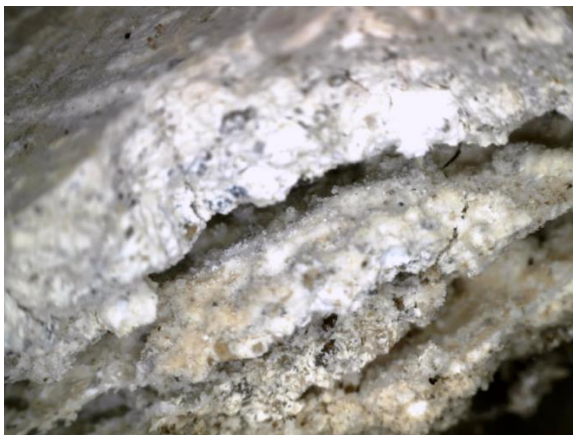
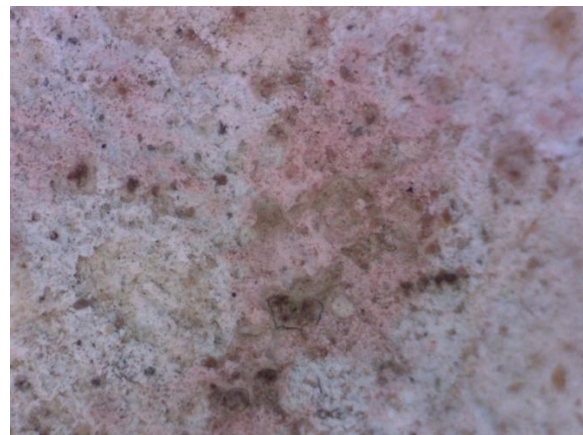
Photos 9 and 10 : Decohesion of intonaco (left) and biological growth on the outside of the church (right) (by: Suzana Damiani).

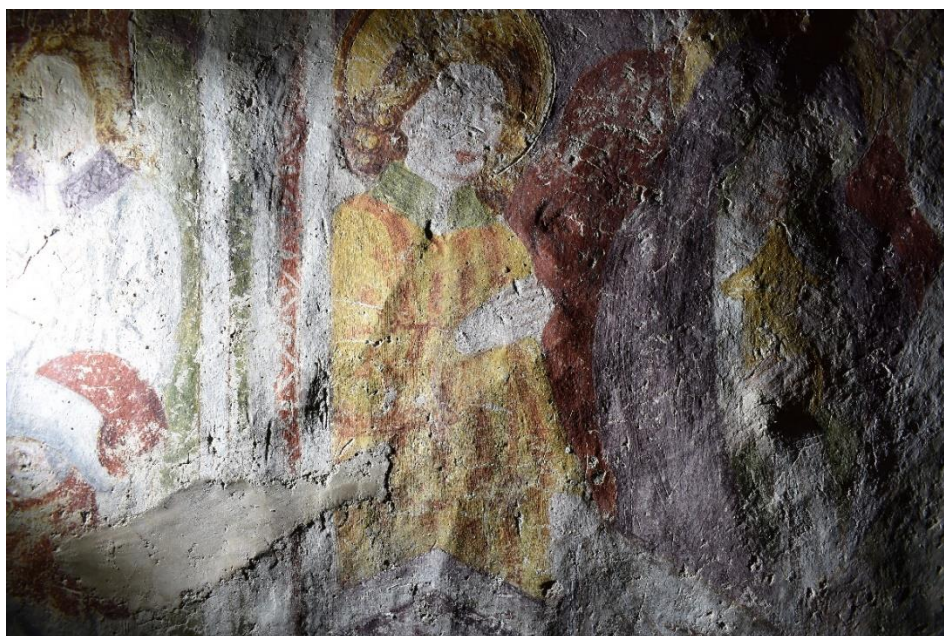
Observing and photographing the surface of the wall painting was crucial for the evaluation of the condition of the painting and used technique. We used a different angle of the lighting (a raking light) to observe cracks, flakes, bulges, salt crusts, brush strokes and *secco* finishings, infillings, etc.

Photo 12: Photograph with the raking light (by: Andrej Jazbec).

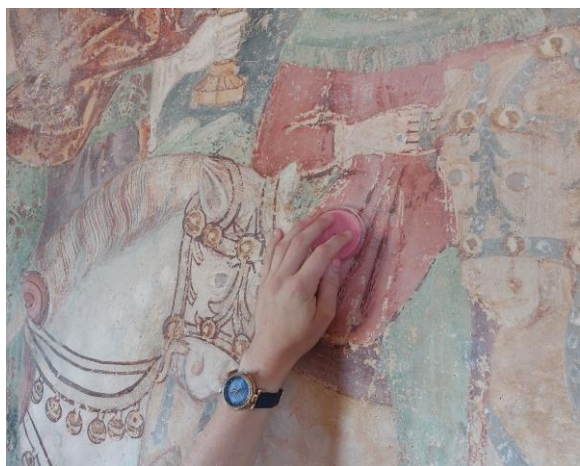
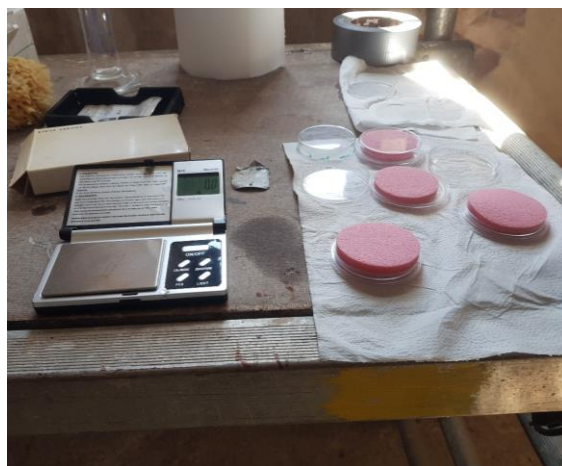
We performed the “*sponge test*” on site. For this purpose we used the Contact sponge kit (CTS srl.). We wetted the sponge with water, weighted it and then pressed it to the surface of the wall. After one minute we took it away and weighted it again. We observed the difference in weight of the sponge. The difference is the final result and the measurement we were after. We compared the final measurements to each other to get the general picture of the absorption state of the wall.

The results showed that the south wall absorbed the highest amount of water, but not significantly more than northern wall. The least amount of water was absorbed by the western wall, at some parts there was even no water absorbed. The test also showed, that the higher the measurement point is up the wall, more water is absorbed. Interesting results gets us also the comparison of the “*sponge test*” results to the “*adhesion assessment test*” results. We can quite clearly see the connection between the state of adhesion and absorption potential. As a general rule we could state, that where is severe lack of adhesion of wall structure, the water absorption potential is also quite high. Our results confirm this thesis.”³

Photos 14 and 15: *Sponge test on the North wall (by: students of Summer School).*

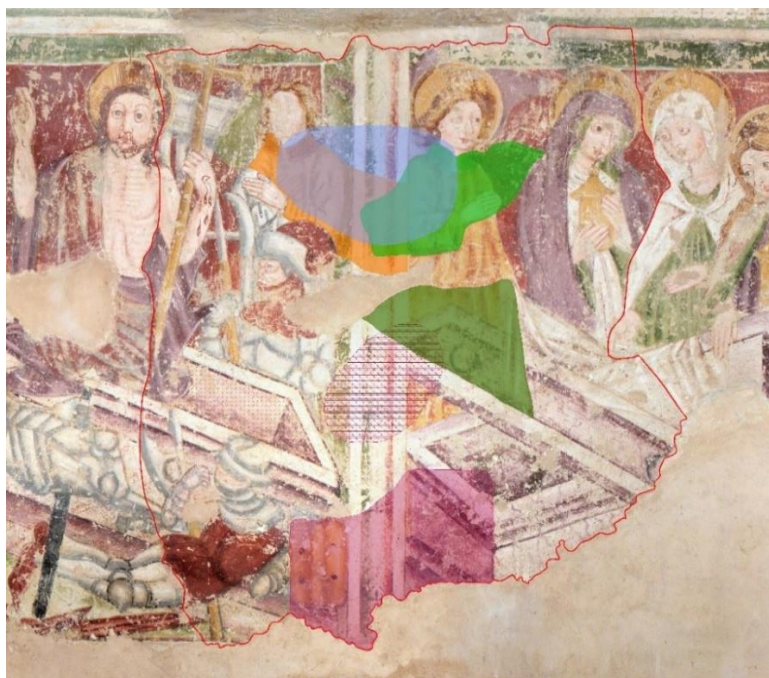
We also applied anion exchange resin (CTS OH strong) on wall painting (area S1) through japanese paper. The contact time was half an hour and we removed it with distilled water and sponges. We chose to do this trial in case the *secco* finishings (with possible organic binder?) on the wall painting are in any way susceptible to cleaning with ammonium carbonate or bicarbonate.

Photo 16: Area S1 (by: Anka Batič, Melissa Cannizzo, other studentns)

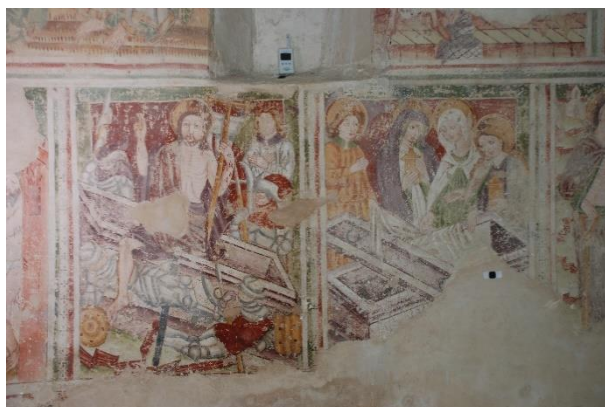
After cleaning with distilled water and sponges (Area S1).

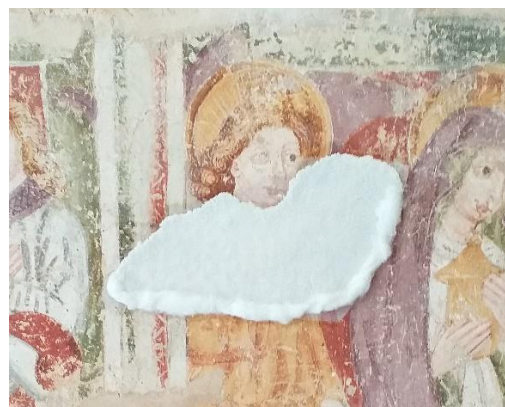
Poulticing with ammonium bicarbonate.

Since the application of the 20 % solution of ammonium bicarbonate did not result in any kind of damage to the wall painting and proved (visually) to clean the surface, we continued with the trials and applied ammonium bicarbonate mixed in a poultice.¹⁰ The intention was to compare the results with different methods of application of ammonium bicarbonate and also contact time with the surface. We applied it on two layers of japanese paper and removed it after half an hour. For cleaning the treated surface we used distilled water and sponge. We continued the trials with applying ammonium carbonate the same way as ammonium bicarbonate: one trial with brush and one with poultice through two layers of japanese paper. We tried this method because we wanted to see if there will be any difference on the surface because of the different pH of the cleaning agent.

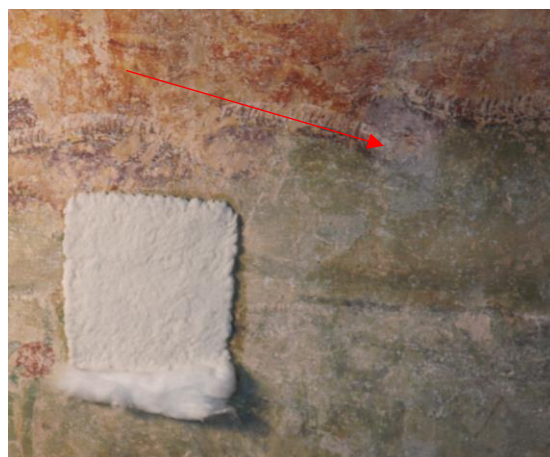
Some whitening after the removal of poultice – it can be removed mechanically or with triammonium citrate.

1. The cleaning of the surface with distilled water beforehand proves to be unproblematic for the paint layer. It can cause whitening on some parts (mainly west and north wall) probably due to residue of a consolidant.

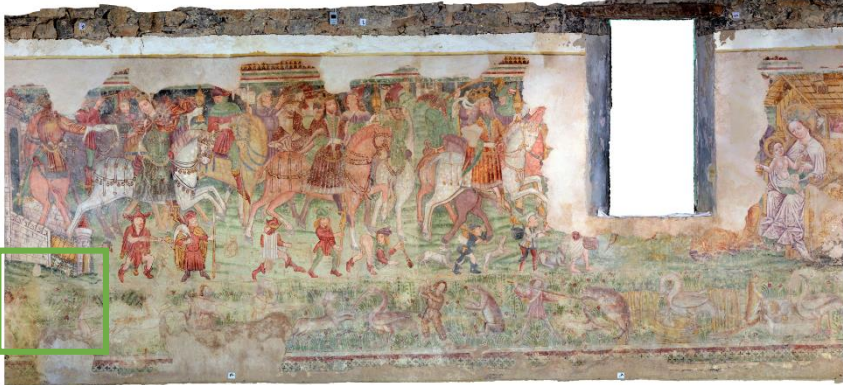
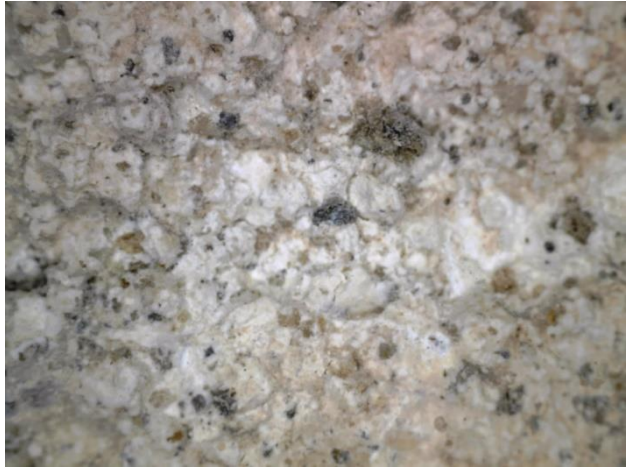
<p><i>Description:</i></p> <p>The last, fine-grained, thin and well-evened layer of plaster on which the wall painting is applied in <i>fresco</i> technique.</p> <p><i>Source of the description:</i> EwaGlos, Vol.17, 2016, p. 140.</p>		
<p><i>Location:</i></p>

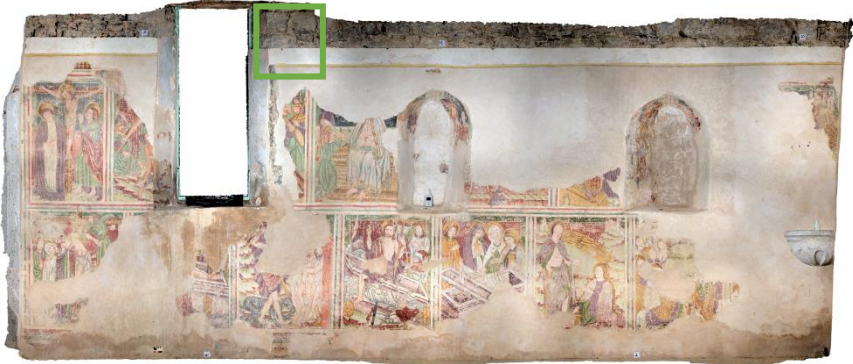
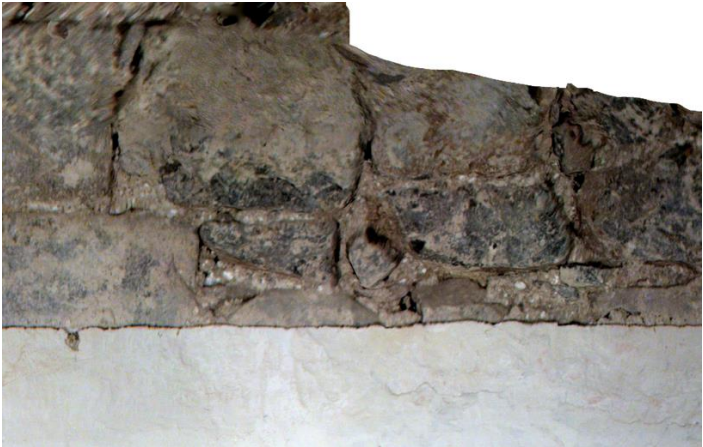
1.	ORIGINAL PAINTING TECHNIQUES	
6.	JOINT	
<p><i>Description:</i></p> <p>The space between masonry blocks which is filled with mortar. In the case of unplastered surfaces, mortar joints contribute to the overall appearance of the architectural surface.</p>		
<p><i>Source of the description:</i> EwaGlos, Vol.17, 2016, p. 38.</p>		
<p><i>Location:</i></p>

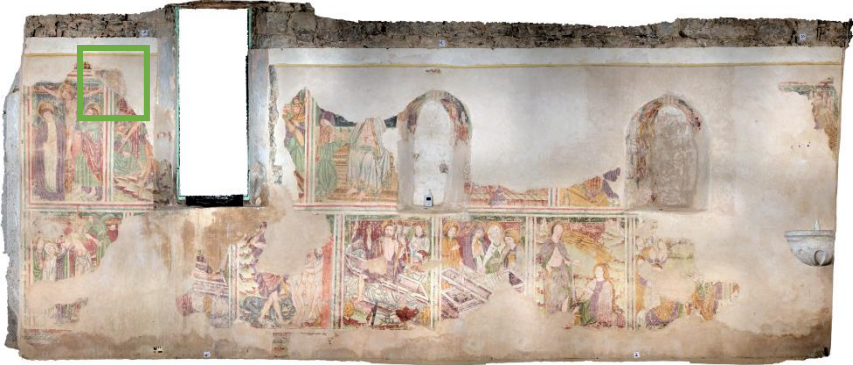
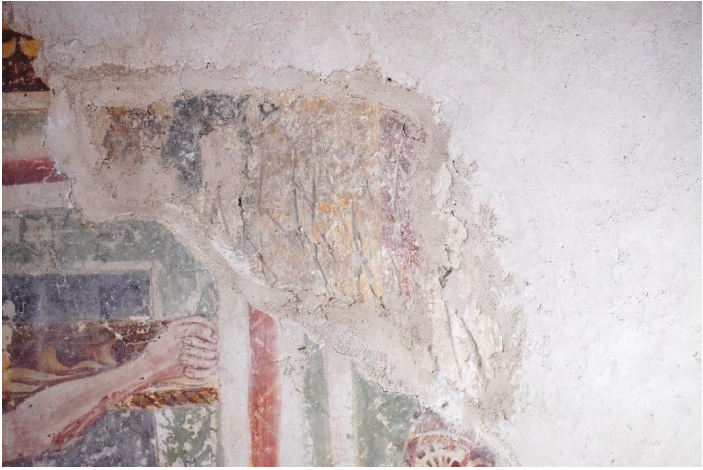
1.	ORIGINAL PAINTING TECHNIQUES	
8.	<i>PALIMPSEST</i>	
<p><i>Description:</i></p> <p>Plaster and painting layers preserved under an existing wall painting.</p>		
<p><i>Source of the description:</i> EwaGlos, Vol.17, 2016, p. 108.</p>		
<p><i>Location:</i></p>

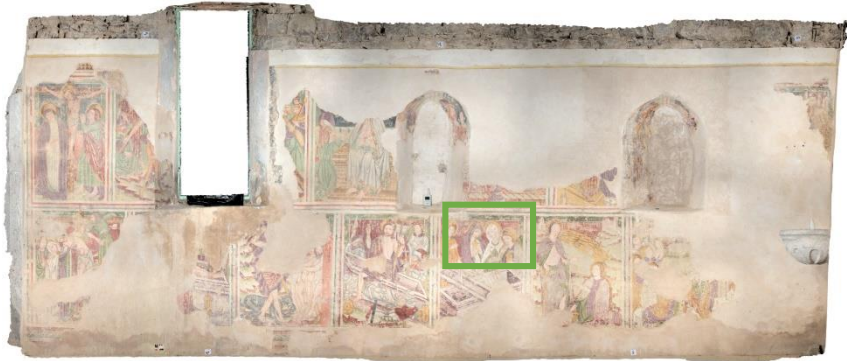
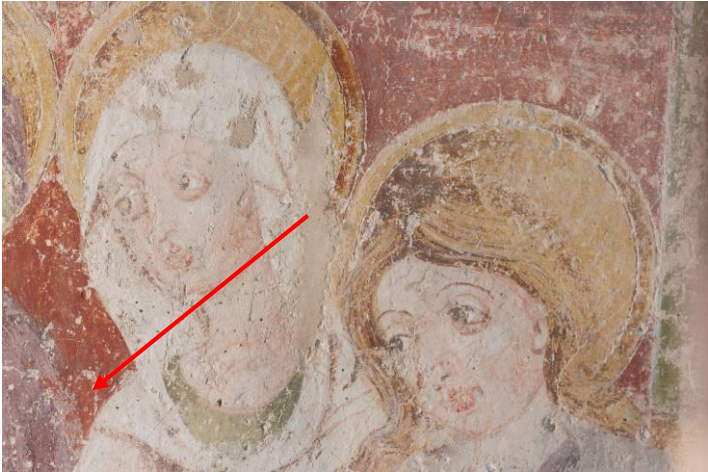
1.	ORIGINAL PAINTING TECHNIQUES	
9.	<i>PENTIMENTO</i>	
<p><i>Description:</i></p> <p>Correction of the painting done by the artist himself.</p>		
<p><i>Source of the description:</i> EwaGlos, Vol.17, 2016, p. 90.</p>		
<p><i>Location:</i></p>

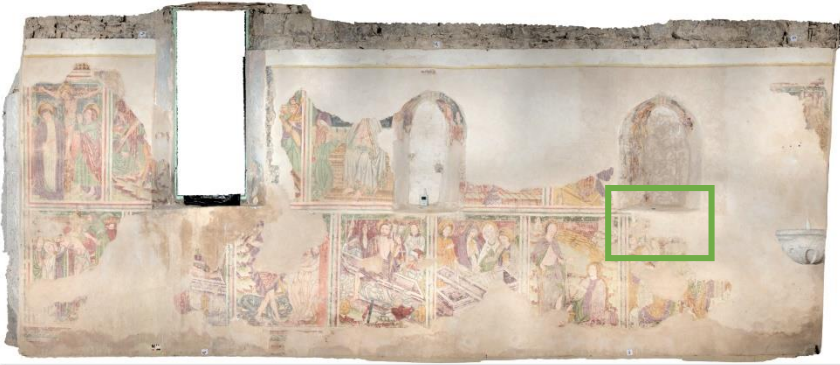
1.	ORIGINAL PAINTING TECHNIQUES	
10.	PLASTER	
<p><i>Description:</i></p> <p>Protective and/or decorative coat which is applied to architectural surfaces. It is also used for molding and casting decorative elements.</p>		
<p><i>Source of the description:</i> EwaGlos, Vol.17, 2016, p. 50.</p>		
<p><i>Location:</i></p>

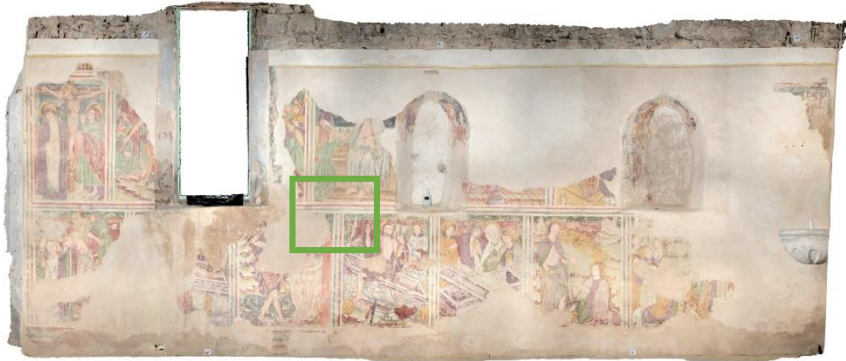
1.	ORIGINAL PAINTING TECHNIQUES	
11.	PONTATA	
<p><i>Description:</i></p> <p>A wide area of plaster applied at the same high as the scaffolding, leaving horizontal seams in the finished work.</p>		
<p><i>Source of the description:</i> EwaGlos, Vol.17, 2016, p. 74.</p>		
<p><i>Location:</i></p>

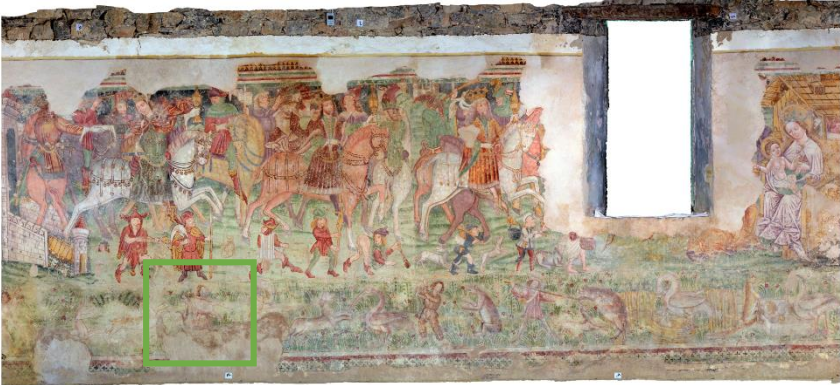
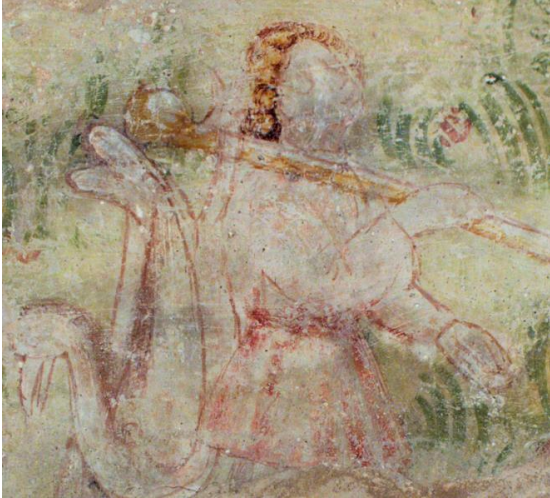
1.	ORIGINAL PAINTING TECHNIQUES	
12.	PREPARATORY DRAWING	
<p><i>Description:</i></p> <p>Preliminary drawing done before further work is undertaken, that is usually followed by work in a different medium. This is done on the intonaco in the case of murals.</p>		
<p><i>Source of the description:</i> EwaGlos, Vol.17, 2016, p. 130.</p>		
<p><i>Location:</i></p>

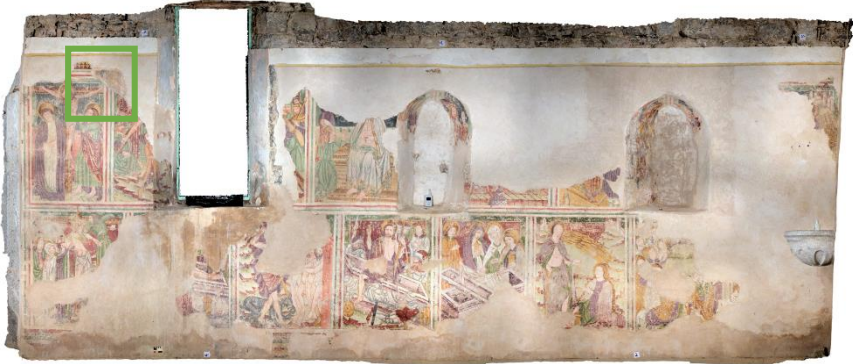
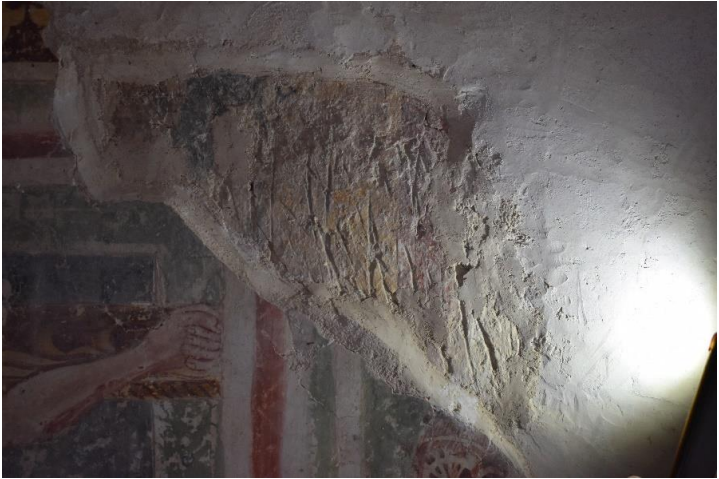
1.	ORIGINAL PAINTING TECHNIQUES	
14.	SCRATCHES	
<p><i>Description:</i></p> <p>Roughening the surface due to achieve better adhesion for the next plaster layer.</p>		
<p><i>Source of the description:</i> Summer school Gradišce 2021.</p>		
<p><i>Location:</i></p>

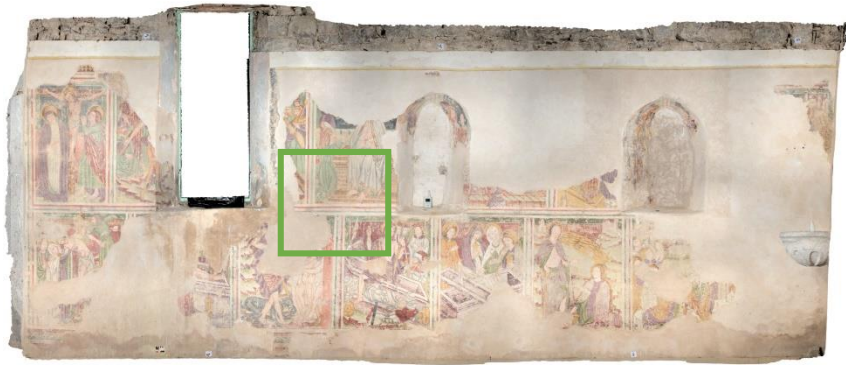
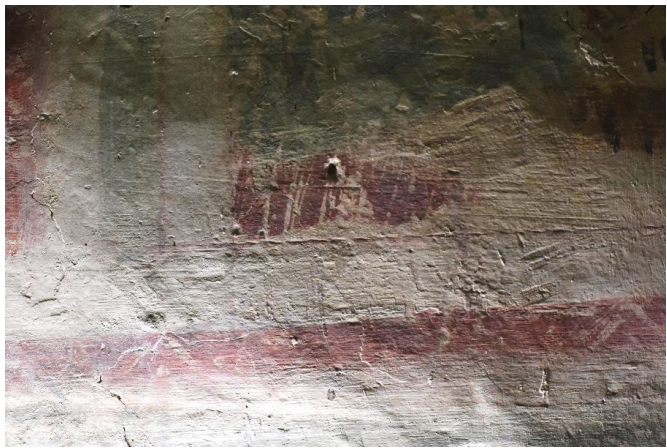
1.	ORIGINAL PAINTING TECHNIQUES	
15.	SNAPPED LINE	
<p><i>Description:</i></p> <p>A method of applying a straight line on plaster (can be coloured or without colour) by stretching a piece of string, pulling back and releasing it so that it snaps against the painting, leaving a mark.</p>		
<p><i>Source of the description:</i> EwaGlos, Vol.17, 2016, p. 126.</p>		
<p><i>Location:</i></p>

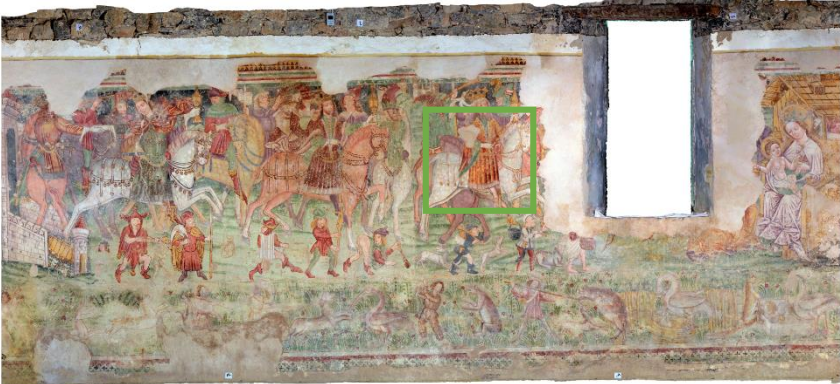
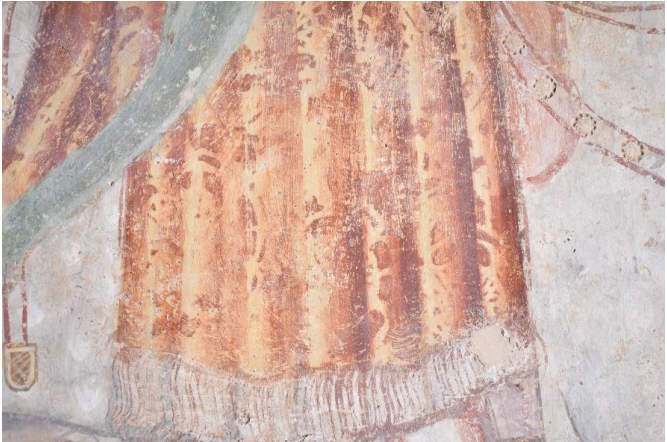
1.	ORIGINAL PAINTING TECHNIQUES	
16.	STENCIL	
<p><i>Description:</i></p> <p>Reproduction technique to produce an ornamental pattern, with the use of a template.</p>		
<p><i>Source of the description:</i> EwaGlos, Vol.17, 2016, p. 140.</p>		
<p><i>Location:</i></p>

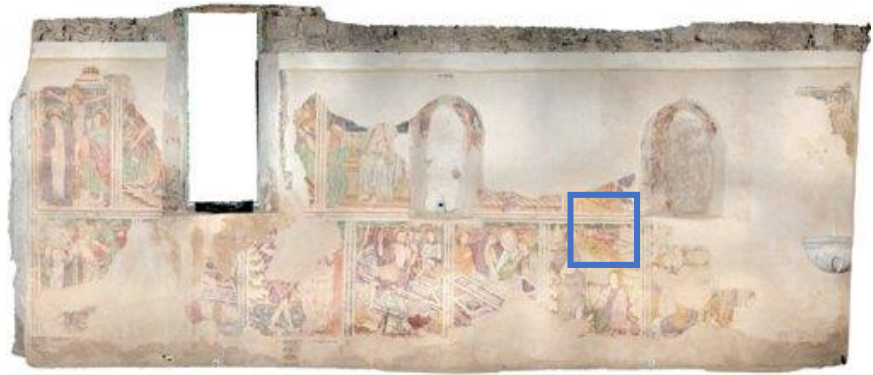
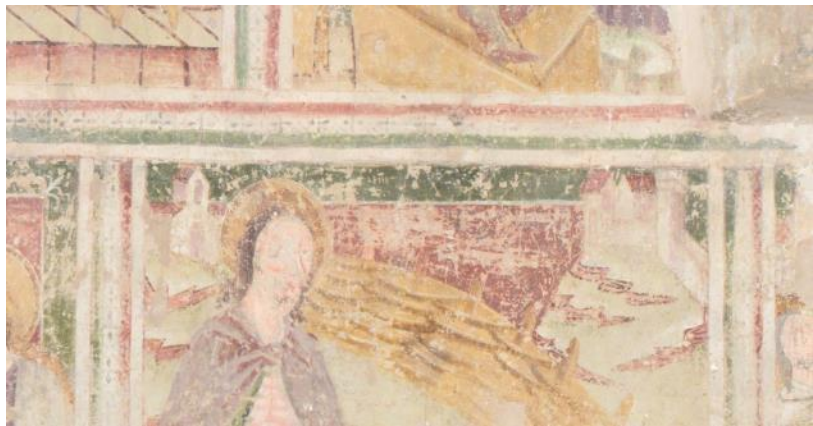
2.	DETERIORATION PHENOMENA	
1.	ABRASION	
<p><i>Description:</i></p> <p>Superficial loss or damage as a result of mechanical action due to friction; the process of rubbing away the surface of the material.</p>		
<p><i>Source of the description:</i> EwaGlos, Vol.17, 2016, p. 186; Cambridge dictionary; dictionary.cambridge.org/dictionary/english/abrasion.</p>		
<p><i>Location:</i></p>

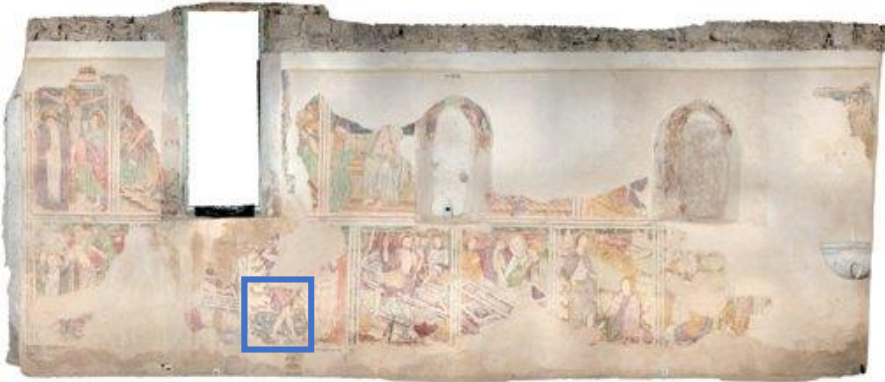
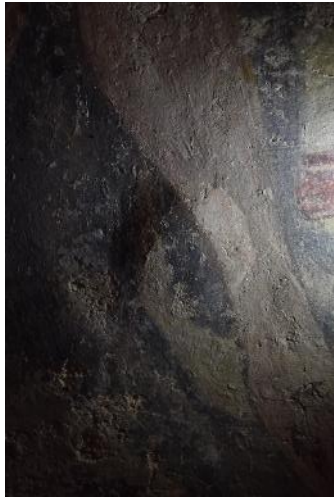
2.	DETERIORATION PHENOMENA	
2.	BULGE	
<p><i>Description:</i></p> <p>Localised rounded protuberance or swelling from within or underneath caused by pressure.</p>		
<p><i>Source of the description:</i> EwaGlos, Vol.17, 2016, p. 200.</p>		
<p><i>Location:</i></p>

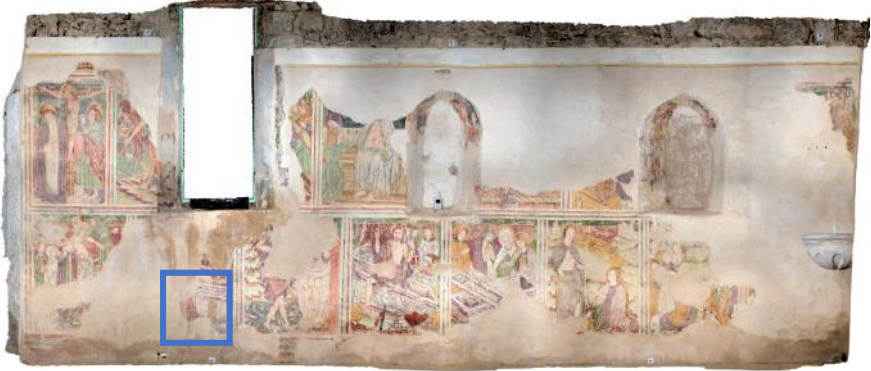
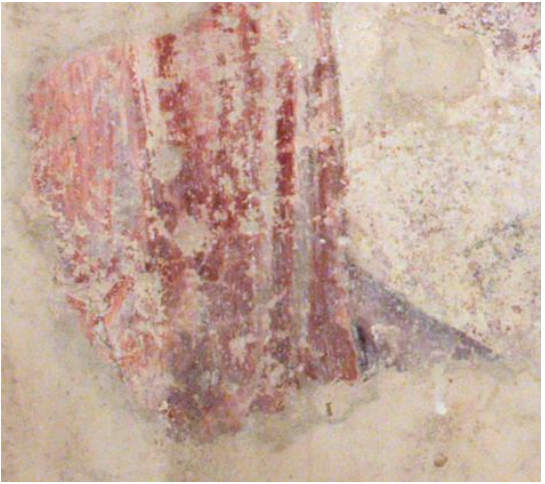
2.	DETERIORATION PHENOMENA	
3.	COLOUR SATURATION	
<p><i>Description:</i></p> <p>The intensification of colour of a surface caused by humidity or by the use of construction or conservation materials.</p>		
<p><i>Source of the description:</i> EwaGlos, Vol.16, 2016, p. 218.</p>		
<p><i>Location:</i></p>

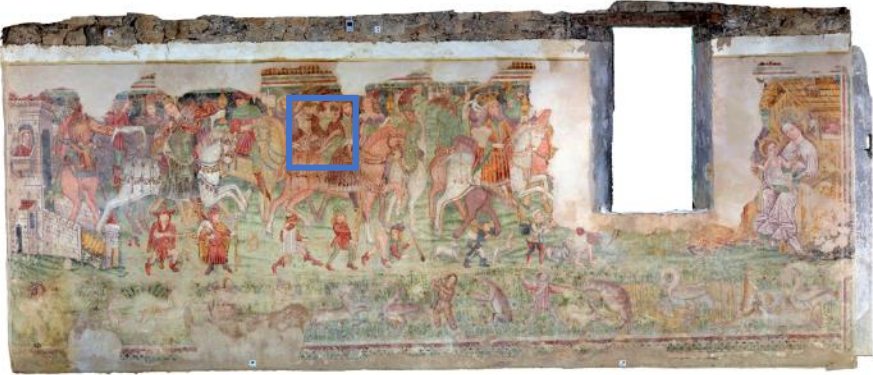
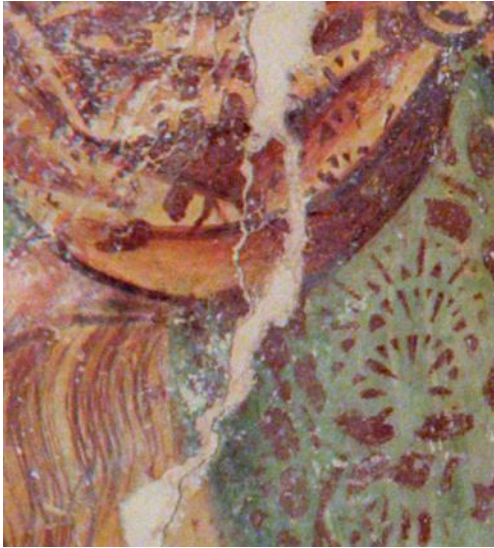
2.	DETERIORATION PHENOMENA	
4.	CRACKS	
<p><i>Description:</i></p> <p>A discontinuity in an architectural surface or wall painting, resulting in a visible separation of one part from another, that extends through one or more layers.</p>		
<p><i>Source of the description:</i> EwaGlos, Vol.17, 2016, p. 204.</p>		
<p><i>Location:</i></p>

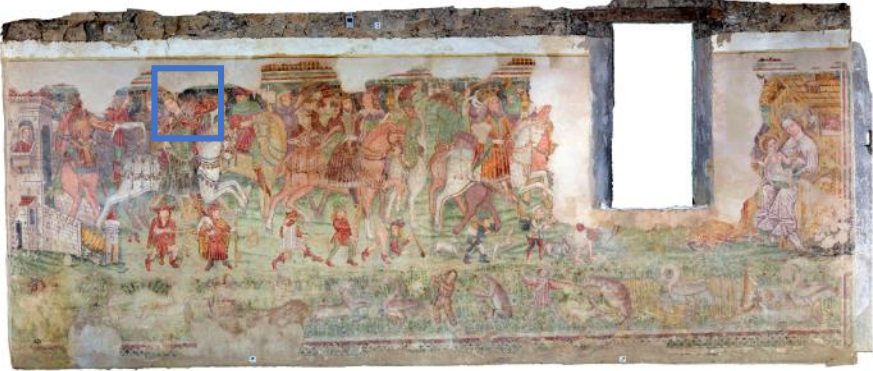
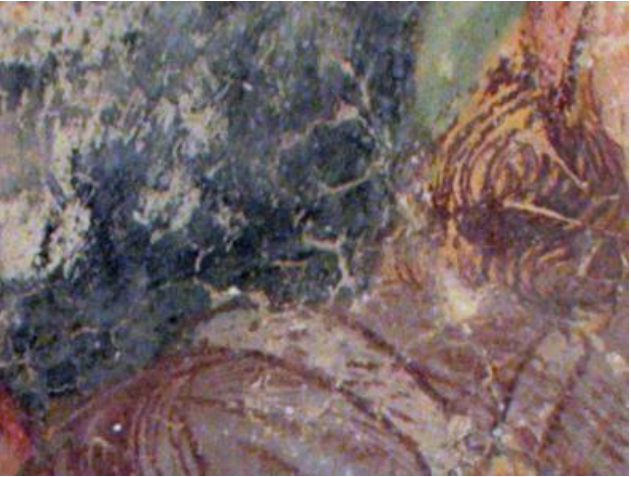
2.	DETERIORATION PHENOMENA	
5.	CRAQUELURE	
<p><i>Description:</i></p> <p>A network of fine minor cracks specific to secco paint layers.</p>		
<p><i>Source of the description:</i> EwaGlos, Vol.17, 2016, p. 208.</p>		
<p><i>Location:</i></p>

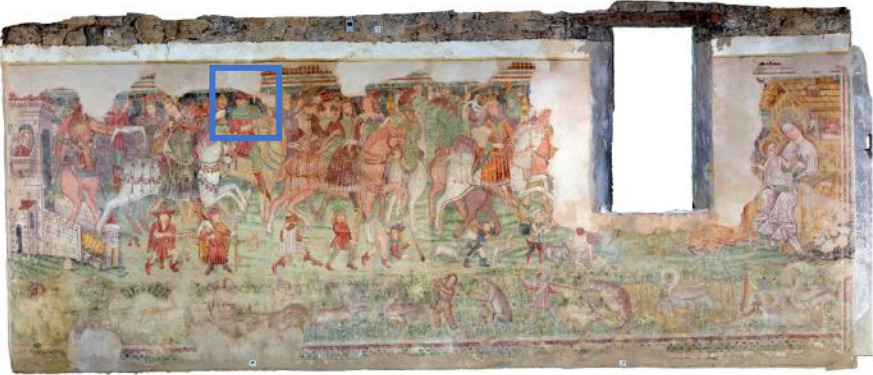
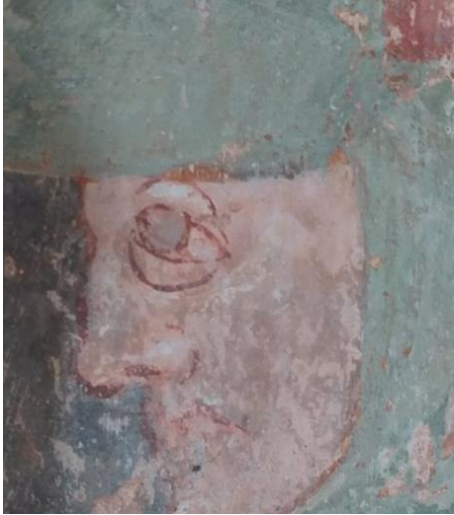
2.	DETERIORATION PHENOMENA	
6.	DARKENING	
<p><i>Description:</i></p> <p>A change in the surface colour due to a decrease in hue (reduction of visible light reflection).</p>		
<p><i>Source of the description:</i> EwaGlos, Vol.17, 2016, p. 216.</p>		
<p><i>Location:</i></p>

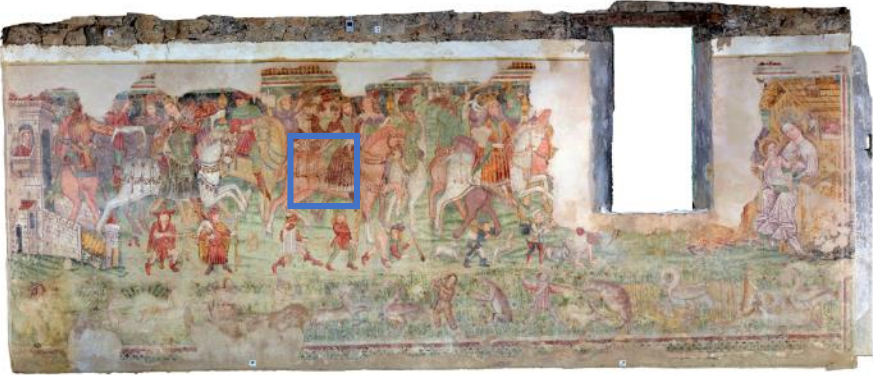
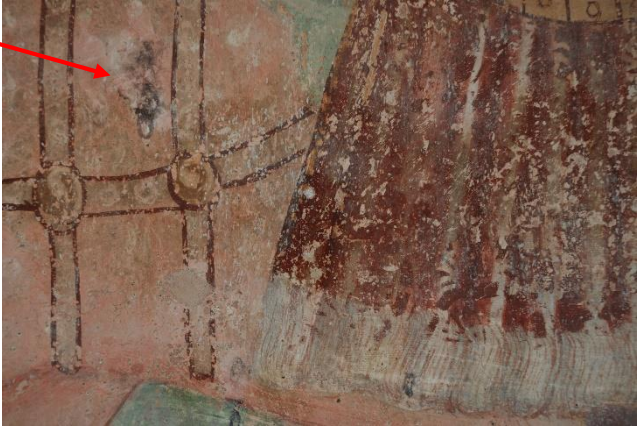
2.	DETERIORATION PHENOMENA	
7.	DEPOSIT	
<p><i>Description:</i></p> <p>Accumulated (foreign) matter on the surface of the paint layer.</p>		
<p><i>Source of the description:</i> Summer school Gradišče 2021.</p>		
<p><i>Location:</i></p>

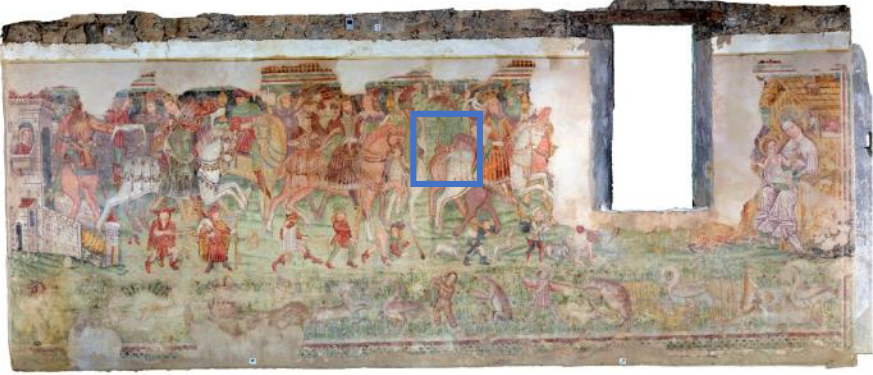
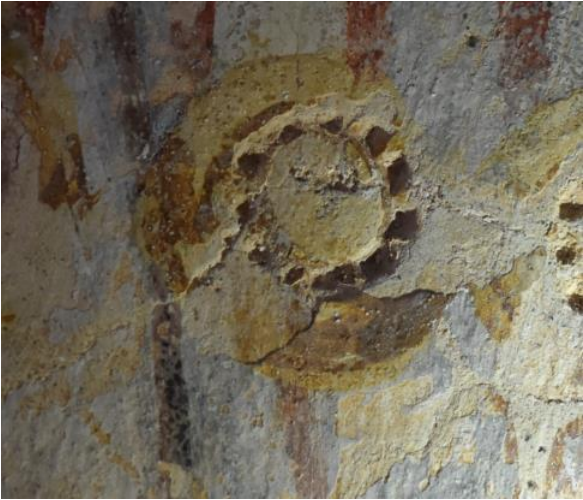
2.	DETERIORATION PHENOMENA	
8.	FLAKES	
<p><i>Description:</i></p> <p>The partial or complete detachment of fragments of the paint layer and/or the ground from an underlying layer (support, plaster). The detachment is parallel to the underlying surface and the fragments are usually small and thin.</p>		
<p><i>Source of the description:</i> Summer school Gradišče 2021.</p>		
<p><i>Location:</i></p>

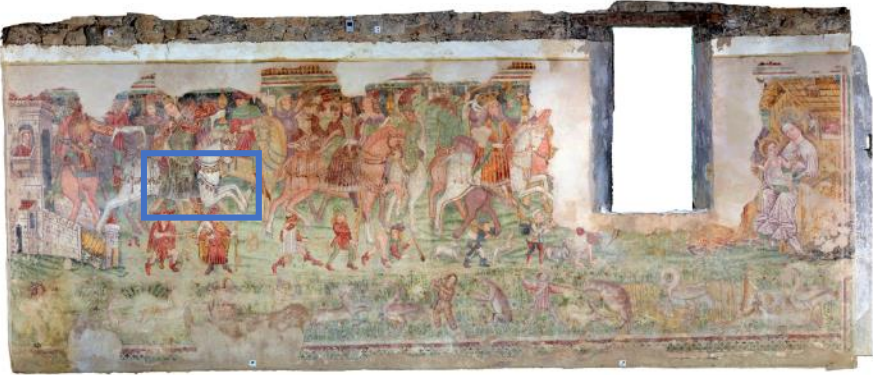
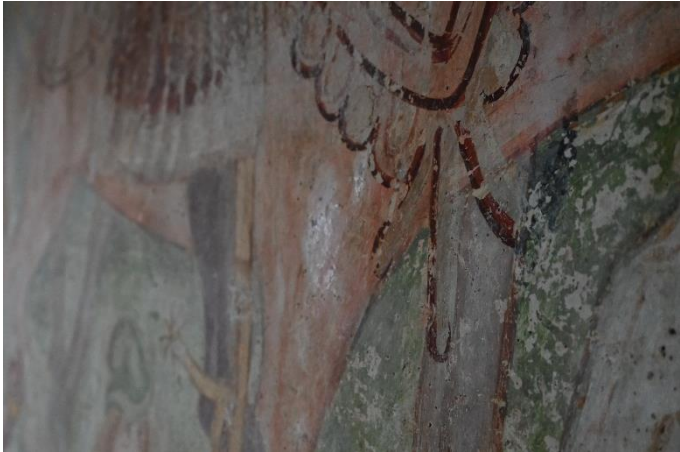
2.	DETERIORATION PHENOMENA	
9.	GLOSSY AREA	
<p><i>Description:</i></p> <p>Reflectance of the light on the painting layer.</p>		
<p><i>Source of the description:</i> Summer school Gradišče 2021, redesigned from EwaGlos, Vol.17, 2016, p. 180.</p>		
<p><i>Location:</i></p>

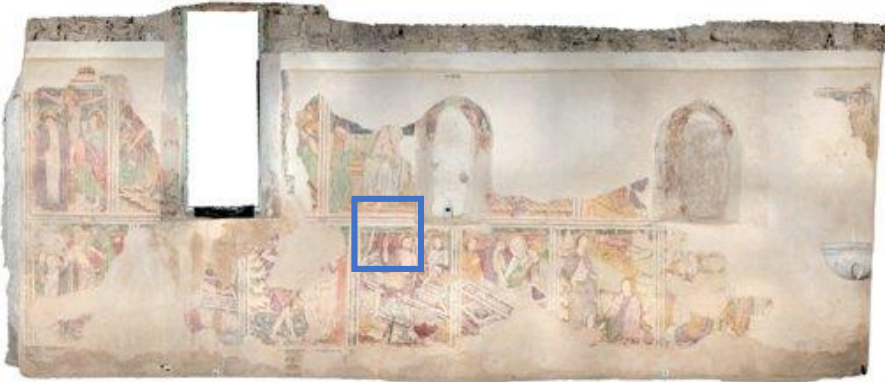
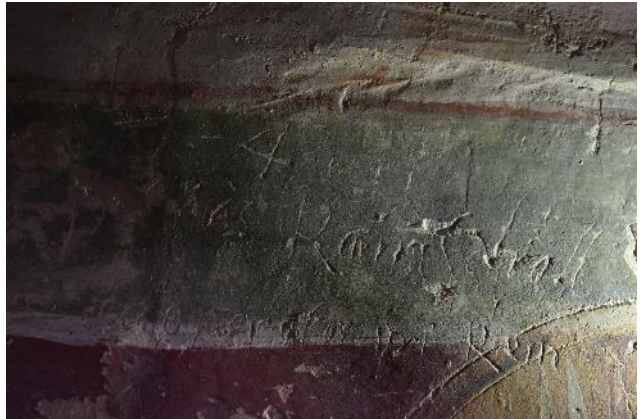
2.	DETERIORATION PHENOMENA	
10.	GRAFFITI	
<p><i>Description:</i></p> <p>Usually damage caused by deliberate or unintentional human acts.</p> <p>Graffiti can be written on the surface with the use of various materials (ex. pencil, spray paints) or scratched into the plaster.</p>		
<p><i>Source of the description:</i> EwaGlos, Vol.17, 2016, p. 173.</p>		
<p><i>Location:</i></p>

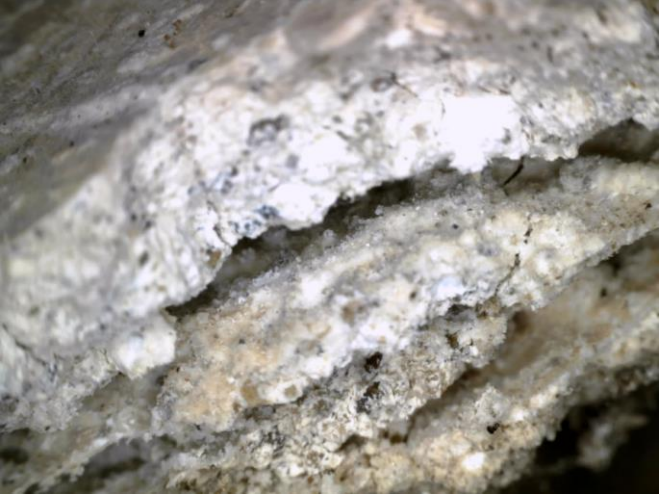
2.	DETERIORATION PHENOMENA	
11.	LACK OF ADHESION (MILD)	
<p><i>Description:</i></p> <p>Lack of adhesion between the plaster layers (rinzafo, arriccio and/or intonaco) or between plaster and the support, resulting in hollow spaces and damages.</p> <p><i>Source of the description:</i> Summer school Gradišče 2021.</p>		
<p><i>Location:</i></p>
