REPORT: INTERNATIONAL 2021 SUMMER SCHOOL GRADIŠČE PRI DIVAČI (SLOVENIA)

CHURCH OF ST. HELEN
CONSERVATION-RESTORATION OF
WALL PAINTINGS

VOLUME 1 FINAL REPORT

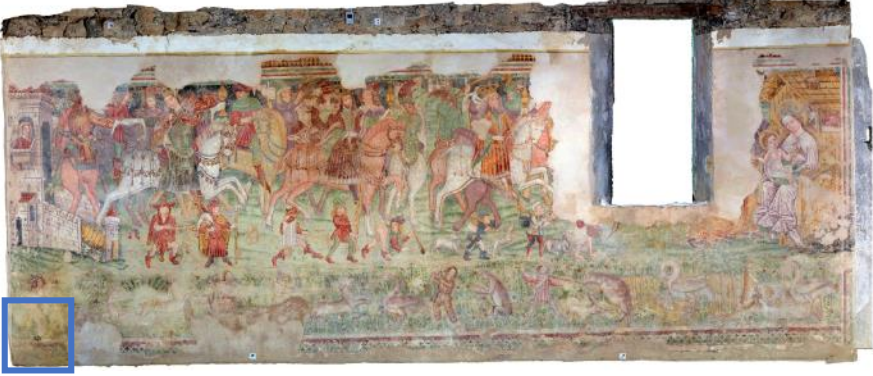
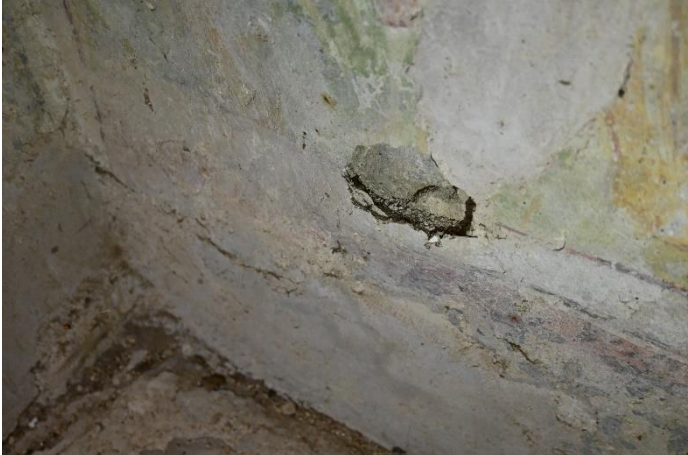
2.	DETERIORATION PHENOMENA	
12.	LACK OF ADHESION (SEVERE)	
<p><i>Description:</i></p> <p>Lack of adhesion between the plaster layers (rinzafo, arriccio and/or intonaco) or between plaster and the support, resulting in hollow spaces and damages.</p> <p><i>Source of the description:</i> Summer school Gradišče 2021.</p>		
<p><i>Location:</i></p>		
<p><i>Detail:</i></p>		
<p><i>CAD reference:</i></p>

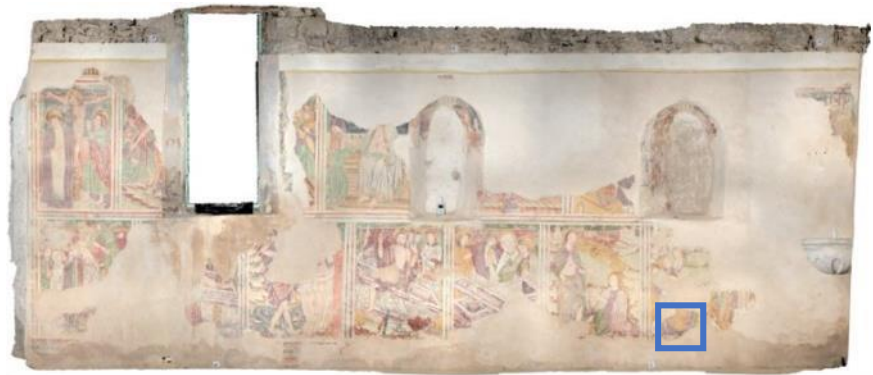
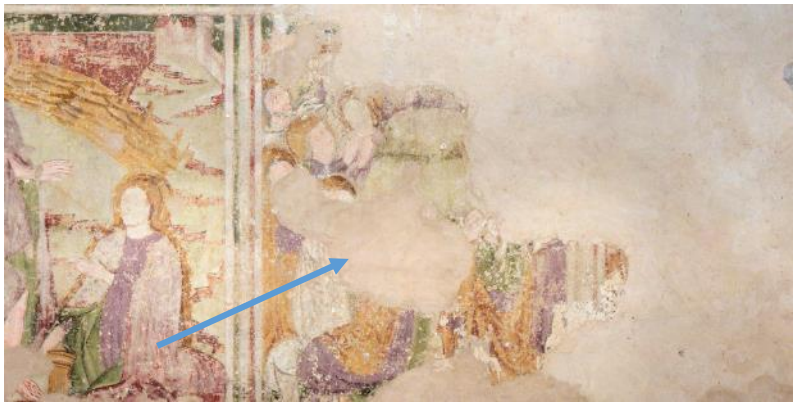
2.	DETERIORATION PHENOMENA	
13.	<i>LACUNA</i>	
<p><i>Description:</i></p> <p>Missing part of a wall painting, discontinuity across a surface which can be of different sizes and depths (paint layer, plaster layers).</p>		
<p><i>Source of the description:</i> Summer school Gradišče 2021, redesigned from EwaGlos, Vol.17, 2016, p. 180.</p>		
<p><i>Location:</i></p>

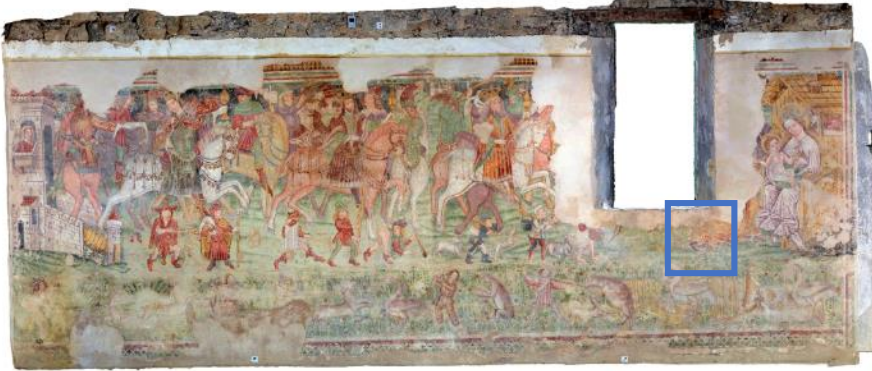
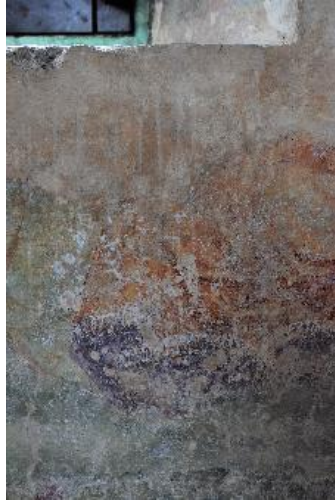
2.	DETERIORATION PHENOMENA	
14.	LEAKING STAINS	
<p><i>Description:</i></p> <p>Change in color due to infiltration of water.</p>		
<p><i>Source of the description:</i> Summer school Gradišče 2021.</p>		
<p><i>Location:</i></p>

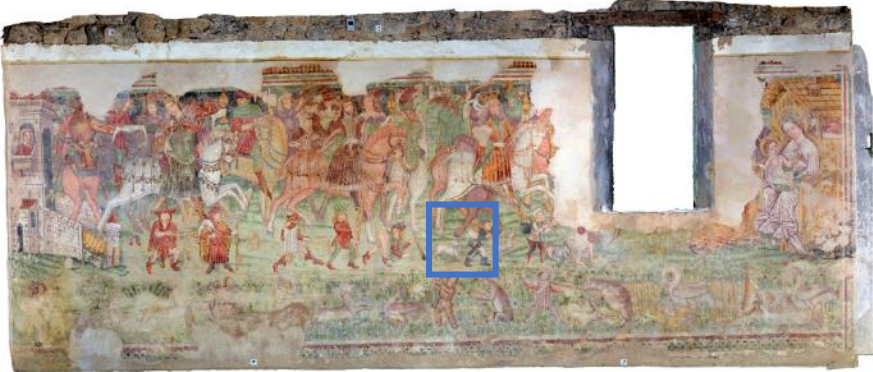
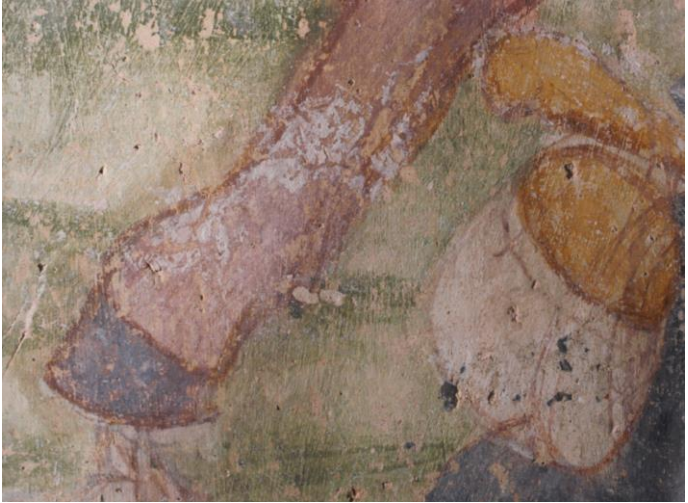
2.	DETERIORATION PHENOMENA	
15.	LIMEWASH RESIDUES	
<p><i>Description:</i></p> <p>Residues of lime wash on wall painting. After uncovering of wall painting residues of limewash can be found.</p>		
<p><i>Source of the description:</i> EwaGlos, Vol.17, 2016, p. 200.</p>		
<p><i>Location:</i></p>

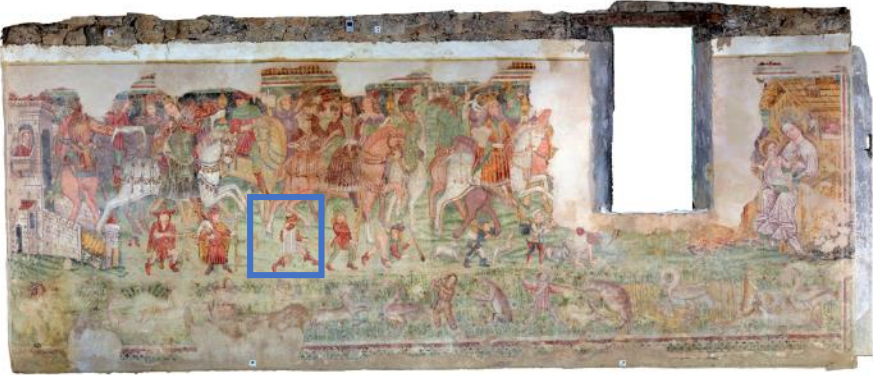
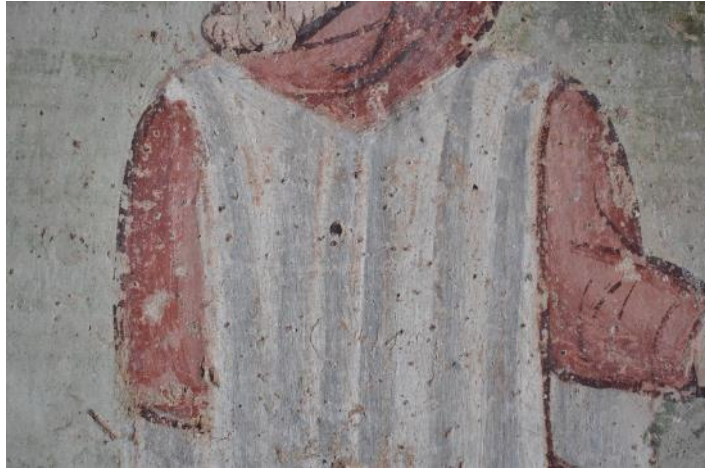
2.	DETERIORATION PHENOMENA	
16.	PITTING	
<p><i>Description:</i></p> <p>Damage of intonaco caused by the volume change of the aggregates.</p>		
<p><i>Source of the description:</i> Summer school Gradišče 2021.</p>		
<p><i>Location:</i></p>

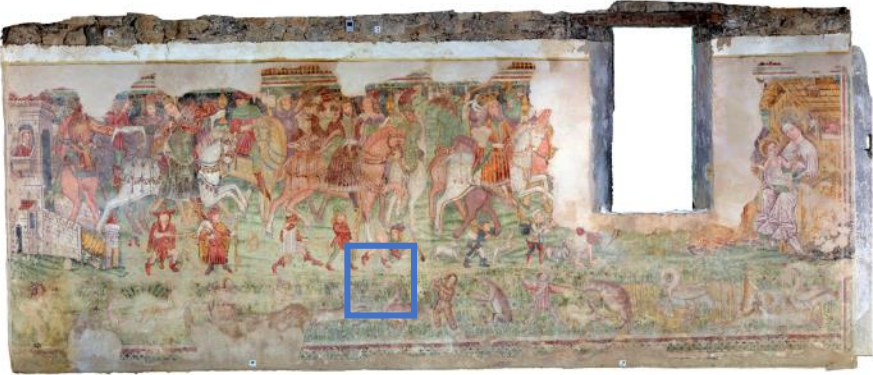
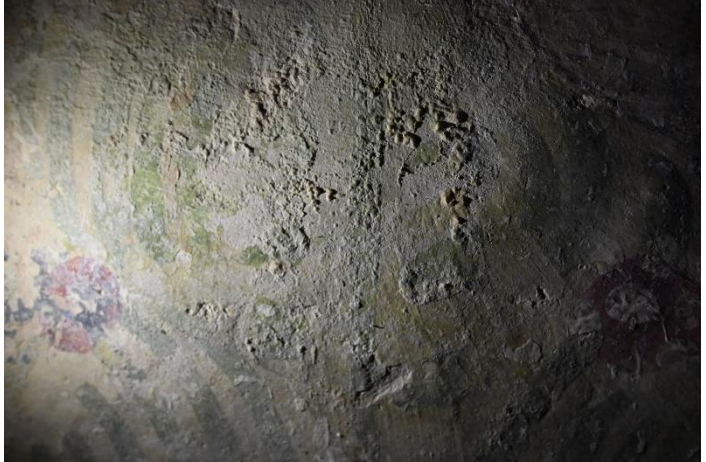
2.	DETERIORATION PHENOMENA	
17.	SALTS CRUST	
<p><i>Description:</i></p> <p>Formation and surface accumulation of soluble salts of crystalline appearance.</p>		
<p><i>Source of the description:</i> Summer school Gradišče 2021, redesigned from EwaGlos, Vol.17, 2016, p. 166.</p>		
<p><i>Location:</i></p>

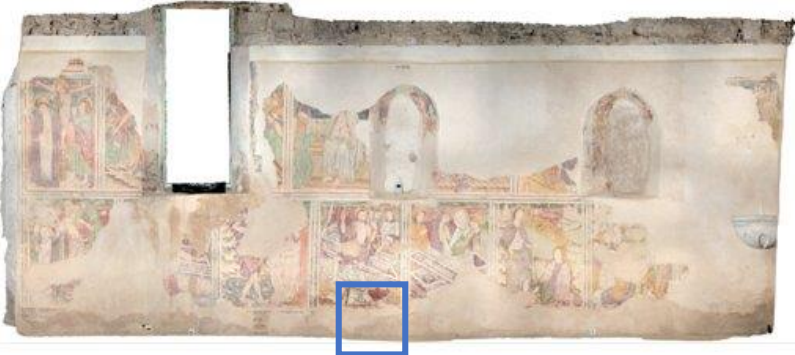
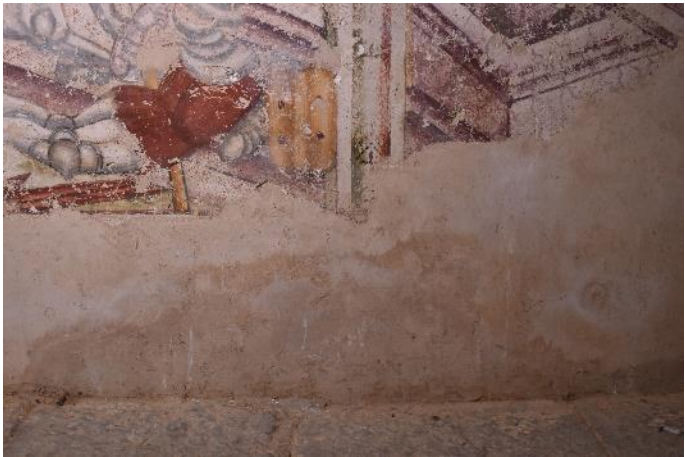
2.	DETERIORATION PHENOMENA	
18.	STAINS	
<p><i>Description:</i></p> <p>Damp stains on the wall due to the condensation process.</p>		
<p><i>Source of the description:</i> Summer school Gradišče 2021.</p>		
<p><i>Location:</i></p>

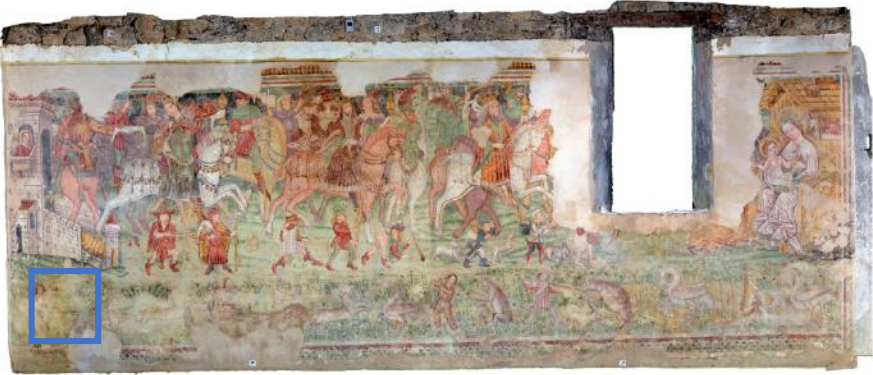
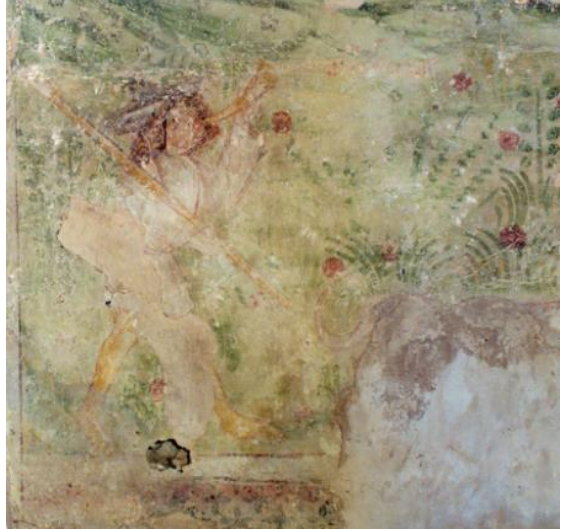
2.	DETERIORATION PHENOMENA	
20.	YELLOWING	
<p><i>Description:</i></p> <p>Chromatic alteration of the materials in a yellowish hue.</p>		
<p><i>Source of the description:</i> Summer school Gradišče 2021, redesigned from EwaGlos, Vol.17, 2016, p. 214.</p>		
<p><i>Location:</i></p>

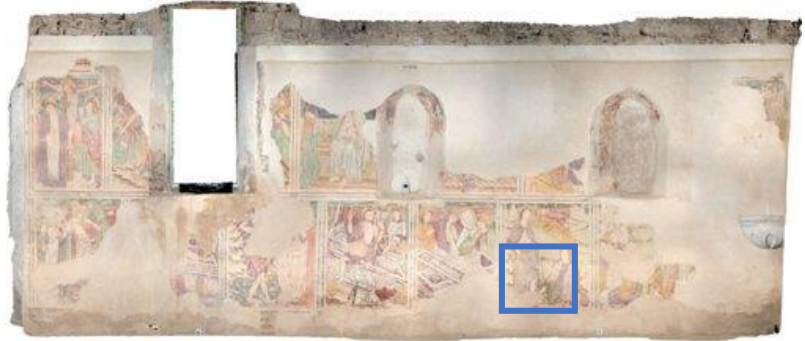
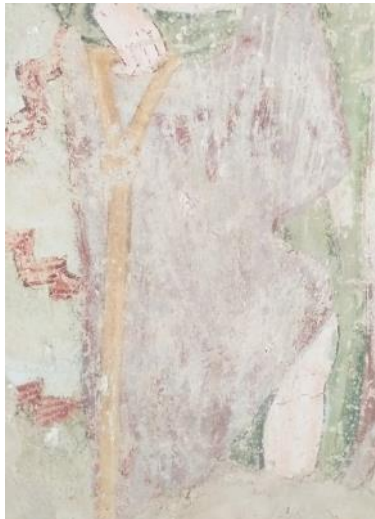
2.	DETERIORATION PHENOMENA	
21.	WHITENING	
<p><i>Description:</i></p> <p>White film on an architectural surface due to the formation of a deposit (particles).</p>		
<p><i>Source of the description:</i> Summer school Gradišče 2021, redesigned from EwaGlos, Vol.17, 2016, p. 212.</p>		
<p><i>Location:</i></p>

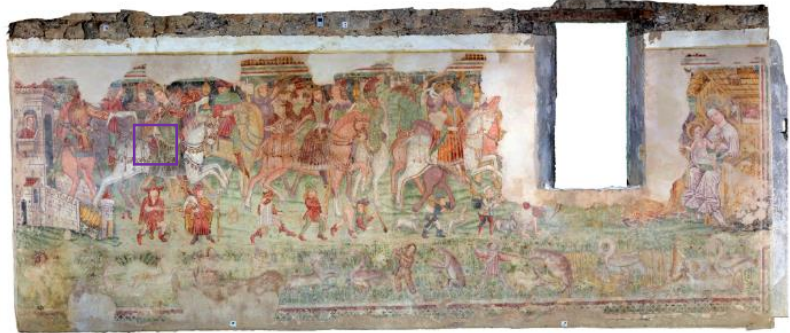
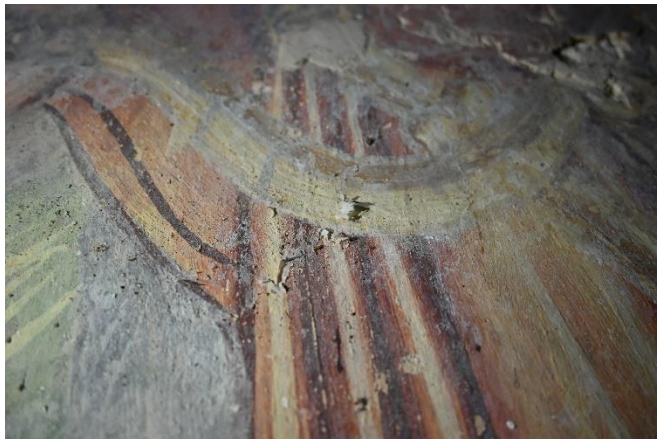
3.	PREVIOUS INTERVENTIONS	
1.	CONSOLIDATION	
<p><i>Description:</i></p> <p>Procedure aimed at re-establishing the loss of mechanical strength and improving the internal cohesion of different layers that make up an artwork. It is performed via the application, by impregnation or injection, of adhesive products within the voids of the structure or material.</p> <p>Comment: There can be two types of consolidation: - Temporary consolidation: provisional application of an adhesive product, that will allow further treatments of the artwork. - Long-term consolidation: definitive application of an adhesive product that attempts to completely permeate the inner spaces of the original material of the artwork. The products used for this purpose must have good stability over time.</p>		
<p><i>Source of the description:</i> EwaGlos, Vol.17, 2016, p. 312.</p>		
<p><i>Location:</i></p>

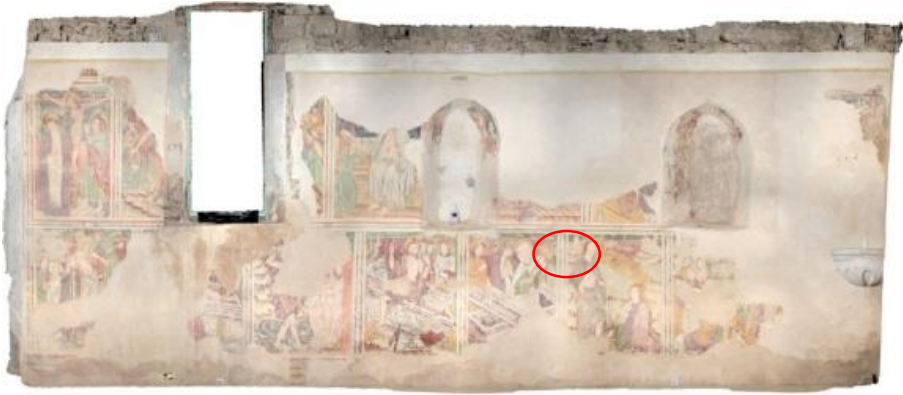
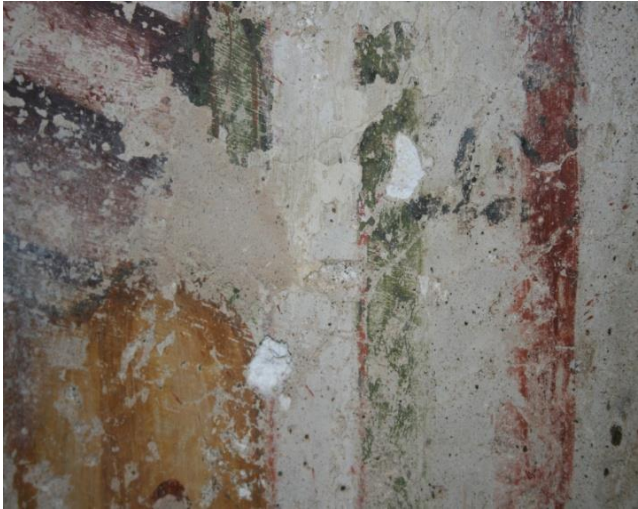
3.	PREVIOUS INTERVENTIONS	
2.	INJECTION OF GROUT	
<p><i>Description:</i></p> <p>Adhesion of layers or fragments of mortars, plasters or renders with the injection of a fluid and fine-grained mortar (grout) inside small spaces, cracks and pores. Comment: in order to avoid potential risks to the object it is necessary to control the amount of water and other solvents in the injected grouts, their compatibility with the original materials and the adhesion between the treated layers.</p>		
<p><i>Source of the description:</i> EwaGlos, Vol.17, 2016 p. 316.</p>		
<p><i>Location:</i></p>

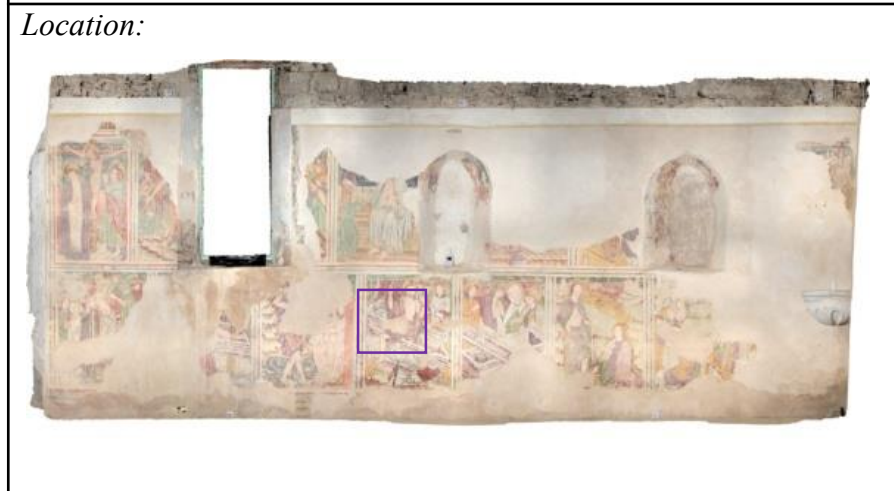
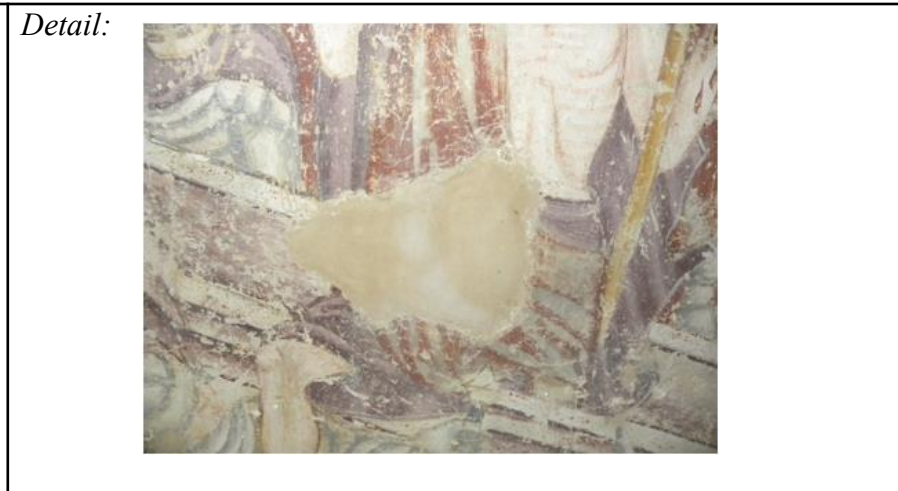
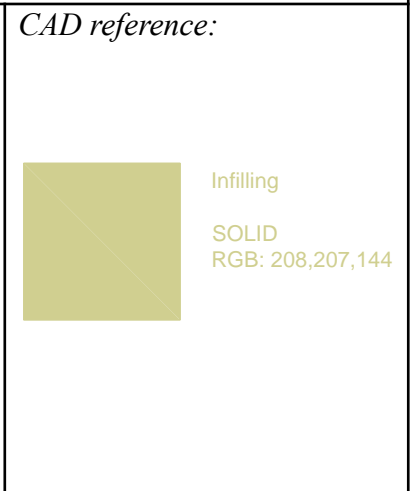
To reestablish continuity between layers reinstating their structural and aesthetic properties. A lacuna in plaster layers can be infilled with a mixture consisting of a filler and a binder. Note: The lacunas in plaster layers are reinstated with new plaster.

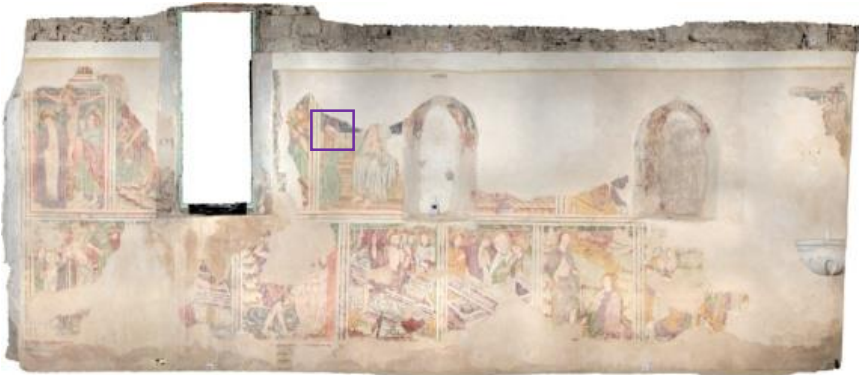
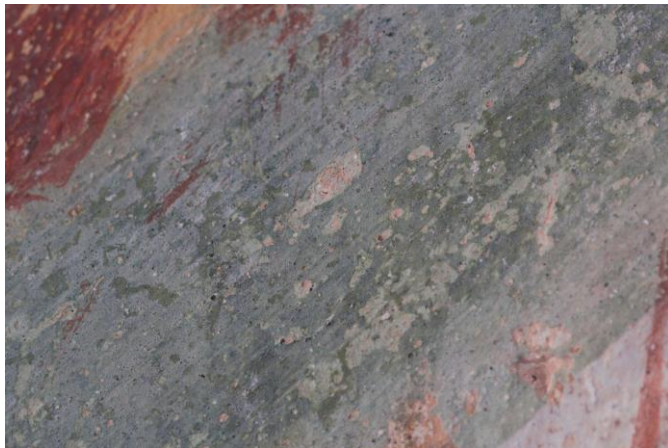
3.	PREVIOUS INTERVENTIONS	
4.	UNCOVERING	
<p><i>Description:</i></p> <p>Uncovering is the process of discovering or exposing a wall painting. It involves the controlled removal of various superimposed and overlaying layers. The removal of these layers can be seen on the paint layer.</p>		
<p><i>Source of the description:</i> Summer school Gradišče 2021, redesigned from EwaGlos, Vol.16, 2016, p. 326.</p>		
<p><i>Location:</i></p>

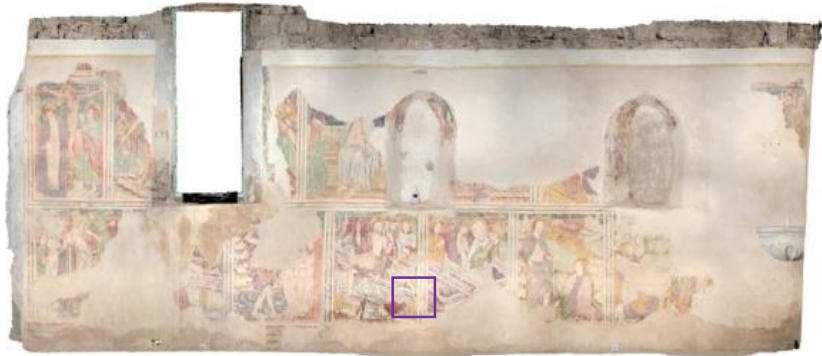
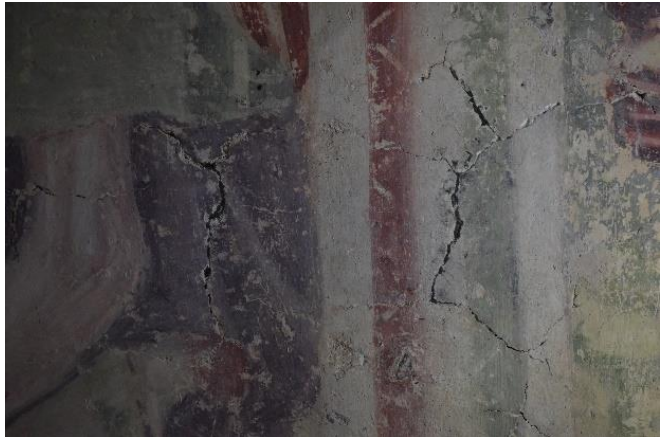
3.	PREVIOUS INTERVENTIONS	
5.	UNKNOWN MATERIAL IN <i>LACUNA</i>	
<p><i>Description:</i></p> <p>Unknown material in <i>lacuna</i> and cracks possibly to assist when injecting the grout.</p>		
<p><i>Source of the description:</i> Summer school Gradišče 2021.</p>		
<p><i>Location:</i></p>

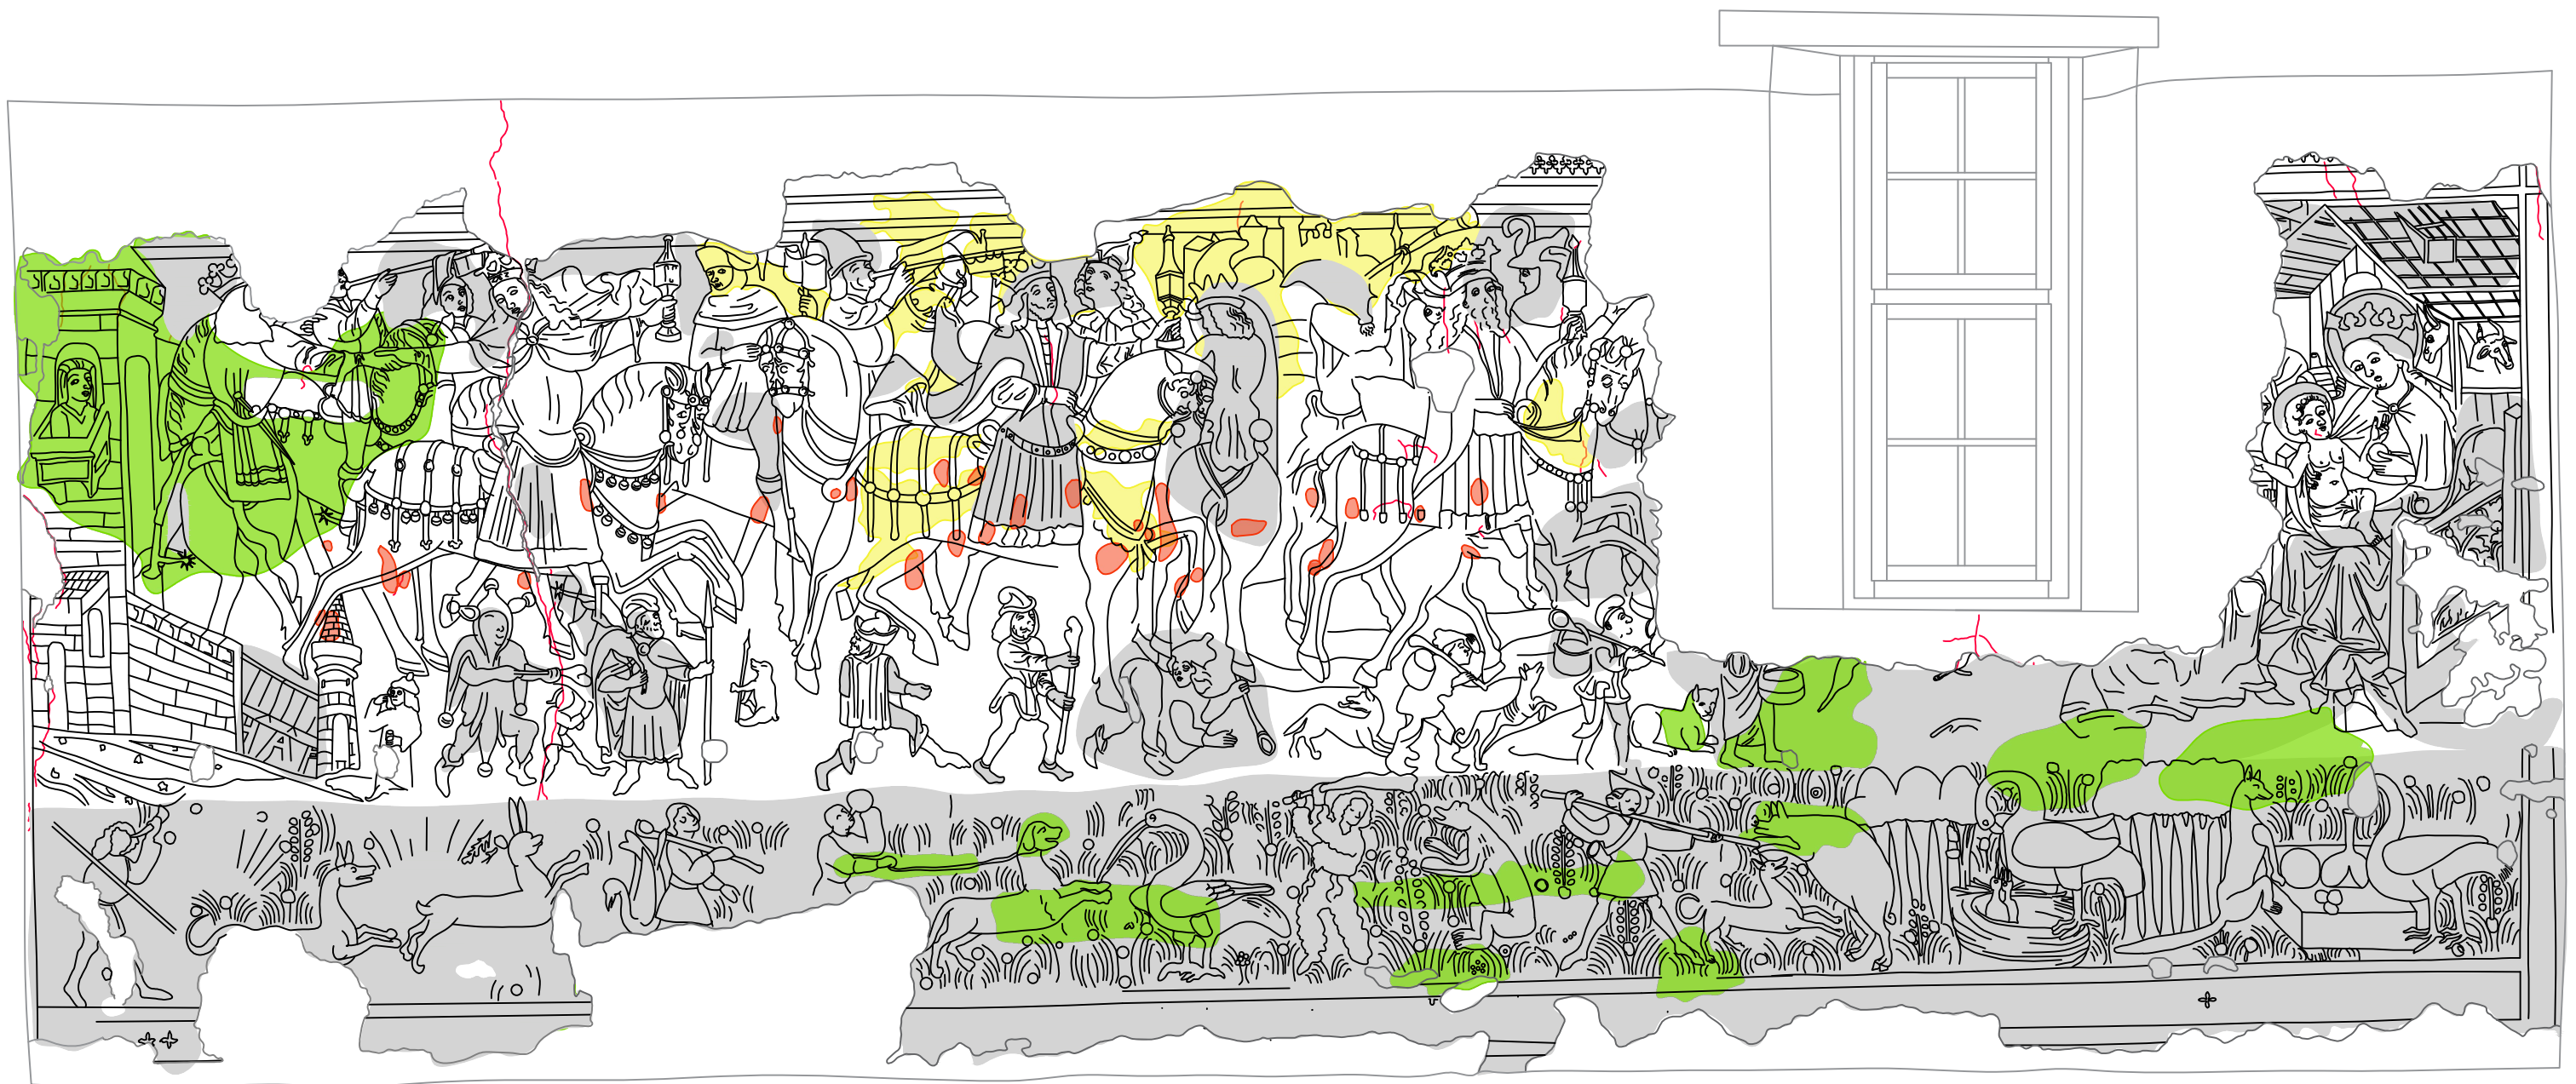
- Glossy area
- Whitening
- Cracks
- Uncovering
- Abrasion
- Yellowing

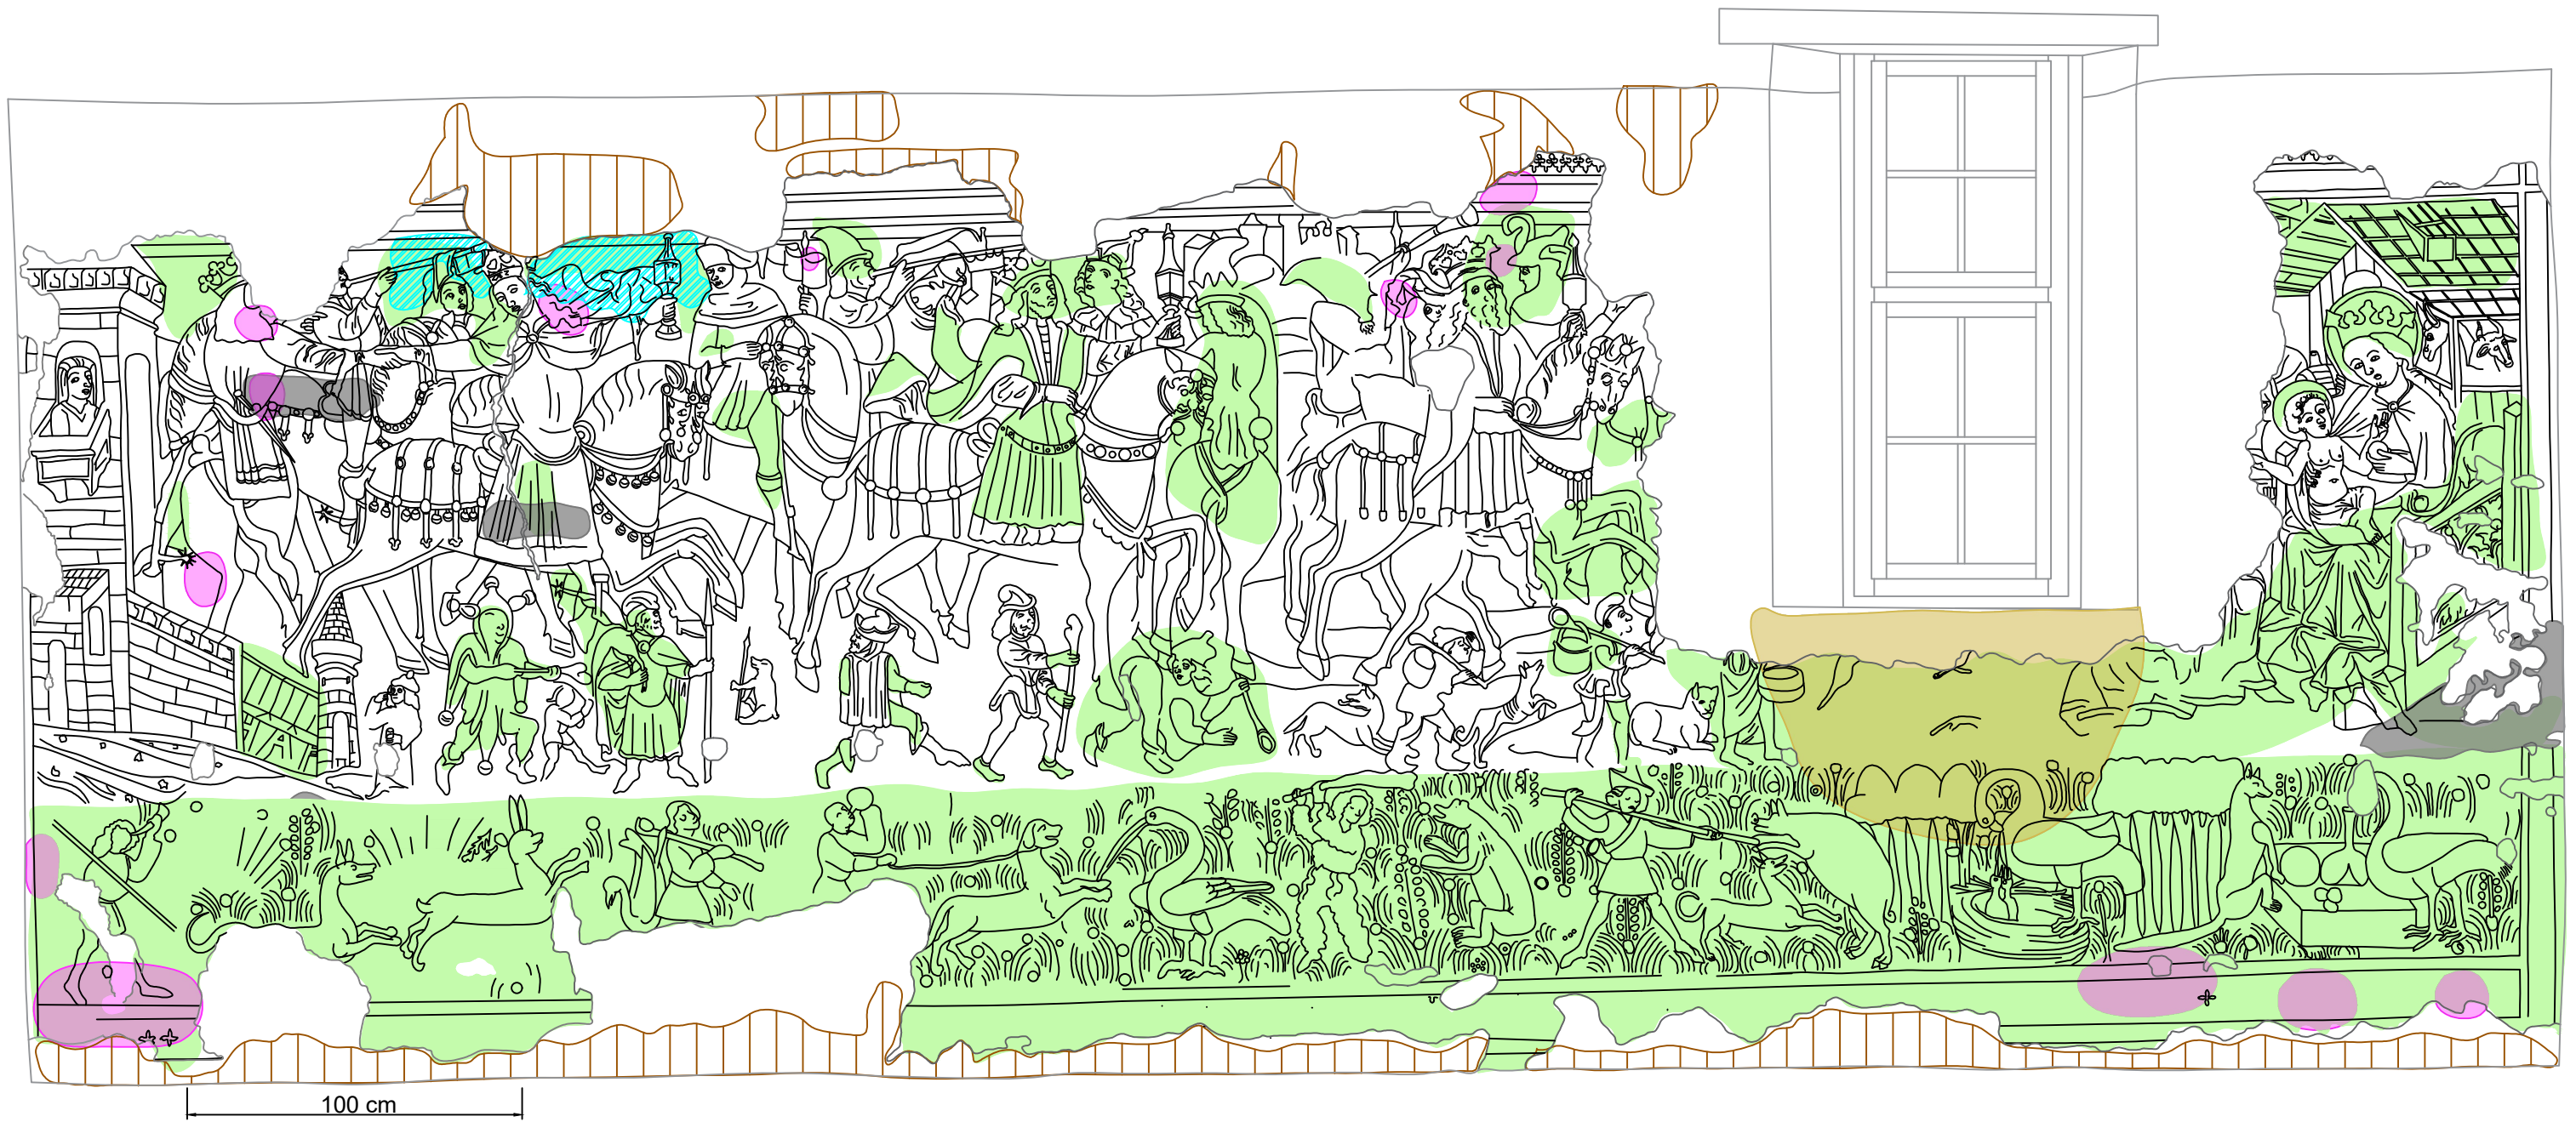
- Abrasion
- Leaking stains
- Stains
- Craquelure
- Colour saturation
- Darkening

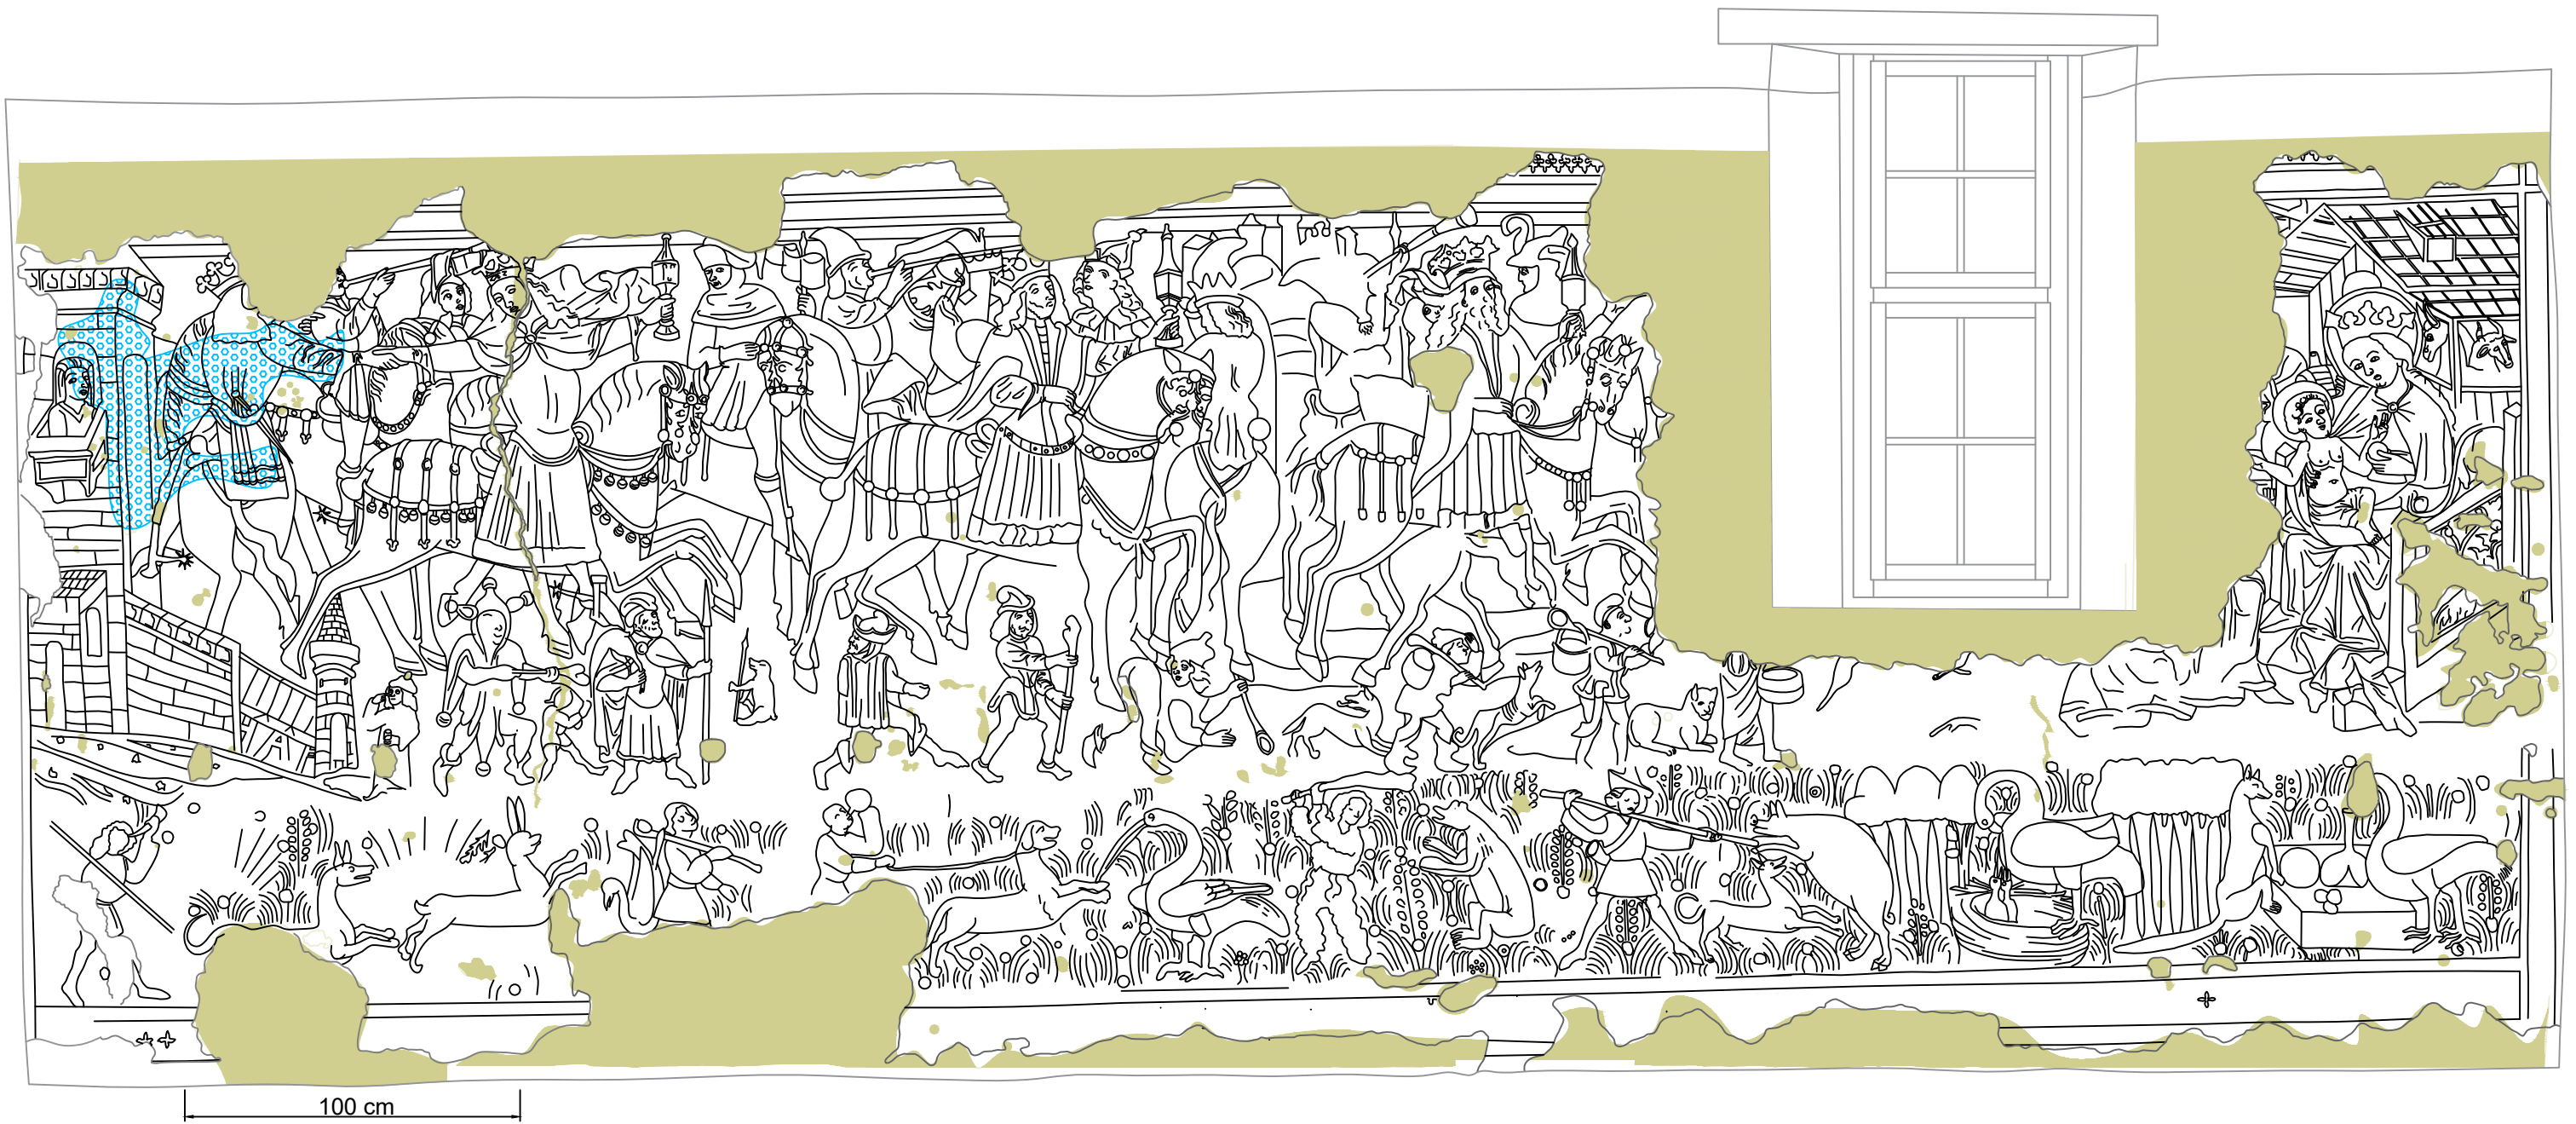
- Consolidation
- Injection of grout
- Unknown material in lacunae
- Infilling
- Uncovering

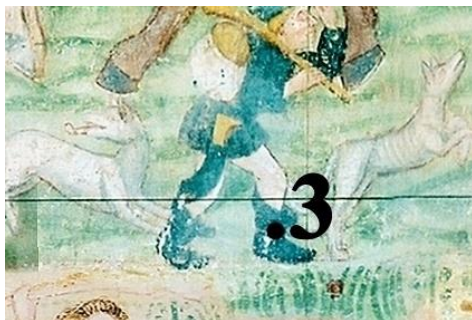
SAMPLE CODE**SAMPLE MICROLOCATION****GDC 3**

N wall, man with bundle over shoulder, grey left boot

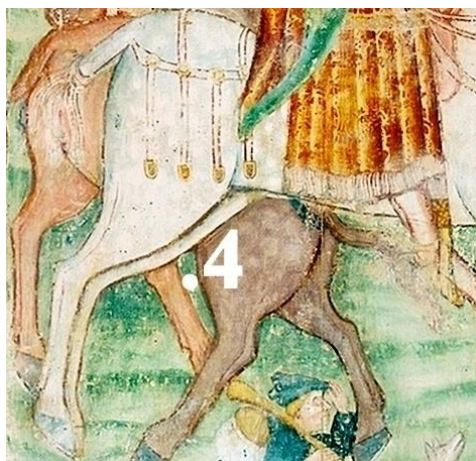
GDC 4

green background between horse legs

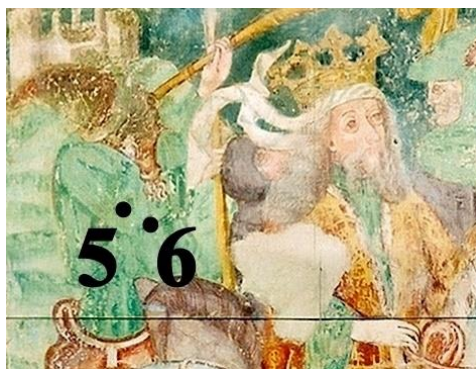
GDC 6

man with instrument, green drapery, darker green, fold, compare with GDC 5

- 4- transparent layer
- 3- green
- 2- red
- 1- plaster

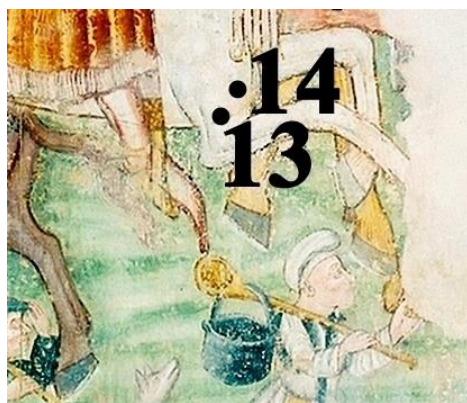
GDC 13

white horse on right side of the painting, right front leg, white background

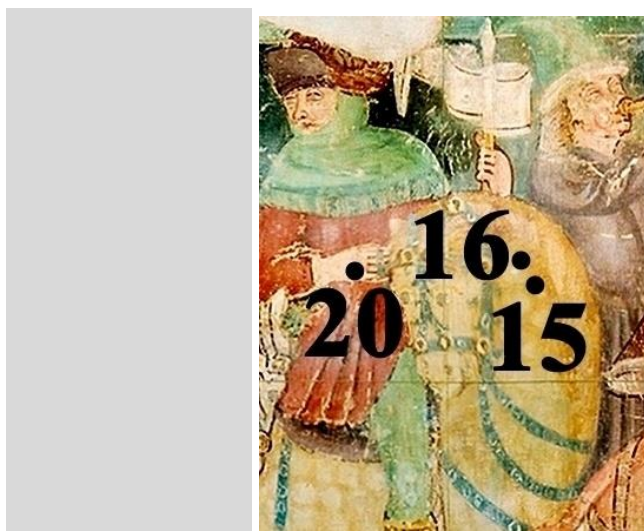
SAMPLE CODE	SAMPLE MICROLOCATION
GDC 16	bright brown horse, circular pattern on the neck, bright ochre

- 3- transparent
- 2- light brown
- 1- plaster

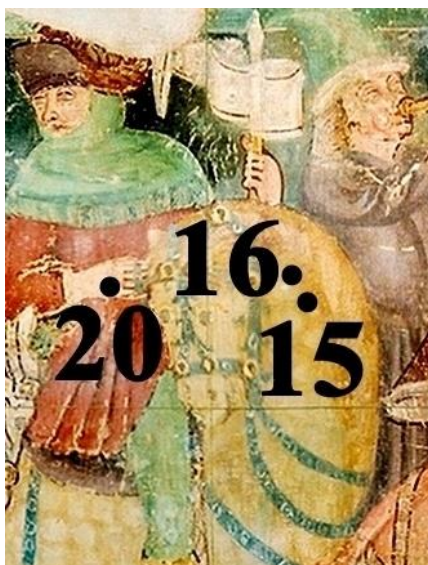
SAMPLE CODE **SAMPLE MICROLOCATION**
GDC 20

N wall, rider on yellow horse, right hand, carnation, retouching or secco, thin layer on plaster, detached

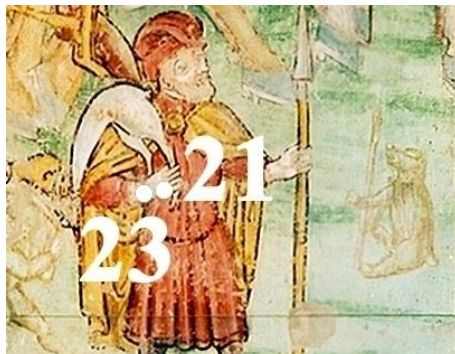
hunter with catch over shoulder, right hand, carnation

- 3- pink (locally)
- 2- light pink
- 1- plaster

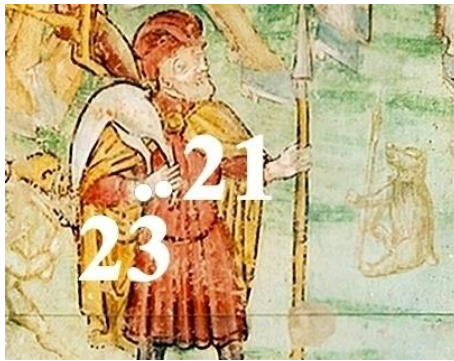
SAMPLE CODE	SAMPLE MICROLOCATION
GDC 23	hunter with catch over shoulder, right hand, carnation, binder analysis

3- transparent layer
2- ochre
1- plaster

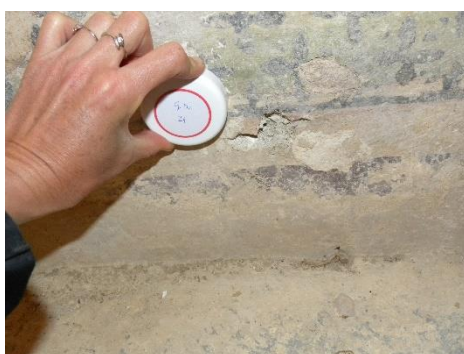
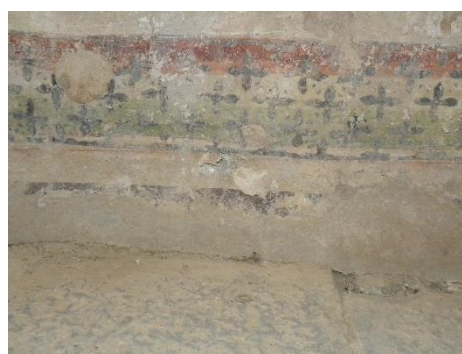
SAMPLE CODE**SAMPLE MICROLOCATION****GDC 24**

mortar, N wall, ornament above the floor, mortar between the lines

On the surface of the mortar, there is a layer of paint. This is followed by the mortar.

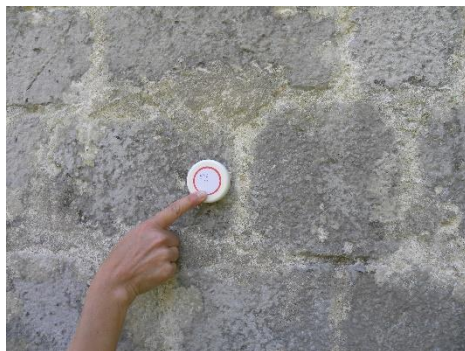
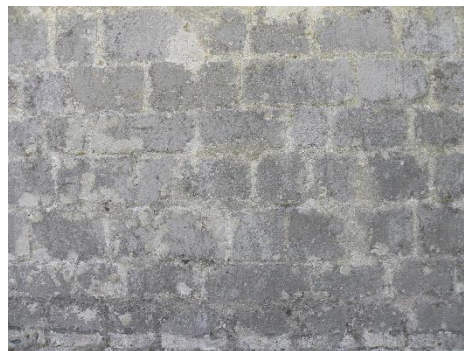
facade mortar, N wall, joint mortar between stones

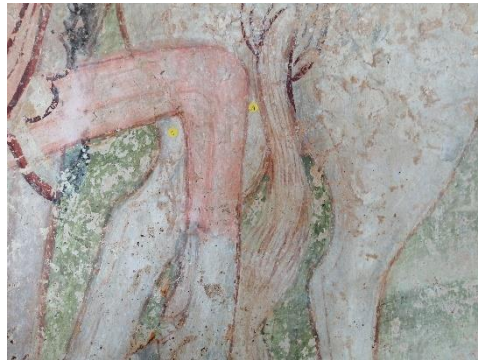
white, N wall, white horse, left leg, under knee of brown horse, BaOH, ammonium bicarbonate, Japanese paper

3- coating/ salts
2- white
1- plaster

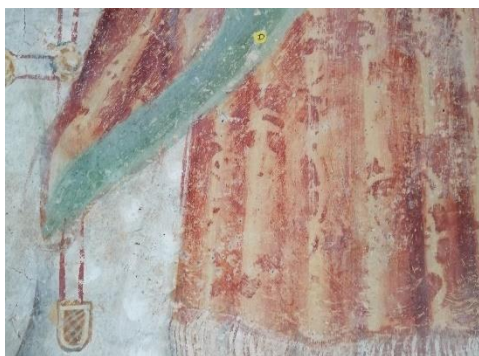
GDC 33

dark green, N wall, left from the window, king, sleeve

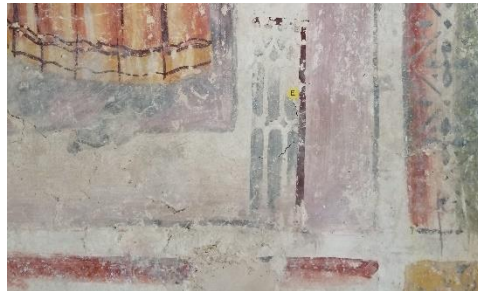
GDC 34

black with orange fluorescence, right of the door, window, ornament bottom right

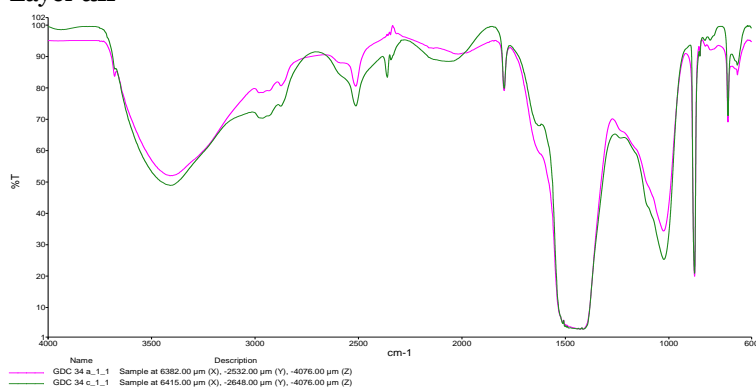
- calcite
- silicates (3680 cm⁻¹), probably magnesium silicate (Kaste et al., 1998) or kaolin (Abazi, 2016)
- calcium oxalate or proteins

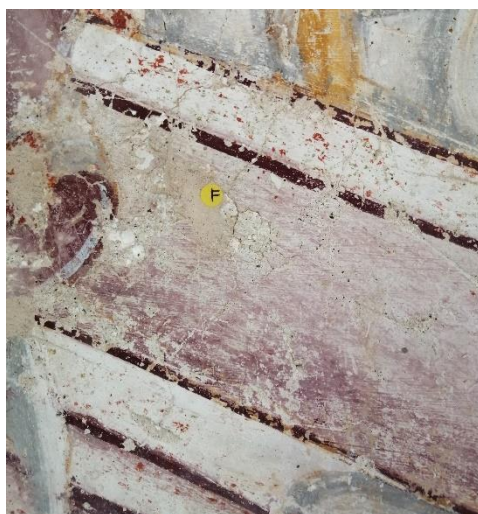
light violet, S wall, grave, anionic resins

2- red
1- plaster

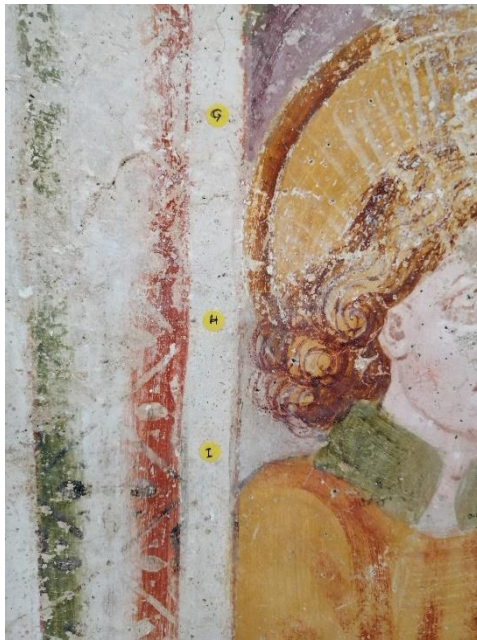
GDC 36
(label G)

white, S wall, right of the window, under 1st niche, frame, cleaned with water

2- white with red particles
1- plaster
