REPORT: INTERNATIONAL 2021 SUMMER SCHOOL GRADIŠČE PRI DIVAČI (SLOVENIA)

CHURCH OF ST. HELEN
CONSERVATION-RESTORATION OF
WALL PAINTINGS

VOLUME 1 FINAL REPORT

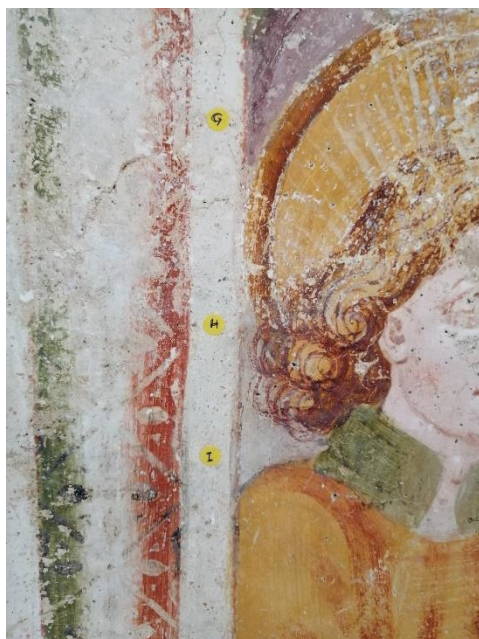
white, S wall, right of the window, under 1st niche, frame, under GDC 36, BaOH

3- coating / salts
2- white with red particles
1- plaster

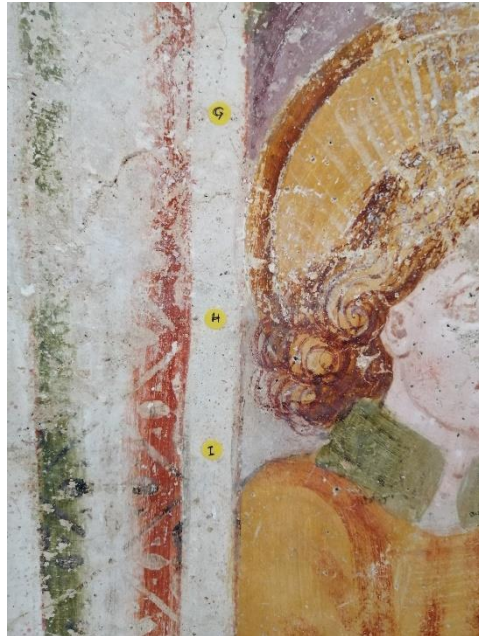
GDC 38
(label I)

white, S wall, right of the window, under 1st niche, frame, under GDC 37, BaOH and ammonium bicarbonate, poultice

2- white
1- plaster

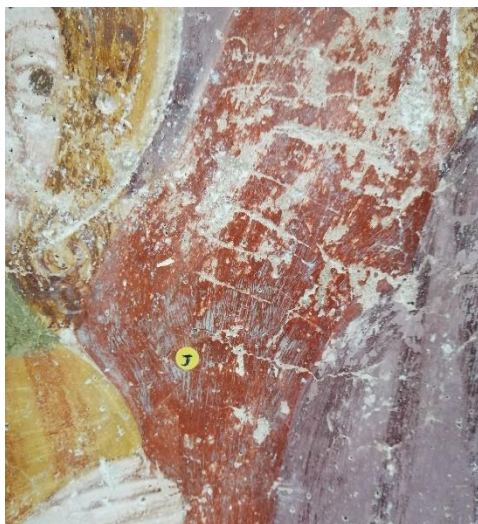
GDC 39

red, S wall, right from the window, under 1st niche, right scene, background between figures, blue pigment?, ammonium bicarbonate with poultrice

No visible blue particles.

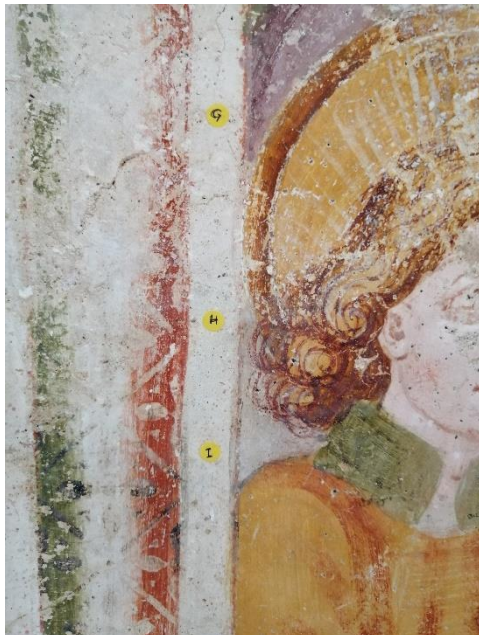
GDC 40
(not labelled, below label I)

white, S wall, right of the window, under 1st niche, frame, left from yellow drapery

2- white
1- plaster

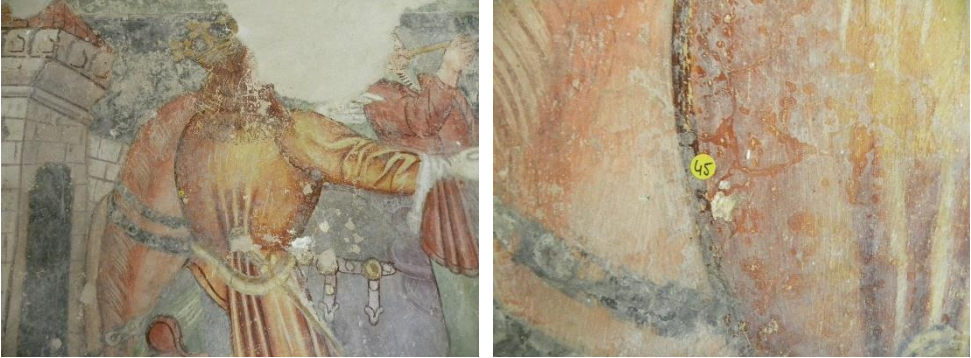
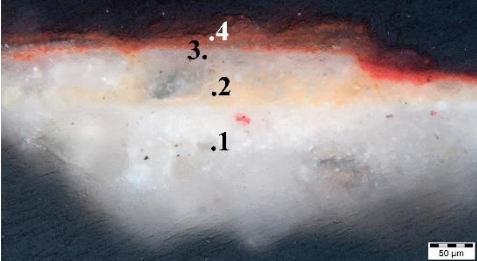
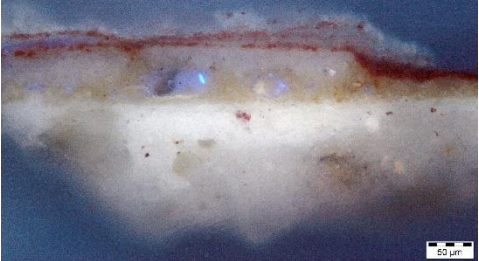
SAMPLE CODE	SAMPLE MICROLOCATION	
GDC 45	red, N wall, man on the left, back, incrustation on surface

STRATIGRAPHY	VIS PHOTOGRAPHY	UVF PHOTOGRAPHY
4- orange and white, exchanging 3- white 2- ochre 1- plaster

- close to the surface only gypsum is observed
- gypsum disappears after 60 μm approx.
- in spectrum d (red line) nitrates appear (1040 cm⁻¹)

- gypsum in top layers, no calcite
- in depth (after approx. 80 μm) amount of gypsum relative to calcite, is smaller, and different amounts can be observed in different spots
- in some spots nitrates are present

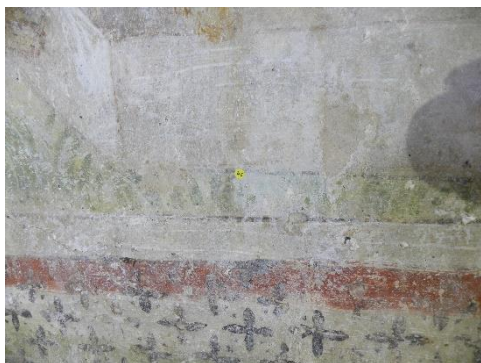
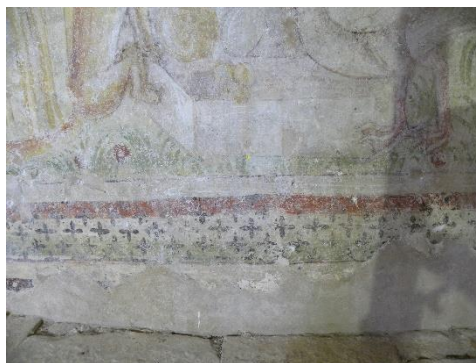
green, N wall, grass under bottle, after cleaning with ammonium bicarbonate salt-like efflorescence appears

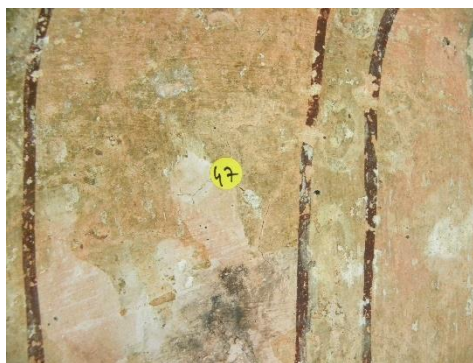
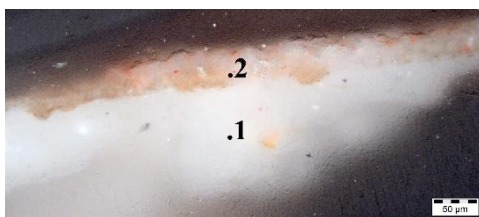
red, back of the horse of the first Magi, coating

2- red
1- plaster

- gypsum visible in some analysed point
- no clear profile like in other samples can be observed

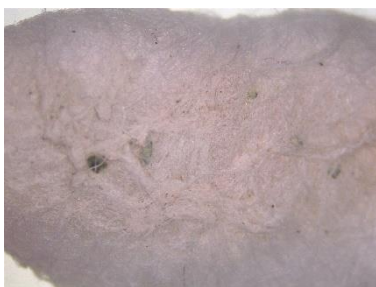
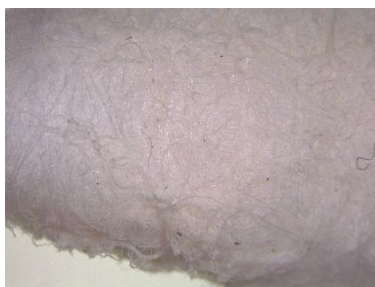
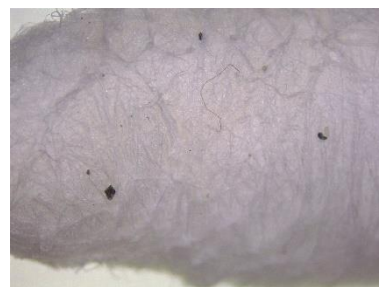
MB_06_CA

amount of gypsum seems to decrease with every next cotton swab
(in contrast to calcite, where no pattern can be observed)

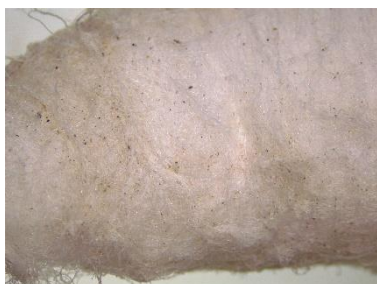
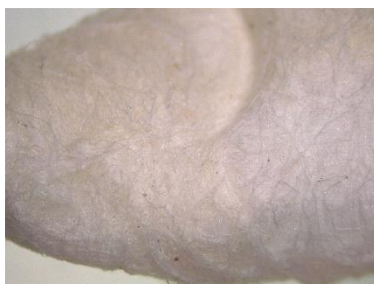
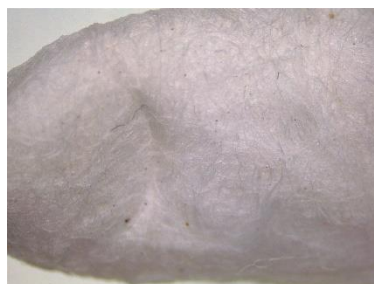
MB_09_CA

amount of gypsum increases after 1st cotton swab

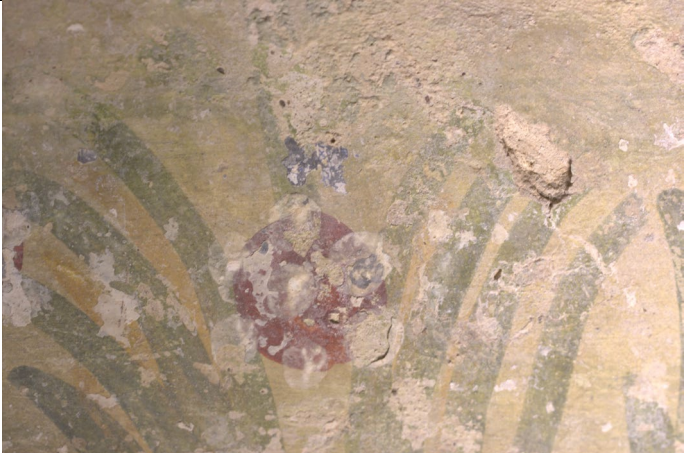
<p><i>Photo 1:</i> gra_csh_nw_op_vis_202108_3; Fresco painting technique with secco finishing.</p>	<p><i>Photo 2:</i> gra_csh_nw_op_rl_20210813_8; Example of direct incisions and punzonatura on painting.</p>

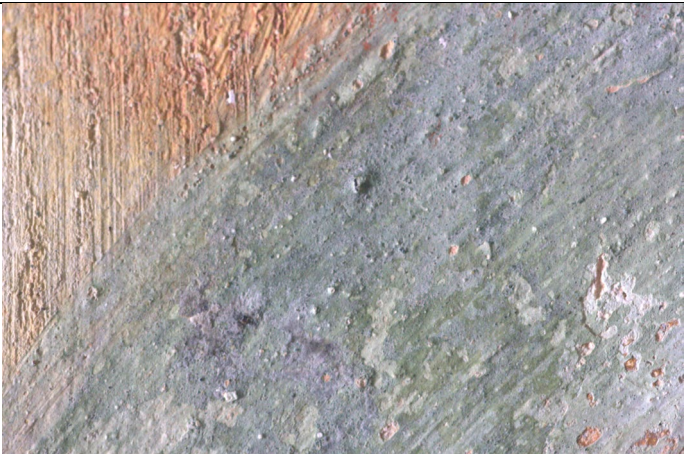
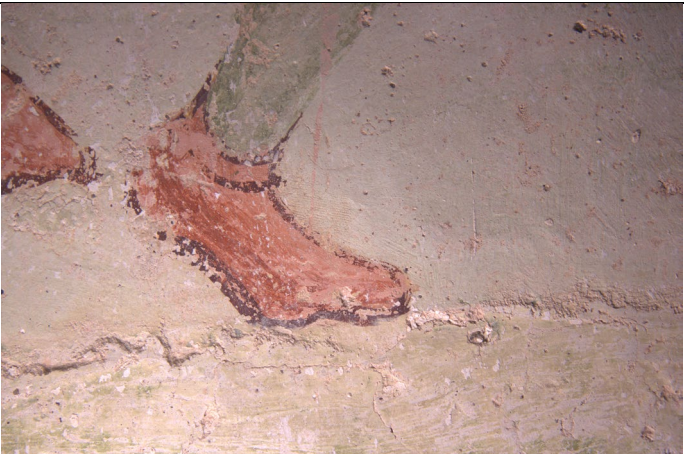
<p><i>Photo 3:</i> gra_csh_nw_op_vis_202108_1; Detail of colour deposit in resemblance of brush stroke.</p>	<p><i>Photo 4:</i> gra_csh_nw_op_vis_20210813_12; Detail pontata.</p>

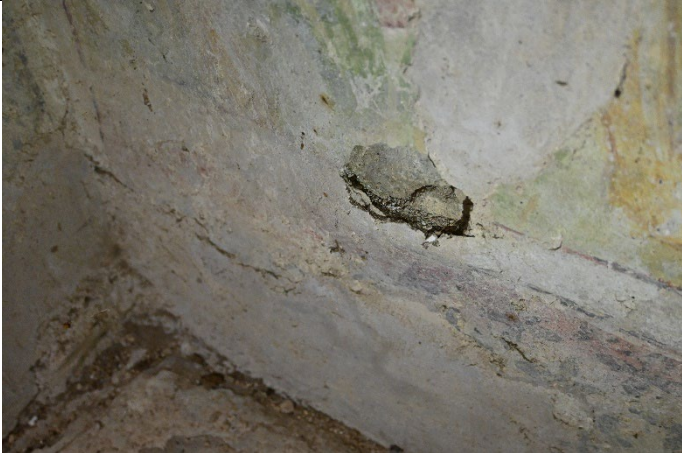
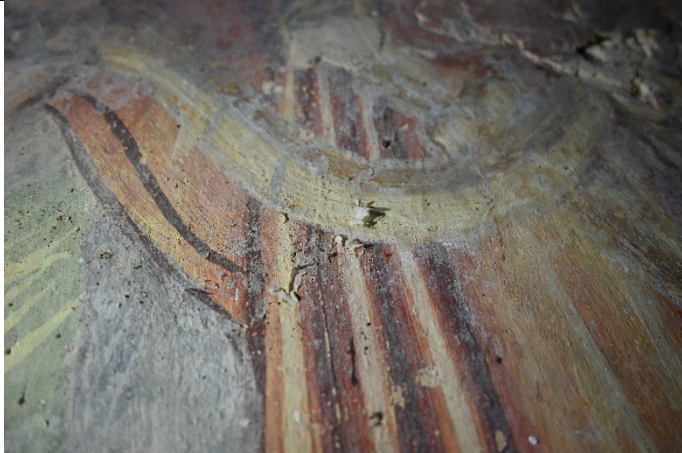
<p><i>Photo 5:</i> gra_csh_nw_dp_vis_20211116_5; Example of opened and active lacuna.</p>	<p><i>Photo 6:</i> gra_csh_nw_dp_vis_20211116_2; Different deposits and impurities on surface of the painting.</p>

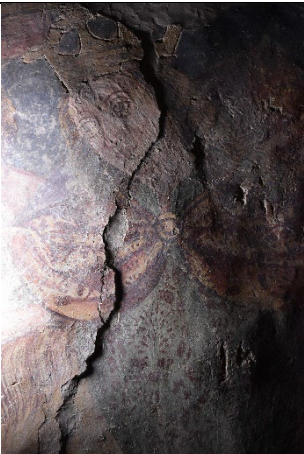
<p><i>Photo 7:</i> gra_csh_nw_dp_rl_20210813_3; Crack on north wall.</p>	<p><i>Photo 8:</i> gra_csh_sw_dp_vis_20210813_6; Example of lacking colour layer due to abrasion or other mechanical causes.</p>

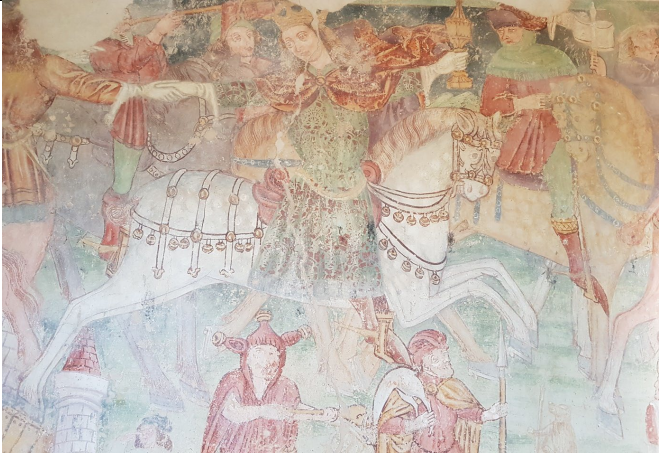
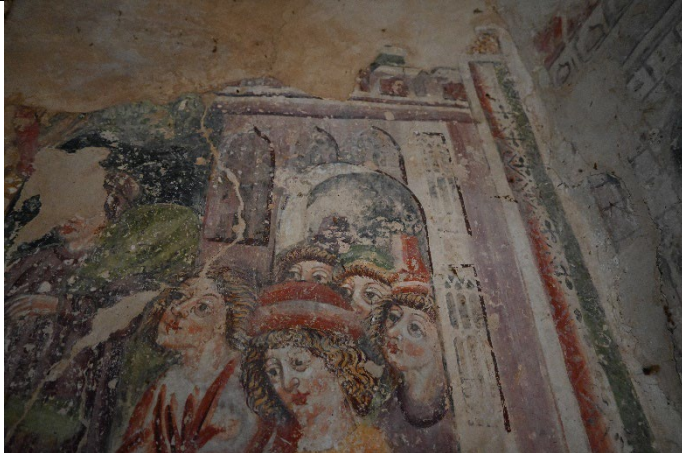
<p><i>Photo 9:</i> gra_csh_nw_pt_vis_20210813_2; Filled crack during previous restoration treatment.</p>	<p><i>Photo 10:</i> gra_csh_ww_pt_vis_20211116_2; Example of previously done infillings on west wall.</p>

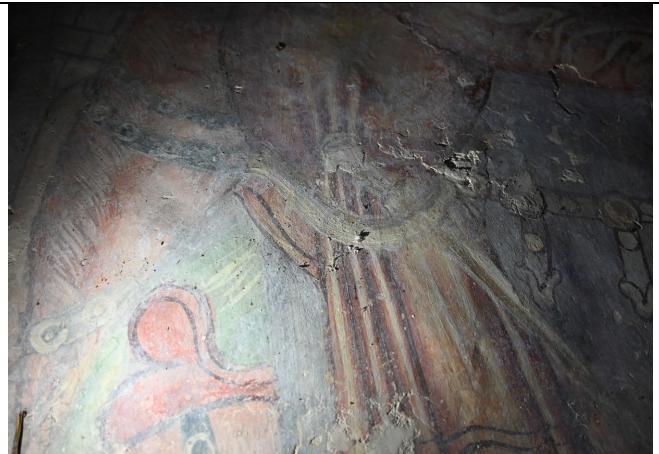
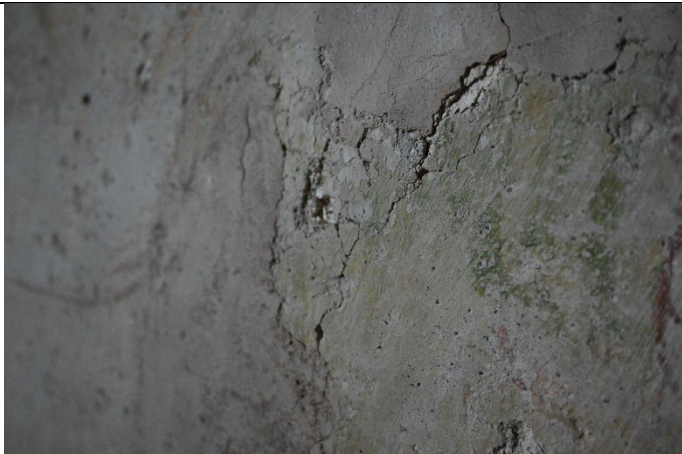
<p><i>Photo 11:</i> gra_csh_nw_dp_rl_20211116_1; Example of a previously done infilling.</p>	<p><i>Photo 12:</i> gra_csh_nw_dp_vis_20211116_1; One of the spots of grout injection.</p>

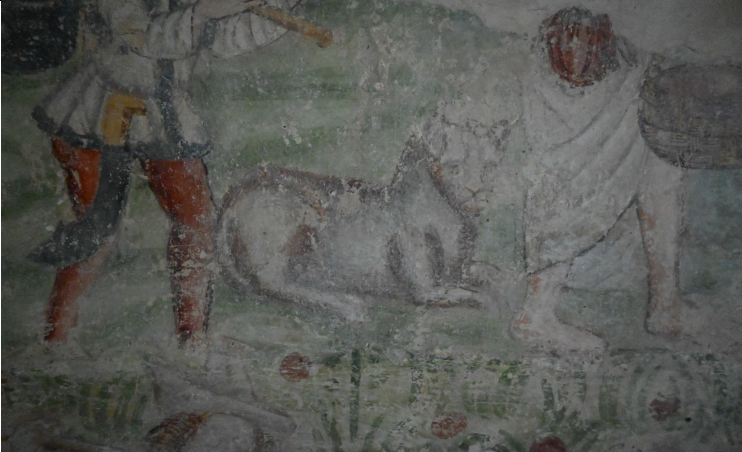
<p><i>Photo 13:</i> 1_gra_csh_nw_a_vis_20210813_detail_lion; Detail of a lion under visual light.</p>		<p><i>Photo 14:</i> 1bb_gra_csh_nw_a_uv_20210813_detail_lion_and_mouse_2; Illuminated with UV light, we could see an animal between lions's legs.</p>

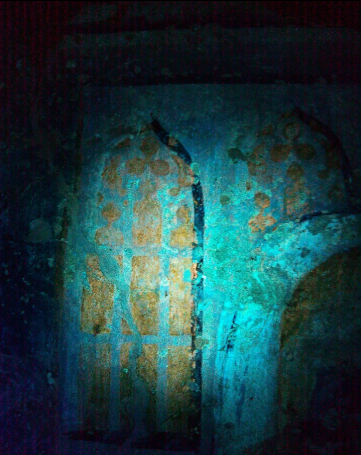
<p><i>Photo 15:</i> 2a_gra_csh_ww_a_vis_20210813_detail_window; Detail of a window under visual light.</p>		<p><i>Photo 16:</i> 2b_gra_csh_ww_a_uv_20210813_detail_window; Illuminated with UV light, the window starts to fluorescence.</p>

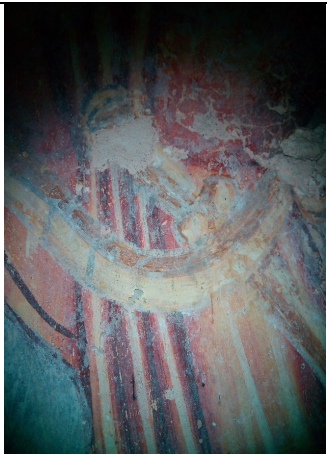
<p><i>Photo 19:</i> 2a_gra_csh_nw_a_vis_20210813_detail_2_consolidant; Detail of a dress under visible light.</p>		<p><i>Photo 20:</i> 2b_gra_csh_nw_a_uv_20210813_detail_2_consolidant; Illuminated with UV light, the dress starts to fluorescence.</p>

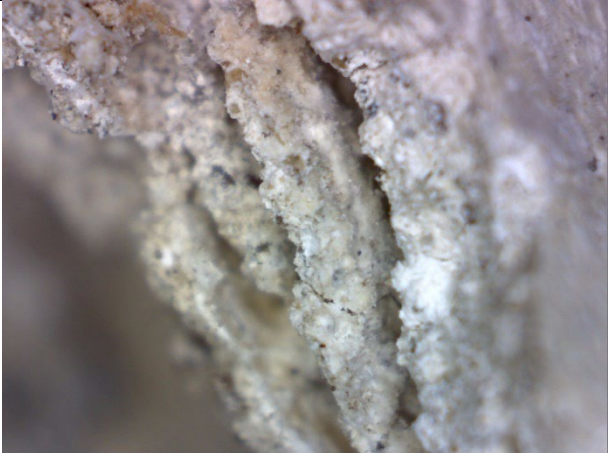
<p><i>Photo 21:</i> gra_csh_nw_a_dl_30x_20210817_1.2_arriccio_inside_lacuna; Detailed photo of opened lacuna, where you can see underlying arriccio.</p>		<p><i>Photo 22:</i> gra_csh_nw_a_dl_20210814_8_stencil_border; Detailed photo of stencil, which is visible in places, where colour was abraded.</p>

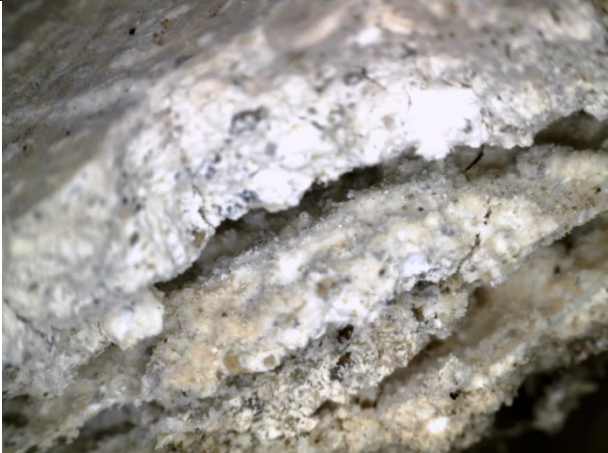
<p><i>Photo 25: gra_csh_nw_a_dl_20210814_4_intonaco_surface; Detailed photo of intonaco and under lying arriccio.</i></p>		<p><i>Photo 26: gra_csh_sw_a_dl_30x_20210819_1_violet_fresco; Detailed photo of violet fresco with secco finishing.</i></p>

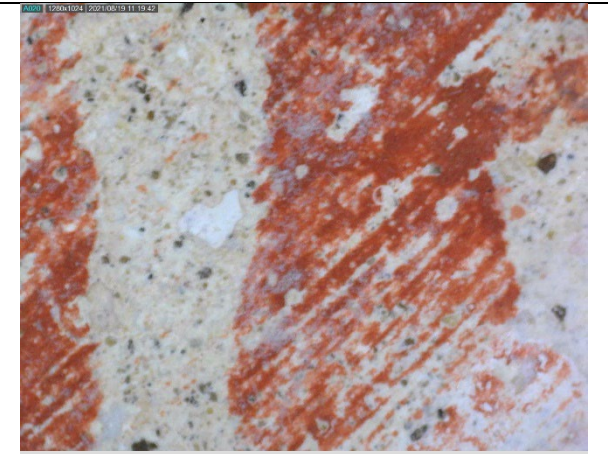
<p><i>Photo 27: gra_csh_sw_a_dl_30x_20210819_7_red_background_abrasion; Detailed photo of abrasion of red colour layer.</i></p>		<p><i>Photo 28: gra_csh_nw_a_dl_20210814_1_(under)drawing_red; Detailed photo of red underdrawing.</i></p>

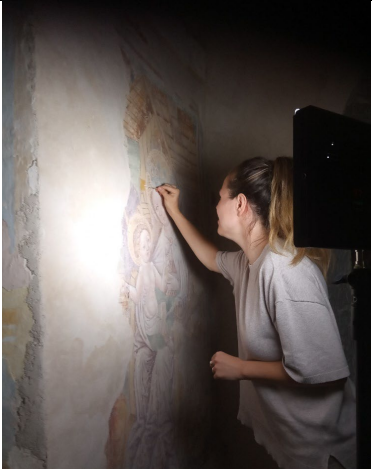
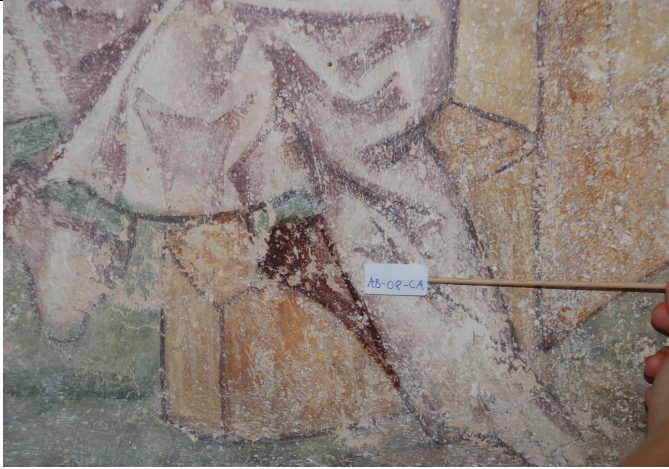
<p><i>Photo 37:</i> gra_csh_peopleworking_20210813_investigation_2; Cohesion assessment performed with cotton swabs wetted in destiled water.</p>	<p><i>Photo 38:</i> gra_csh_nw_a_vis_20210816_AB_06_CA_1; Cohesion assessment of violet colour part.</p>

Beside material identification, aim of the analyses was to support observations from cleaning tests and assess the efficiency of the consolidation trials. **Cohesion assessment** was observed on selected cotton swabs. On the analysed swabs, mainly calcite and salts (mainly gypsum and calcium oxalates) were present. Some of the cotton swabs were coloured by fine pigment dust and single pigment particles were observed.

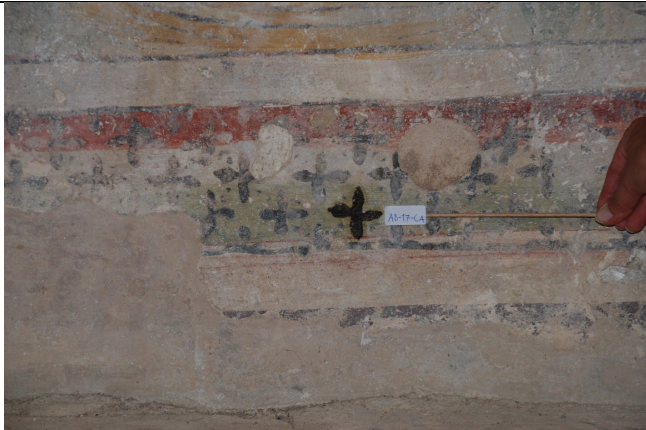
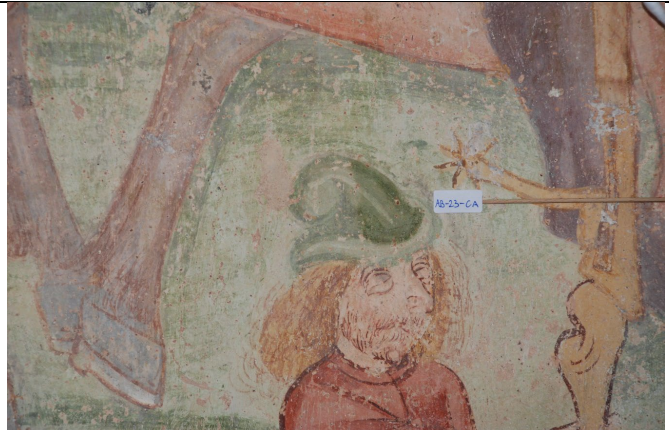
<p><i>Photo 39:</i> gra_csh_nw_a_vis_20210816_AB_17_CA_1; Cohesion assessment of black colour part.</p>	<p><i>Photo 40:</i> gra_csh_nw_a_vis_20210816_AB_23_CA_1; Cohesion assessment of green colour part.</p>

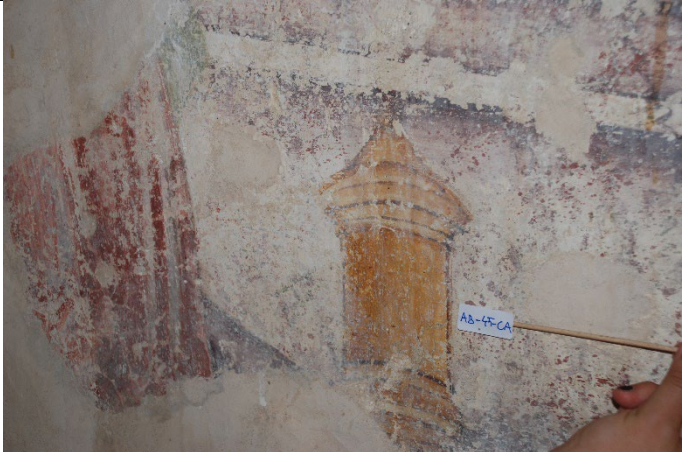
<p><i>Photo 41:</i> gra_csh_sw_a_vis_20210816_AB_45_CA_1; Cohesion assessment of yellow colour part.</p>

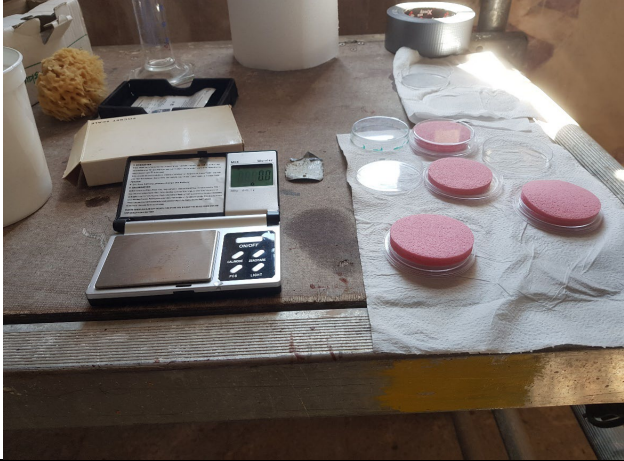
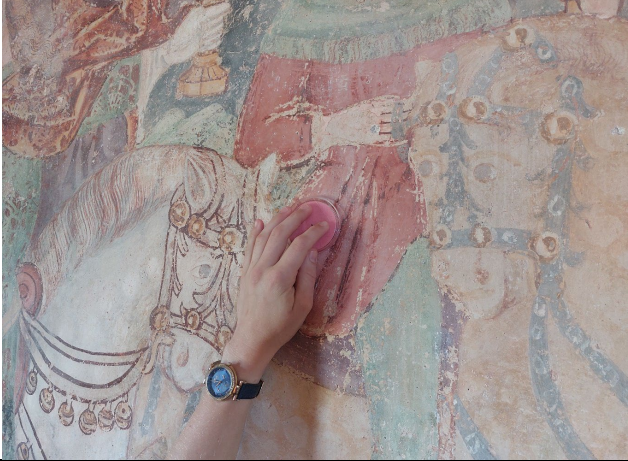
<p><i>Photo 45:</i> gra_csh_a_vis_20210814_ST_1; Preparations for sponge test.</p>	<p><i>Photo 46:</i> gra_csh_a_vis_20210814_ST_5; Example of performed sponge test on one of testing locations.</p>

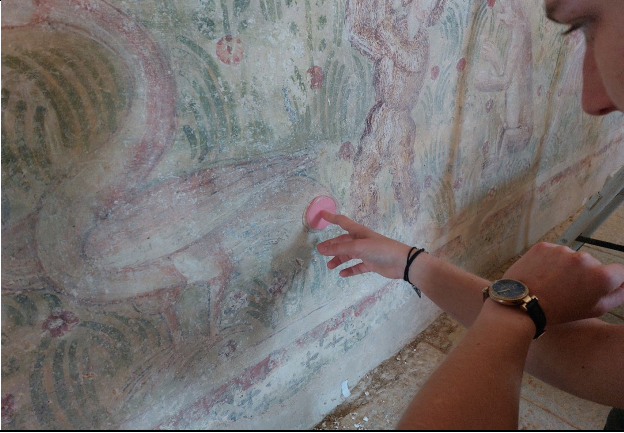
<p><i>Photo 47:</i> gra_csh_a_vis_20210814_ST_4; During sponge test, we measured time of exposure.</p>	<p><i>Photo 48:</i> gra_csh_a_vis_20210814_ST_3; Detailed report on locations of tests and results.</p>

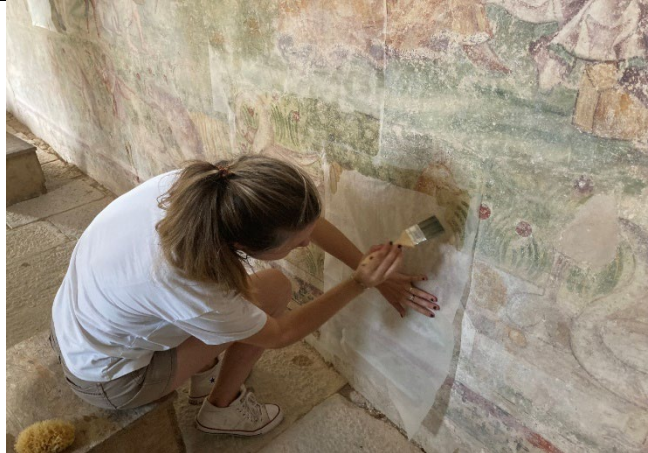
<p><i>Photo 49:</i> gra_csh_peopleworking_202108_cleaning_10; Applying of Japanese paper with water-wetted brush.</p>

After this promising results, we decided to proceed with more broad cleaning trials. First, we selected a few areas on different walls, where we performed our try-outs. All selected areas we cleaned with sponges and left to dry overnight. During the cleaning, we could see, that we removed some impurities off the surface, which seemed more colourful and overall cleaned after the procedure. After the drying process, we observed, that in some areas white veil has formed on the surface.

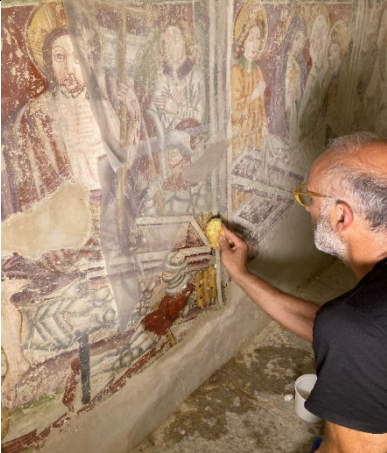
<p><i>Photo 50:</i> gra_csh_peopleworking_202108_cleaning_8; Water cleaning with sponge through Japanese paper.</p>

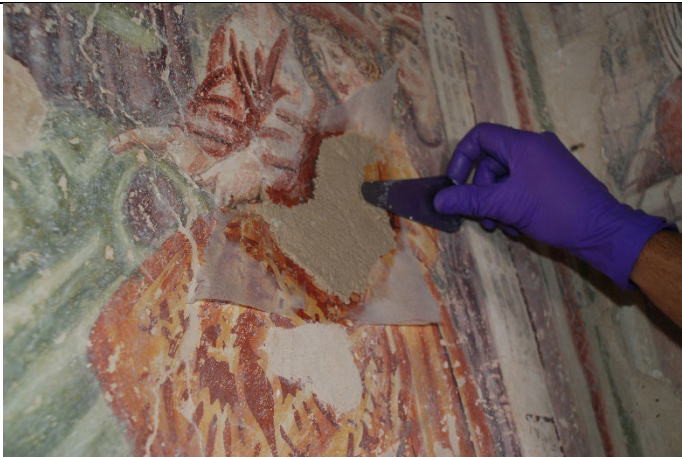
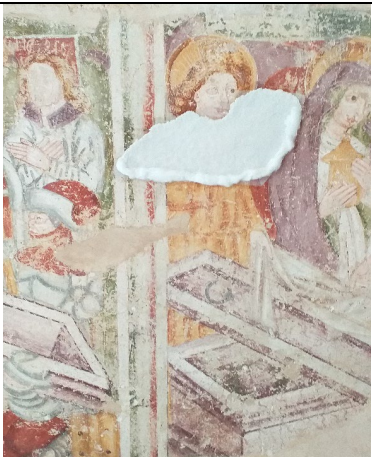
<p><i>Photo 51:</i> gra_csh_peopleworking_20210818_cleaning_17; Removing the poultice mixed with ammonium bicarbonate.</p>	<p><i>Photo 52:</i> gra_csh_sw_a_vis_20210814_AB-P_1; Example of applied poultice mixed with ammonium bicarbonate.</p>

To treat the white veil and further clean the surface, we decided to try *ammonium bicarbonate solution*. We also tried different methods of application. The most efficient seemed to be application of the solution in form of poultice. In some cases, the white veil was easily cleaned off the surface after the bicarbonate treatment, in other the white veil seemed to grow even

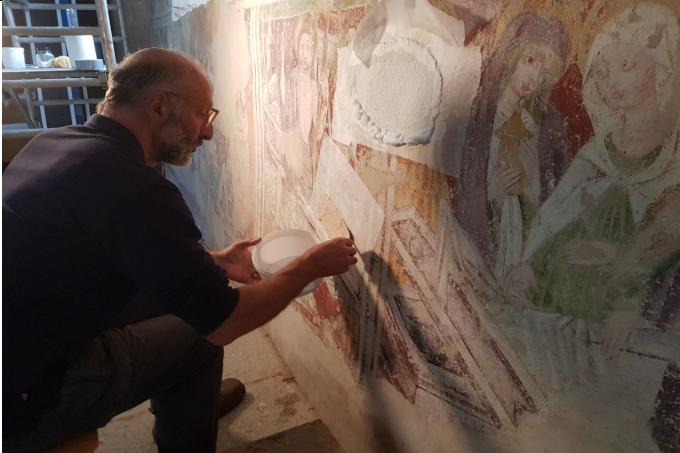
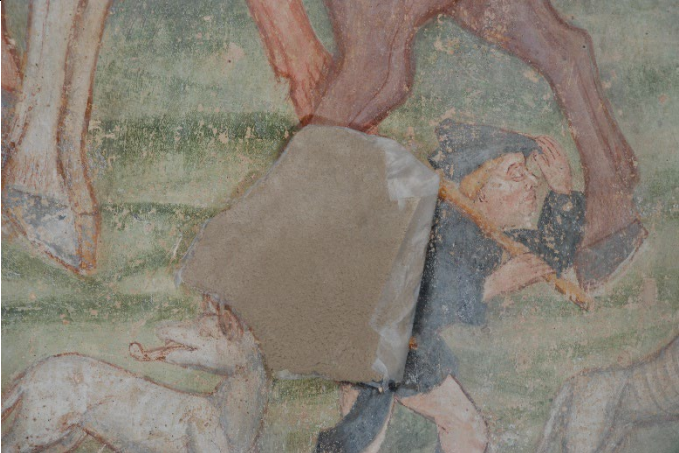
<p><i>Photo 53:</i> gra_csh_peopleworking_20210819_cleaning_1; Applying of anionic exchange resins through Japanese paper.</p>	<p><i>Photo 54:</i> gra_csh_nw_a_vis_20210813_AB-P_1; Applying of poultice mixed with ammonium bicarbonate.</p>

further. To treat such areas, we tried different mechanical methods, which were all mostly efficient, and some chemical, such as *triammonium citrate*, which also gave sufficient results. After we got such good results with *ammonium bicarbonate* treatment, we decided to try cleaning the surface also with *ammonium carbonate*. The treatment was successful in removing the white veil and also some unidentified grey-ish stains on the upper side of the northern wall. We also tried the treatment with *ionic exchange resins* to try to treat the sulfation of the surface. The results are quite minimal and negligible.

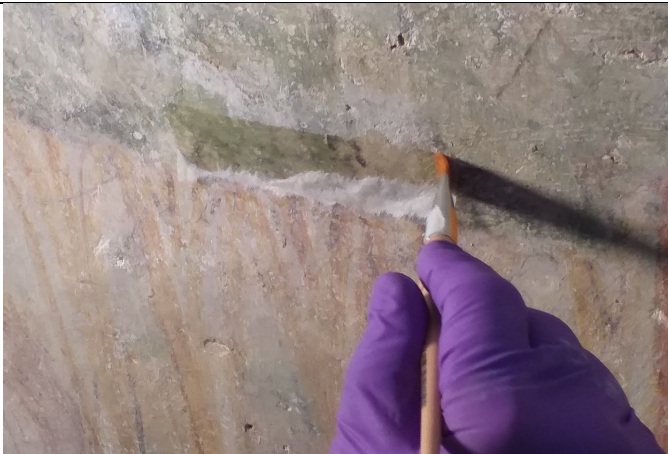
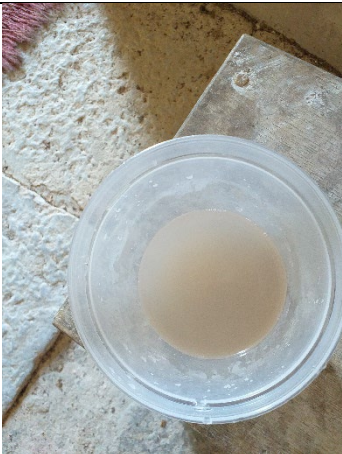
<p><i>Photo 55:</i> gra_csh_peopleworking_20210817_cleaning_2; Attempt of abstraction of white residues with triammonium citrate.</p>	<p><i>Photo 56:</i> gra_csh_nw_a_vis_20210814_W-JP_1; State of used water after cleaning trials.</p>
