REPORT: INTERNATIONAL 2022 SUMMER SCHOOL GRADIŠČE PRI DIVAČI (SLOVENIA)

CHURCH OF ST. HELEN
CONSERVATION-RESTORATION OF WALL
PAINTINGS

VOLUME 2 FINAL REPORT

FINAL REPORT

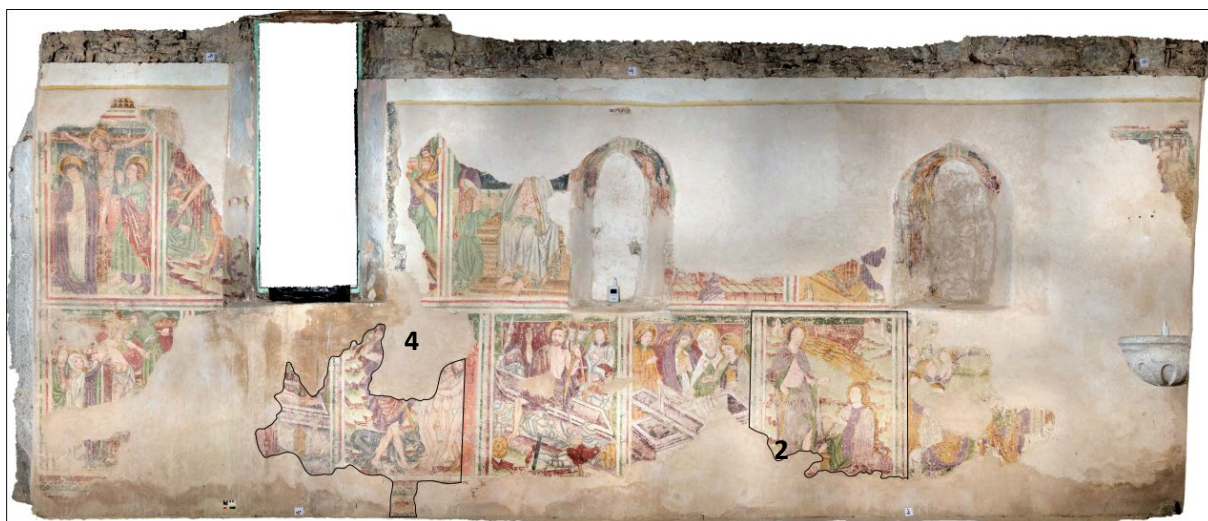
Figure 2: South wall. Areas, selected by students for cleaning and several trials.

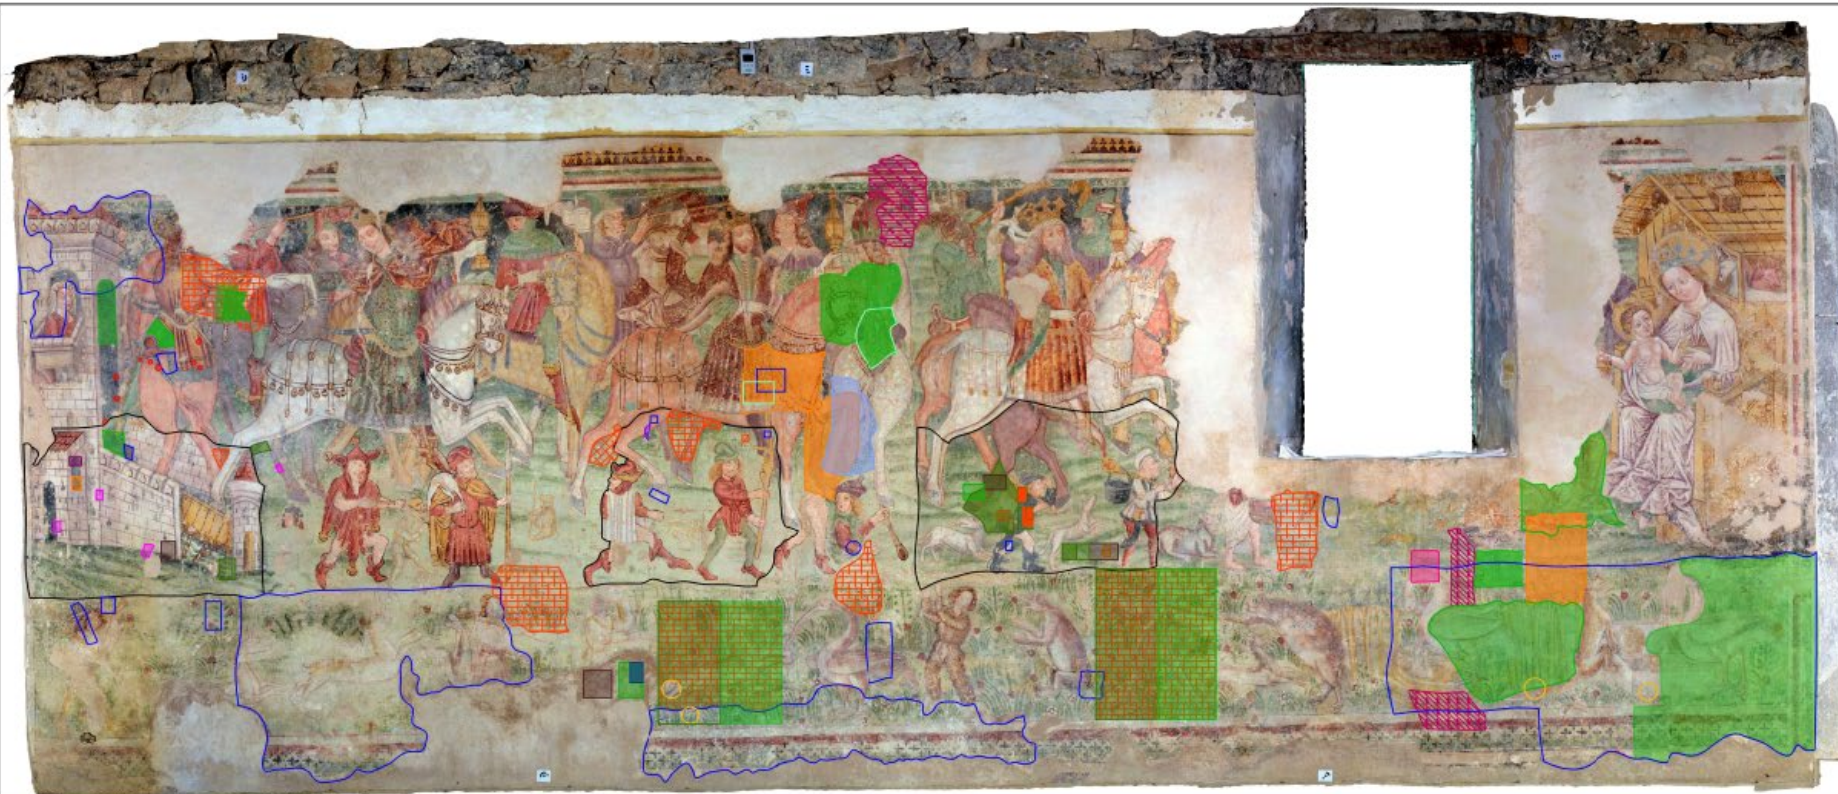
Summer School Gradišče pri Divači, 2022: Mapping, Cleaning trials, North wall.

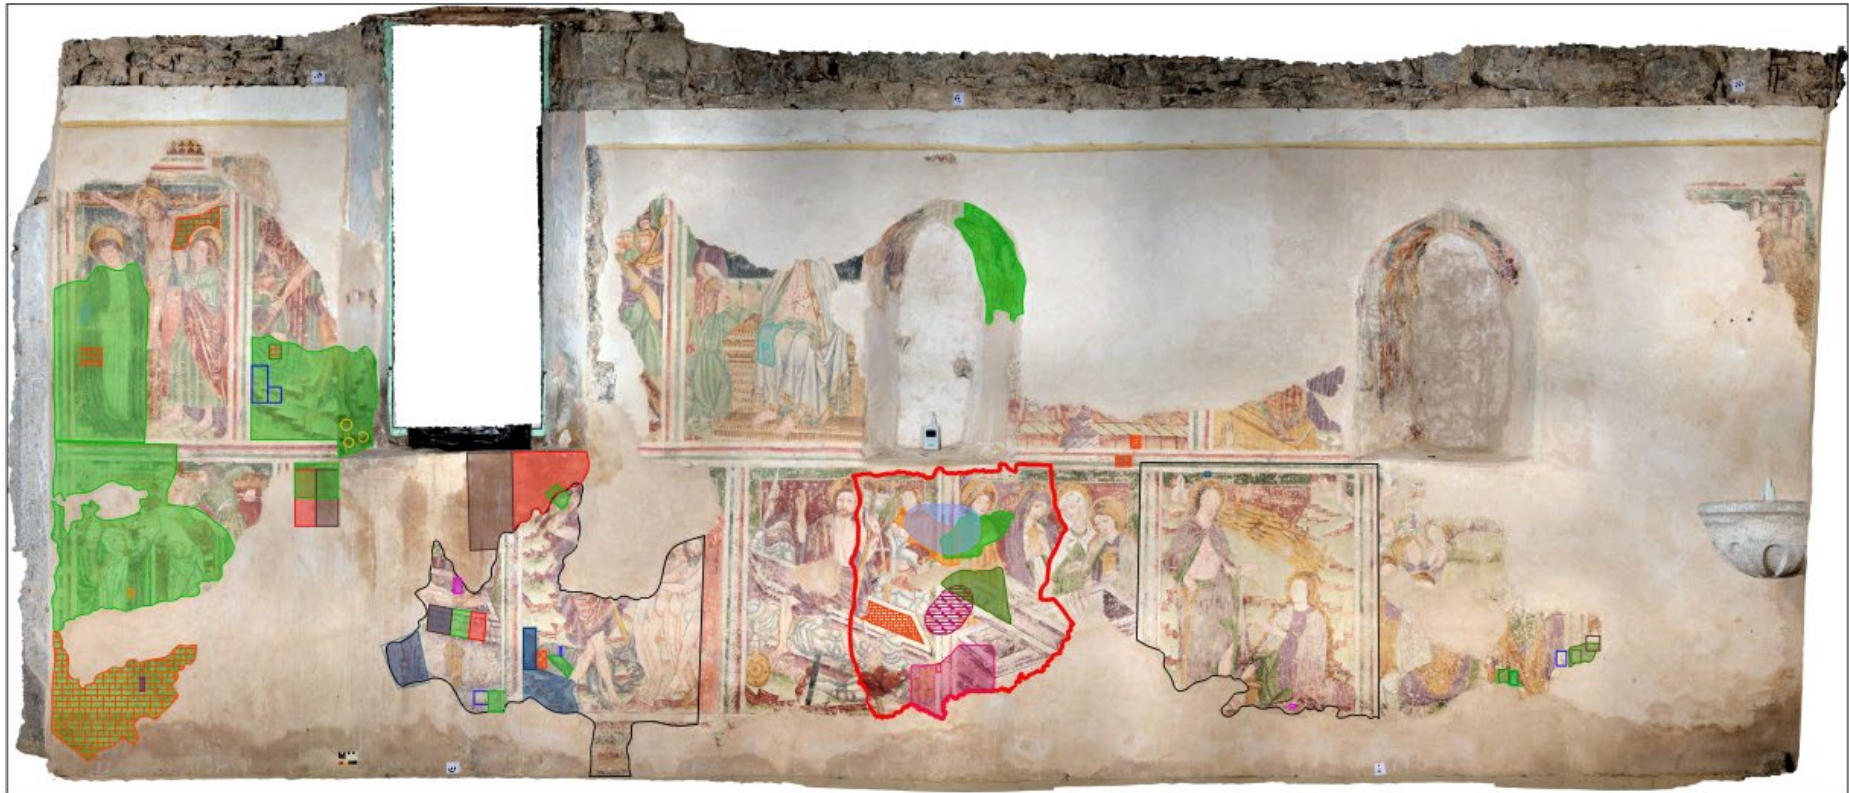
Summer School Gradišče pri Divači, 2022: Mapping, Cleaning trials, South wall.

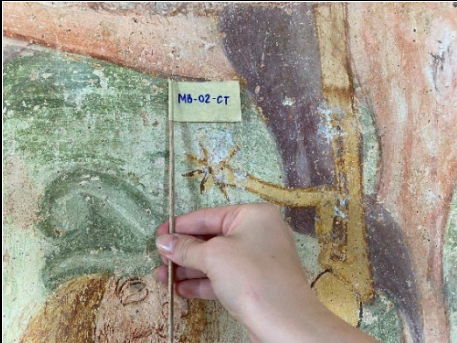
<p>gra_csh_nw_in_vis_20220906_MB_02_CT_3</p>
MB-3-CT	AB5		<ol style="list-style-type: none"> 1. Japanese paper 1x 2. Application of paste with spatula/15min 3. Removing limewash with scalpel 	Limewash residue	Limewash softened, easier to remove with mechanical force.

MB-2-CT	IER1		<ol style="list-style-type: none"> 1. Japanese paper 1x 2. Application of resin*/30min 3. Wetting 3-4x 4. Cleaning with cotton swab (water) 	Limewash residue	White veil appeared, can be cleaned off with water, limewash stayed the same.

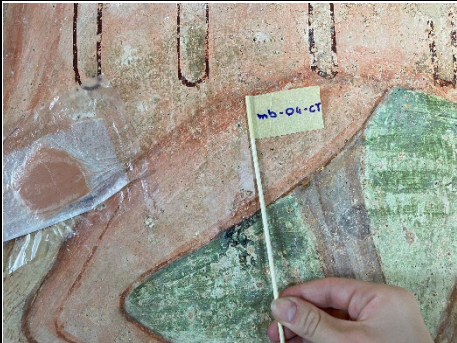
<p>gra_csh_nw_in_vis_20220906_MB_04_CT_3</p>

<p>gra_csh_nw_in_vis_20220906_MB_03_CT_3</p>
MB-4-CT	AB5		<ol style="list-style-type: none"> 1. Japanese paper 1x 2. Application of paste with spatula/15min 3. Removing limewash with scalpel 	Brown spots	No results.

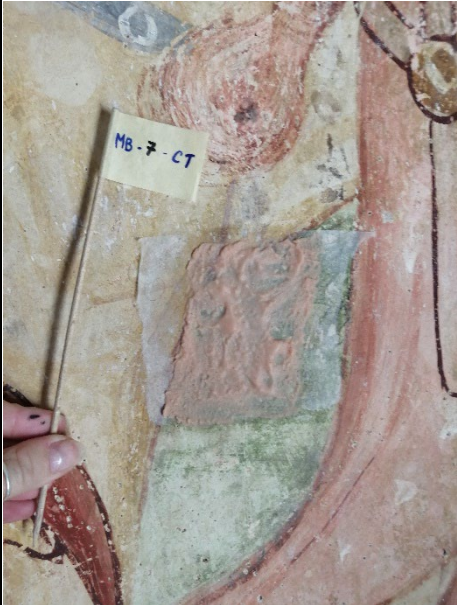
<p>gra_csh_nw_in_vis_20220908_MB_07_CT_2</p>

<p>gra_csh_nw_in_vis_20220906_MB_05_CT_2</p>
	MB-6-CT	IER1	<ol style="list-style-type: none"> 1. Japanese paper 1x 2. Application of resin*/30min 3. Wetting 3-4x 4. Cleaning with cotton swab (water) 	White veil, bigger surface	White veil less visible.	<p>gra_csh_nw_in_vis_20220912_MB_06_CT_1</p>
	MB-7-CT	IER2	<ol style="list-style-type: none"> 1. Japanese paper 1x 2. Application of resin with brush /30min 3. Wetting 3-4x 4. Cleaning with cotton swab (water) 	White veil	More white veil appeared.

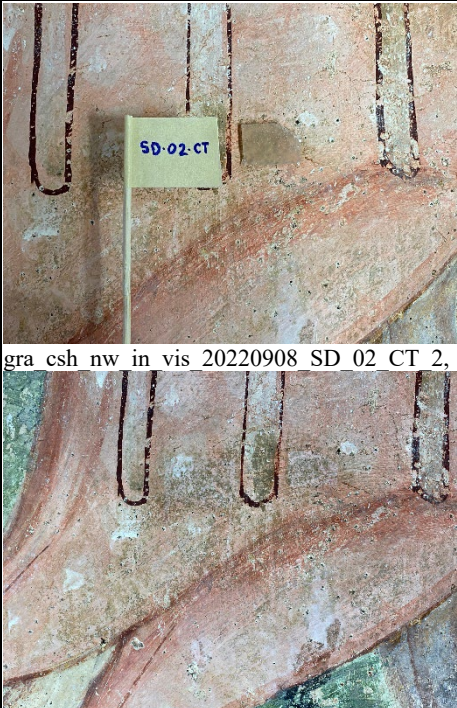
<p> gra_csh_nw_in_vis_20220908_SD_02_CT_2, gra_csh_nw_in_vis_20220908_SD_01,02_CT_3 </p>

SD-1-CT	AG2	<ol style="list-style-type: none"> 1. Applying rigid gel/5min 2. Removing gel 3. Rinsing with water 	Brown spots	No results.	gra_csh_nw_in_vis_20220908_SD_01_CT_2, gra_csh_nw_in_vis_20220908_SD_01,02_CT
	SD-2-CT	AG5	<ol style="list-style-type: none"> 1. Applying rigid gel/5min 2. Removing gel 3. Rinsing with water 	Brown spots	Lightened brown spots and original colour.

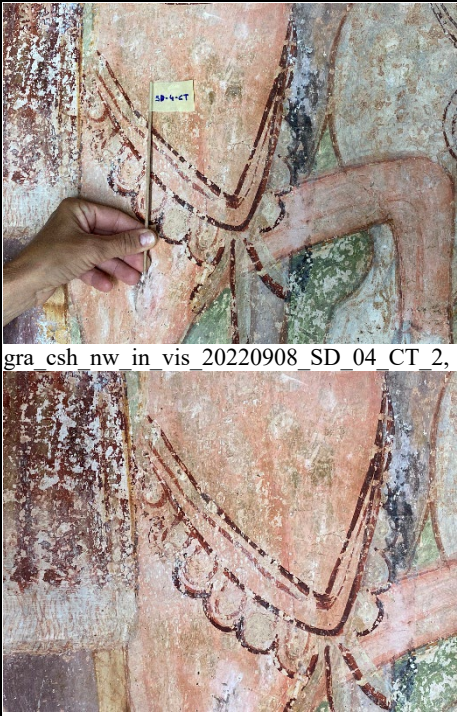
<p>gra_csh_nw_in_vis_20220908_SD_04_CT_2,</p> <p>gra_csh_nw_in_vis_20220908_SD_04_CT_3</p>

<p>gra_csh_nw_in_vis_20220908_SD_03_CT_2</p>
	SD-4-CT	KSG1	<ol style="list-style-type: none"> 1. Applying gel with brush 2. Massaging with brush for 1min 3. Cleaning with cotton swab 	Brown spots	No results.

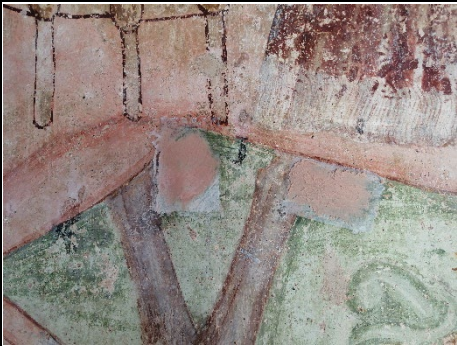
<p>gra_csh_nw_in_vis_20220906_MB_01_CT_2_IP_02_CT_2,</p>

<p>gra_csh_nw_in_vis_20220906_IP_01_CT_2,</p> <p>IP-01-CT</p> <p>gra_csh_nw_in_vis_20220906_IP_01_CT_3</p>
IP-2-CT	AB5		<ol style="list-style-type: none"> 1. Japanese paper 1x 2. Application of paste with spatula/15min 3. Removing limewash with scalpel 	Limewash residue	Limewash softened, easier to remove with mechanical force.

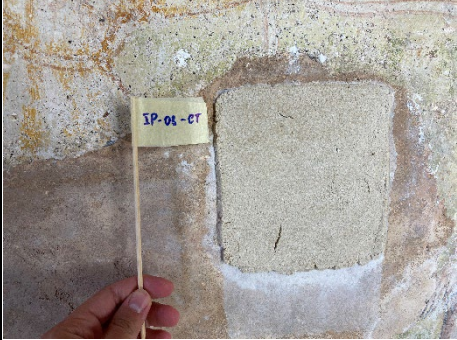
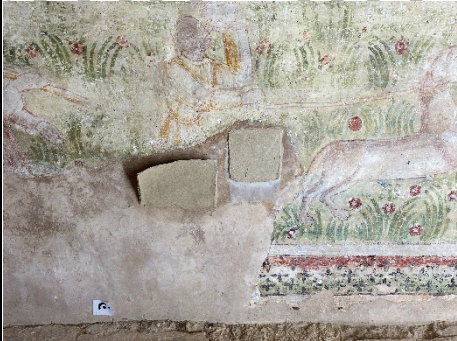
<p>gra_csh_nw_in_vis_20220908_IP_03_CT_2,</p>

<p>gra_csh_nw_in_vis_20220906_IP_02_CT_3</p>
IP-3-CT	W1	<ol style="list-style-type: none"> 1. Japanese paper 1x 2. Application of poultice with spatula/over night-till falling 3. Rinsing with sponge and water 	Trial on infilling	No visible results.

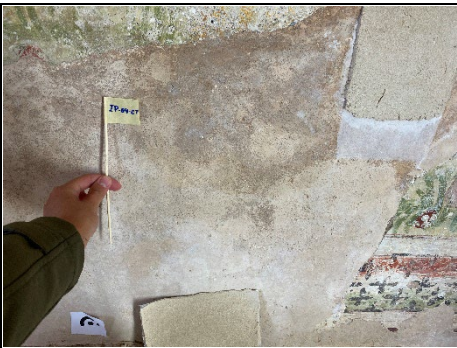
<p>gra_csh_nw_in_vis_20220908_IP_04_CT_3</p>
	IP-5-CT	IER1	<ol style="list-style-type: none"> 1. Japanese paper 1x 2. Application of resin*/30min 3. Wetting 3-4x 4. Cleaning with cotton swab (water) 	White veil, bigger surface	White veil less visible.

IP-4-CT	AB1	<ol style="list-style-type: none"> 1. Japanese paper 1x 2. Application od poultice with spatula/over night-till falling 3. Rinsing with sponge and water 	Trial on infilling	No visible results.

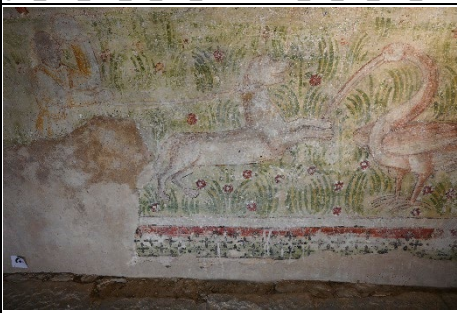
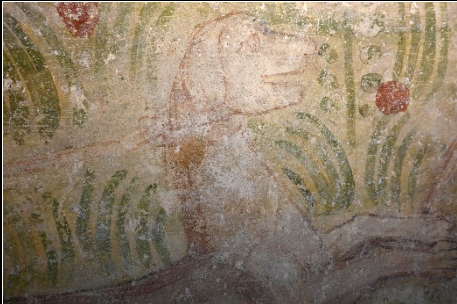
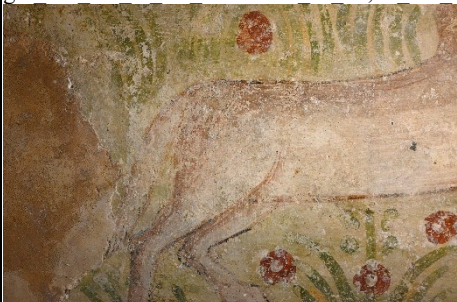
<p>gra_csh_nw_in_vis_20220908_IP_05_CT_2</p>
	IP-6-CT	AB1 and IER1	<p>FIRST APPLICATION</p> <ol style="list-style-type: none"> 1. Japanese paper 1x 2. Application of poultice/45min 3. On one part rinsing with water 4. On one part no rinsing <p>SECOND APPLICATION</p> <ol style="list-style-type: none"> 1. Japanese paper 1x 2. Application of resin with brush/15min 3. Wetting 3-4x 4. Cleaning with cotton swab (water) 	Big surface, white veil, limewash residue ...	Limewash softened, easier to remove with mechanical force. ...

<p>gra_csh_nw_in_vis_20220908_IP_06,07_CT_3_detail2</p>
IP-7-CT	AB4 and IER1	<p>FIRST APPLICATION</p> <ol style="list-style-type: none"> 1. Japanese paper 1x 2. Application of poultice/45min 3. On one part rinsing with water 4. On one part no rinsing <p>SECOND APPLICATION</p> <ol style="list-style-type: none"> 1. Japanese paper 1x 2. Application of resin with brush/15min 3. Wetting 3-4x 4. Cleaning with cotton swab (water) 	Big surface, white veil, limewash residue ...	Limewash softened, easier to remove with mechanical force. ...	<p>gra_csh_nw_in_vis_20220908_IP_06,07_CT_3,</p> <p>gra_csh_nw_in_vis_20220908_IP_06,07_CT_3_detail,</p> <p>gra_csh_nw_in_vis_20220908_IP_06,07_CT_3_detail2</p>

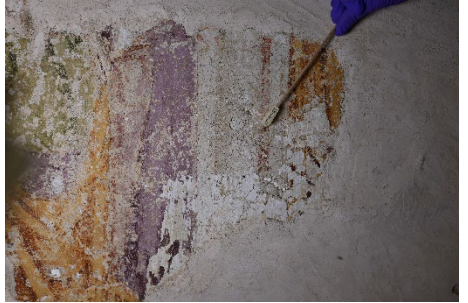
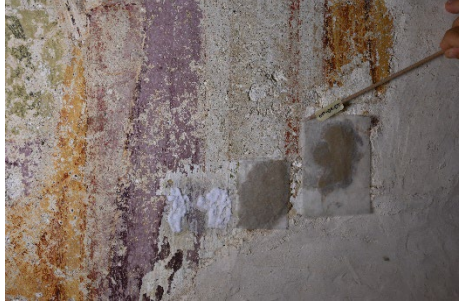
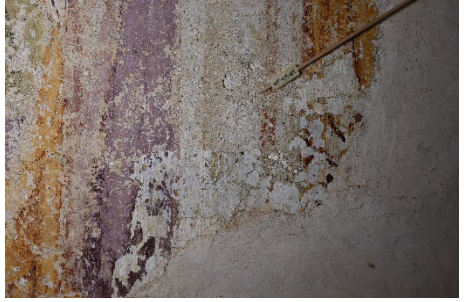
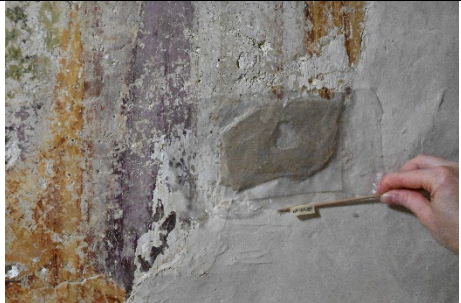
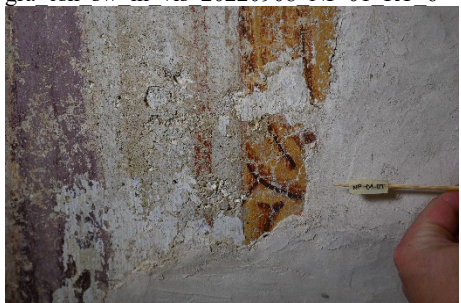
<p>gra csh sw in vis 20220907 NP-01 RT 1</p>

GROUP NUMBER	TEST TRIAL NUMBER	MATERIAL CODE	APPLICATION/ CONTACT TIME	COMMENTS		REFERENCE PHOTOS
				PROBLEM	RESULT	
2/sw	NP-01-RT	W1, AB1, AB5, AB1	<p>FIRST: application on the right side of the tested area.</p> <ol style="list-style-type: none"> Japanese paper, Poultice with water covered with one layer of Japanese paper left for 30 min, Removal and cleaning with wet cotton swab, Mechanical action with scalpel. <p>SECOND: application on the middle part of the tested area.</p> <ol style="list-style-type: none"> Japanese paper, Poultice with ammonium bicarbonate 20 % solution covered with one layer of Japanese paper left for 30 min., Removal and cleaning with wet cotton swab, Mechanical action with scalpel. <p>THIRD: application on the left part of the tested area.</p> <ol style="list-style-type: none"> Ammonium bicarbonate paste left for 30 min, Removal and cleaning with wet cotton swab, Mechanical action with scalpel. <p>FOURTH: application on the right side of the tested area (same area as first + second). Same as the second trial with longer contact time = 4 h 30 min, covered with plastic foil.</p>	Residues of limewash	<p>FIRST: Immediately: No color on the cotton. It is hardly distinguishable if the limewash is softer than before. The limewash is not easier to remove with the scalpel than before.</p> <p>SECOND: same as for the first application.</p> <p>THIRD: same as for the first and the second application.</p> <p>FOURTH: Immediately: a tiny bit of the limewash stuck on the Japanese paper. Limewash is softer than before and comes off easier than before (when working with a scalpel). The color of the paint layer underneath feels wetter. On the <i>intonaco</i> you can only thinner the limewash (and not completely remove).</p>

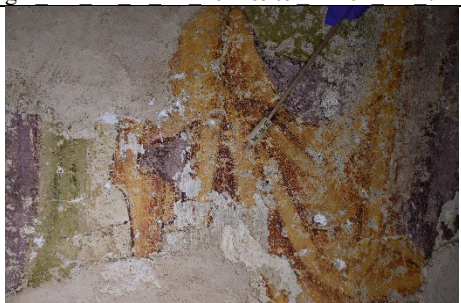
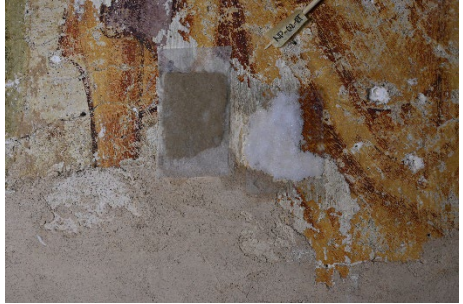
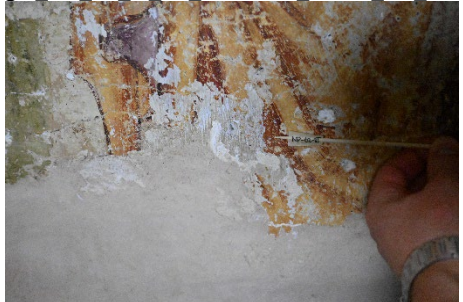
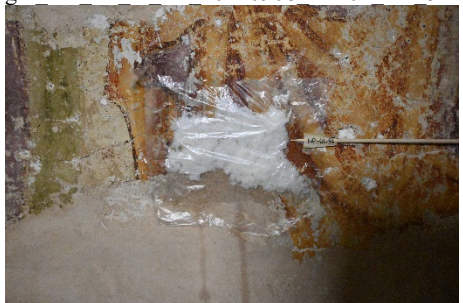
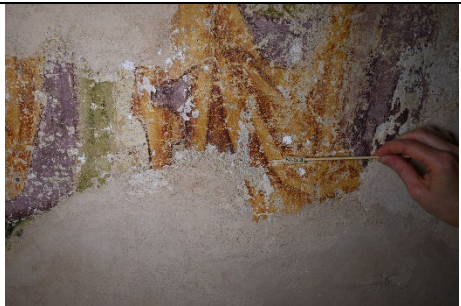
<p>gra_csh_sw_in_vis_20220907_NP-02_RT_1</p>

<p>gra_csh_sw_in_vis_20220909_NP-01_RT_7</p>
	NP-02-RT	AB5, AB1, AB3	<p>FIRST: application on the right side of the tested area.</p> <ol style="list-style-type: none"> 1. Ammonium bicarbonate paste left for 30 min, 2. Removal and cleaning with wet cotton swab, 3. Ammonium bicarbonate paste left for 45 min., 4. Removal and cleaning with wet cotton swab. <p>SECOND: application on the left part of the tested area.</p> <ol style="list-style-type: none"> 1. Japanese paper, 2. Poultice with ammonium bicarbonate 20% solution covered with one layer of 		<p>FIRST: Immediately: No color on the cotton. It is hardly distinguishable if the limewash is softer than before. The limewash is not easier to remove with the scalpel than before.</p> <p>SECOND: same as for the first trial.</p> <p>THIRD: Immediately: limewash comes off easier than before, but not as easy as at NP-01-RT after the 4 h 30 min-application.</p>

<p>Japanese paper left for 30 min.,</p> <ol style="list-style-type: none"> 3. Removal and cleaning with wet cotton swab, 4. Mechanical action with scalpel. <p>THIRD: application over the whole tested area. same as the second but with poultice made of Arbocel 1000 without Sepiolite left for 1 h 30 min and covered with plastic foil.</p>

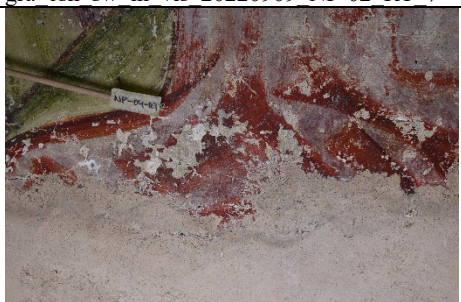
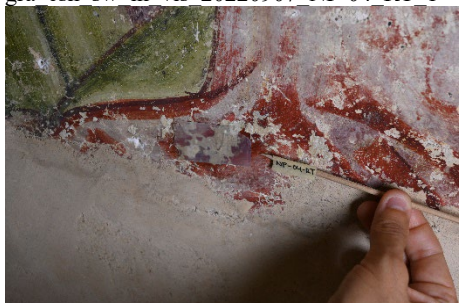
<p>gra csh sw in vis 20220907 NP-04 RT 1</p>

<p>gra csh sw in vis 20220909 NP-02 RT 7</p>
	NP-04-RT	AG1	<ol style="list-style-type: none"> 1. Agar solid gel for 30 min, 2. Removal, no cleaning. 	Residues of limewash	Immediately: No color on the cotton. It is hardly distinguishable if the limewash is softer than before. The limewash is not easier to remove with the scalpel than before.

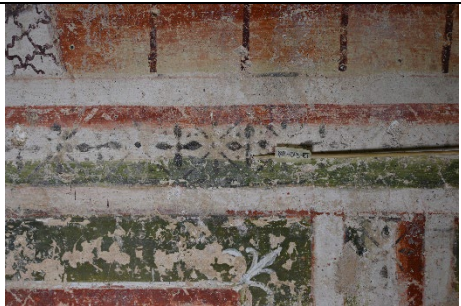
NP-08-RT	W1	<ol style="list-style-type: none"> 1. Japanese paper, 2. Poultice with water covered with plastic foil left overnight (approx..15 h), 3. Removal and cleaning with wet cotton swab. 	Residues of limewash	Immediately: a bit of the limewash stuck on the Japanese paper. Spot was then left.	<p>gra csh sw in vis 20220907 NP-08 RT 1</p> <p>gra csh sw in vis 20220907 NP-08 RT 3</p>
	NP-09-RT	IER1 and IER2	<p>FIRST:</p> <ol style="list-style-type: none"> 1. Japanese paper, 2. anion exchange resin in H₂O left for 30 min, 3 times reactivated with H₂O, 3. Removal, cleaning with wet cotton swab. <p>SECOND:</p> <ol style="list-style-type: none"> 1. Japanese paper, 2. anion exchange resin in ammonium bicarbonate 20% left for 50min, 4 times 	White veil	<p>FIRST:</p> <p>Immediately: Deposit (probably dirt, yellowish) on the cotton. Dried: Reduced the white veil. Under UV-light minimal residues of the cleaning are visible.</p>	<p>gra csh sw in vis 20220907 NP-09 RT 1</p>

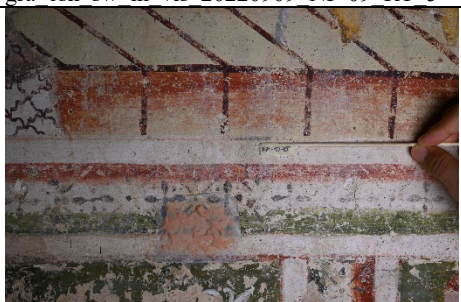
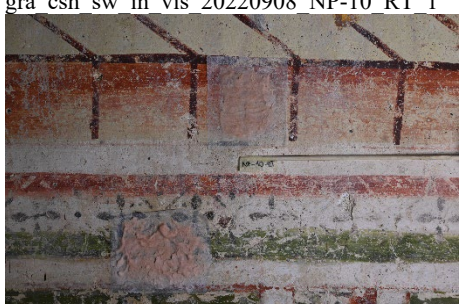
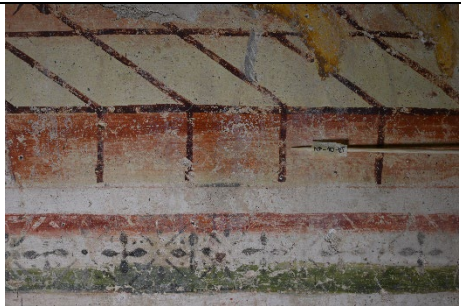
<p>gra csh sw in vis 20220908 NP-10 RT 1</p>

<p>gra csh sw in vis 20220909 NP-09 RT 5</p>
	NP-10-RT	IER1	<ol style="list-style-type: none"> 1. Japanese paper, 2. anion exchange resin in H₂O left for 30min, 1 time reactivated with H₂O, 3. Removal, cleaning with wet cotton swab. 	White veil	Immediately: The red color is unstable (traces on the cotton), but it is also unstable in not treated areas.

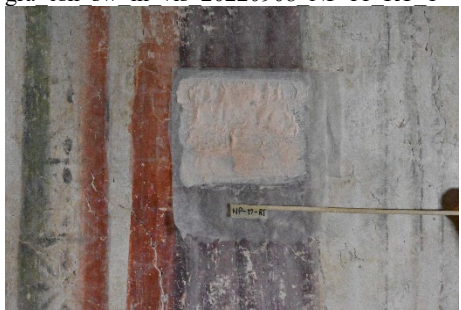
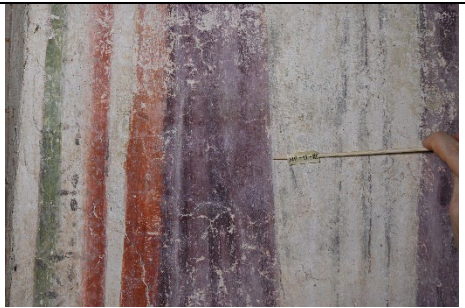
<p>gra csh sw in vis 20220908 NP-11 RT 2</p>

<p>gra csh sw in vis 20220909 NP-10 RT 3</p>
	NP-11-RT	IER1	<p>On a spot, that had already been cleaned by Anka with a poultice in ammonium bicarbonate.</p> <ol style="list-style-type: none"> Two layers of Japanese paper, anion exchange resin in H₂O left for 45 min, Removal, cleaning with wet cotton swab. 	White veil	<p>Immediately: Color more unstable than before. Dried: Not homogeneously cleaned. The white veil is slightly removed.</p>

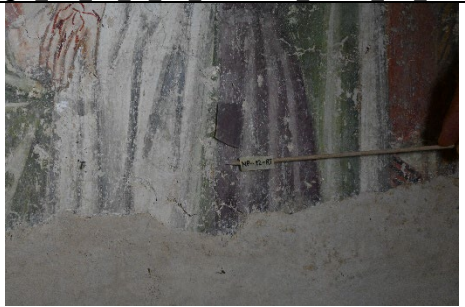
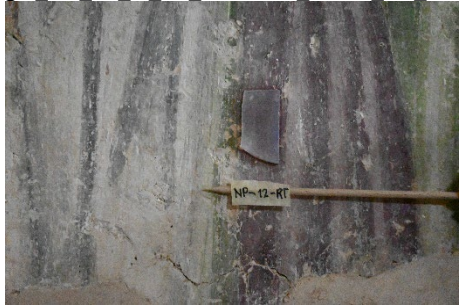
<p>gra csh sw in vis 20220908 NP-12 RT 1</p>

<p>gra csh sw in vis 20220909 NP-11 RT 3</p>
	NP-12-RT	AG7	<ol style="list-style-type: none"> 1. Japanese paper², 2. Agar solid gel in Ammonium bicarbonate 20% and DTPA 3%, pH 6 left for 35min., 3. Removal, cleaning with wet cotton swab. 	White veil	<p>Immediately: purple color more unstable than before. Dried: White veil reappeared.³</p>

³ Ammonium bicarbonate and chelating agent with pH 6 not OK.

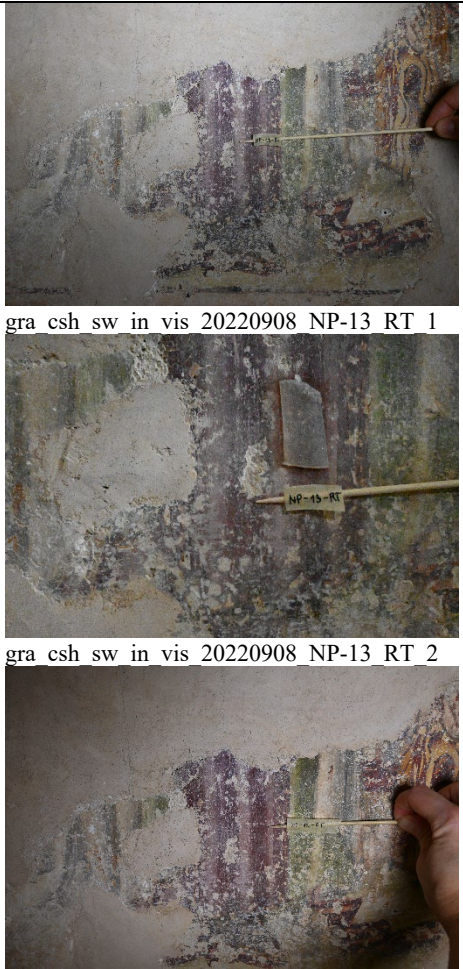
<p>gra_csh_sw_in_vis_20220908 NP-13 RT 1</p> <p>gra_csh_sw_in_vis_20220908 NP-13 RT 2</p> <p>gra_csh_sw_in_vis_20220909 NP-13 RT 3</p>
--	----------	-----	---	------------	---	---

NP-13-RT	AG6	<ol style="list-style-type: none"> 1. Agar solid gel with EDTA pH 8.6 directly on the wall left for 20 min⁴., 2. Removal, cleaning with wet cotton swab. 	White veil	<p>Immediately: color more unstable than before. Dried: good result.⁵</p>

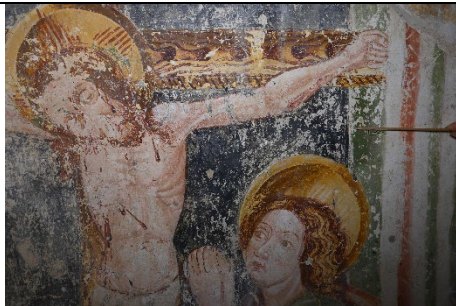
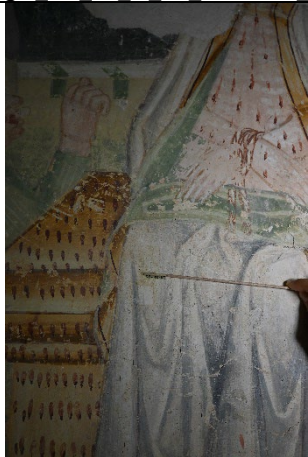
gra csh sw in vis 20220909 NP-17 RT 1

South wall: deterioration phenomenon that should be cleaned: brown spots. In this test area it was difficult to distinguish whether the deterioration phenomenon was brown spots or yellowing. A success was achieved with AG3 (NP-17-RT).

NP-17-RT	AG3	1. Agar solid gel with TAC left for 13 min. ⁶ , 2. Removal, cleaning with wet cotton swab.	Brown spots	Immediately: a brownish layer removed (visible on cotton swabs). Darker color more unstable after application. ⁷

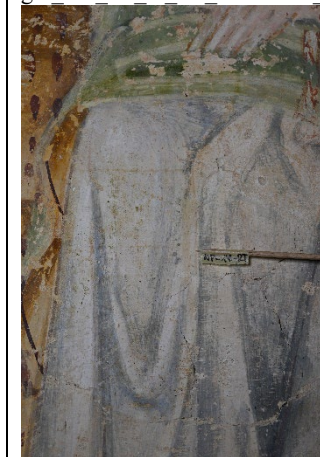
gra_csh_sw_in_vis_20220909_NP-17_RT_5

NP-18-RT	AG3	<ol style="list-style-type: none"> 1. Agar solid gel with TAC left for 13 min.⁸, 2. Removal, cleaning with wet cotton swab, 3. Cleaning with a toothbrush and ammonium bicarbonate solution. 	White veil	<p>Immediately: no color on the agar, but a lot of color traces on the cotton swab. The white veil reappeared⁹. Still wet when we left.</p>	<p>gra_csh_sw_in_vis_20220909_NP-18_RT_1</p> <p>gra_csh_sw_in_vis_20220909_NP-18_RT_2</p>
--	----------	-----	--	------------	--	---

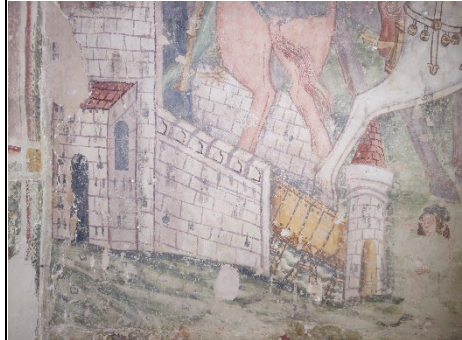
<p>gra_csh_nw_a_vis_20220912_AB_01_CT_1</p>

GROUP NUMBER	TEST TRIAL NUMBER	MATERIAL CODE	APPLICATION/ CONTACT TIME	COMMENTS		REFERENCE PHOTOS
				PROBLEM	RESULT	
3/Nw	AB – 01- CT		<ol style="list-style-type: none"> 1. Japanese paper 1x 2. Poultice/40min 3. Water rinsing over JP, removal of JP, Cleaning with cotton swab (water) 	White veil and whitewash	Minimal removal of limewash residues.

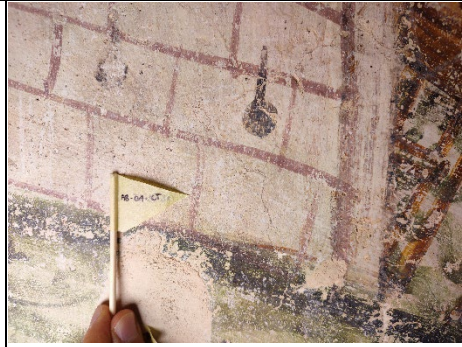
<p>gra_csh_nw_a_vis_20220908_AB_01_CT_3</p>
AB – 2- CT	AG1	<ol style="list-style-type: none"> 1. Directly on the wall 2. Gel/20min 3. Cleaning with cotton swab (water) 	White veil and whitewash	There is no cleaning results.

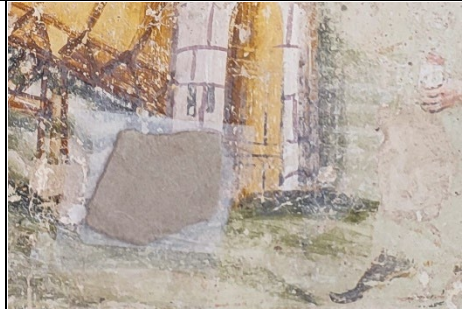
<p>gra_csh_nw_a_vis_20220908_AB_03_CT_2</p>

<p>gra_csh_nw_a_vis_20220908_AB_02_CT_2</p> <p>gra_csh_nw_a_vis_20220908_AB_02_CT_3</p>	
AB – 3- CT	AB1	<ol style="list-style-type: none"> 1. Japanese paper 1x 2. Poultice/20min 	White veil and whitewash	Removal of pigment, a little dirt remains on the tampon, minimal removal of limewash residues.	<p>gra_csh_nw_a_vis_20220912_AB_01_CT_1</p>

<ol style="list-style-type: none"> 3. Water rinsing over JP, removal of JP 4. Cleaning with cotton swab (water)

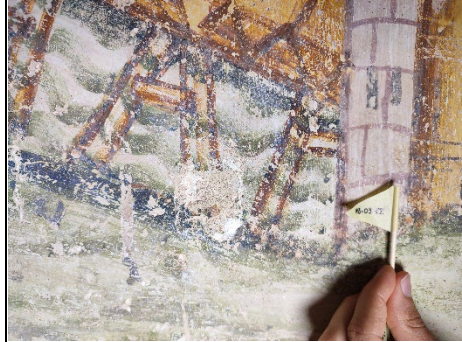
<p>gra_csh_nw_a_vis_20220908_AB_03_CT_3</p>
	AB – 4- CT	AG1	<ol style="list-style-type: none"> 1. Directly on the wall 2. Gel/20min 3. Cleaning with cotton swab (water) 	White veil and whitewash	There is no cleaning results.

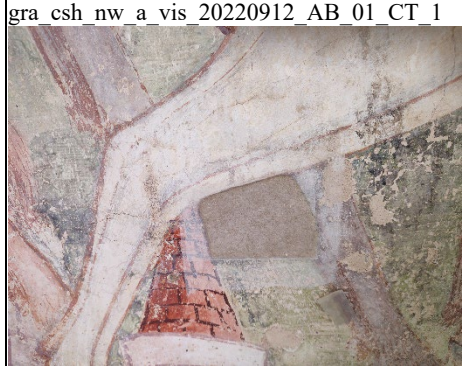
<p>gra_csh_nw_a_vis_20220908_AB_04_CT_3</p>
	AB – 5- CT	AB1	<ol style="list-style-type: none"> 1. Japanese paper 1x 2. Poultice/1h 3. Cleaning with cotton swab (water) 	White veil and whitewash	The yellow pigments are very weak, the dirt comes off very well, removes limewash quite easily.

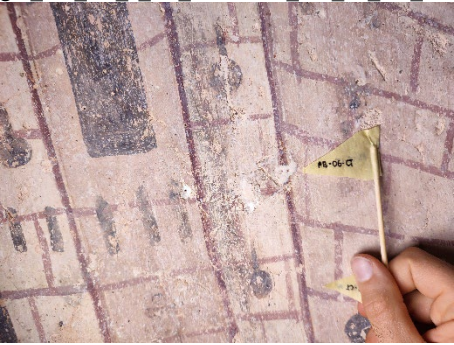
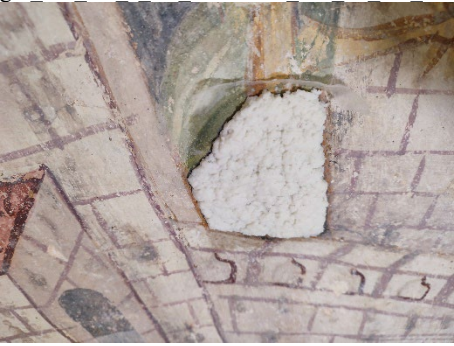
<p>gra_csh_nw_a_vis_20220912_AB_01_CT_1</p> <p>gra_csh_nw_a_vis_20220908_AB_07_CT_2</p>

<p>gra_csh_nw_a_vis_20220912_AB_01_CT_1</p> <p>gra_csh_nw_a_vis_20220908_AB_06_CT_2</p>
	AB – 7- CT	AB4	<ol style="list-style-type: none"> 1. Japanese paper 1x 2. Poultice/1h 3. Cleaning with Ammonium bicarbonate with 1%EDTA with Japan paper 4. Water rinsing 	White veil and whitewash	Limewashe removed with ease, cotton is dirty.

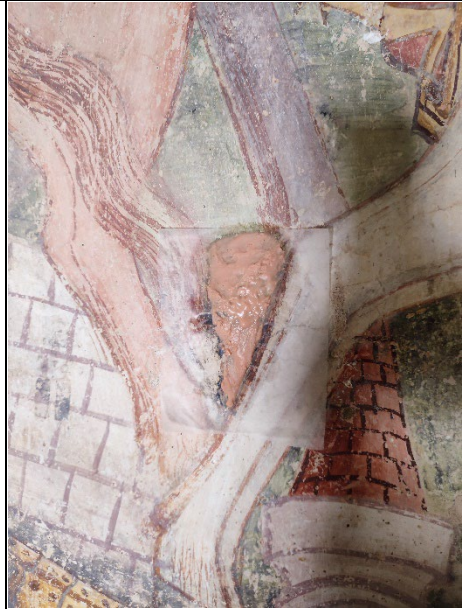
<p>gra_csh_nw_a_vis_20220908_AB_11_CT_2</p>

<p>gra_csh_nw_a_vis_20220908_AB_09_CT_2</p>
AB – 10- CT	AG6	<ol style="list-style-type: none"> 1. Directly on the wall 2. Gel/15min 3. Cleaning with cotton swab (water) 	White veil and whitewash	Good result for whitewash residues, cotton is dirty, the white veil has been partially removed.	<p>gra_csh_nw_a_vis_20220912_AB_01_CT_1</p>	
AB-11-CT	IER1	<ol style="list-style-type: none"> 1. Japanese paper 1 x 2. Poultice / 45 min ammonium bicarbonate rinsing over JP, removal of JP / 10 min 3. Water cleaning with a cotton swab on JP / 10 min 	White veil and whitewash	<p>Surface becomes white colours come off.</p> <p>Limewash reduced.</p>	<p>gra_csh_nw_a_vis_20220912_AB_01_CT_1</p>

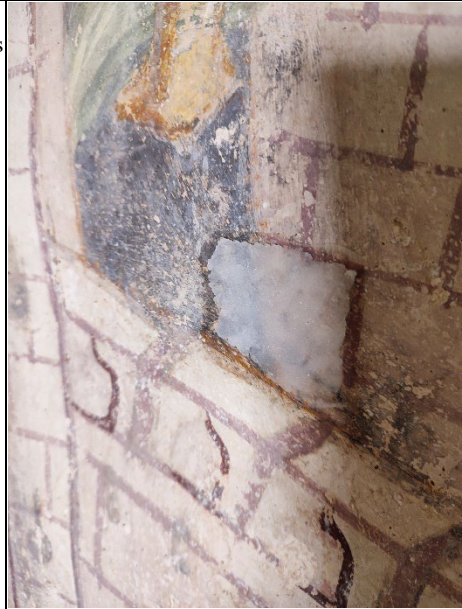
<p>gra_csh_nw_a_vis_20220908_AB_12_CT_2</p>

<p>gra_csh_nw_a_vis_20220908_AB_11_CT_3</p>
AB-12-CT	AB5	<ol style="list-style-type: none"> 1. Japanese paper 1 x 2. Poultice / 30 min 3. EDTA rinsing over JP, removal of JP / 10 min 	White veil and whitewash	No result with EDTA A lot of mechanical strength, and weakens the surface and the pigments.	gra_csh_nw_a_vis_20220912_AB_01_CT_1

4. Cleaning with an eraser and a fiberglass brush		With the eraser cleaning and the fiberglass brush, the whitewash is easily removed.

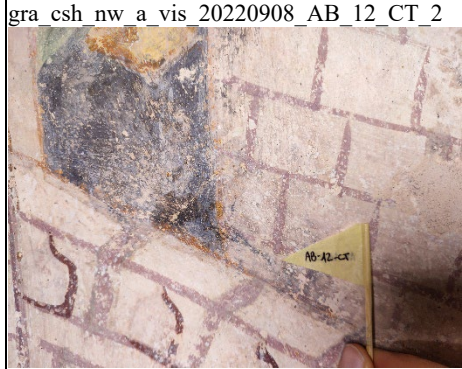
<p>gra_csh_nw_a_vis_20220908_AB_12_CT_3</p>
AB-13-CT	AB4	<ol style="list-style-type: none"> 1. Japanese paper 1 x 2. Poultice /2h30 3. Cleaning with cotton swab (water)/ 10 min 	White veil and whitewash	Very good result Limewash softened, good surface cleaning, easily removes white veil.	gra_csh_nw_a_vis_20220912_AB_01_CT_1

The evaluation of the results was not easy because different terminologies were used. The evaluation shows that on the **north wall** the cleaning trial AB-13-CT achieved a good result for both the white veil and the limewash/whitewash residues. It should be noted that the cleaning test MB-8-CT (group 5) also achieved good results. It is not listed under limewash/whitewash residues, because an even better result was achieved with the MB-10-CT (AB3) trial. Below are the two cleaning trials AB-13-CT and MB-8CT (group 5) in detail:

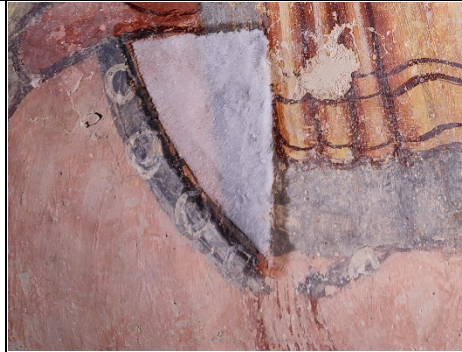
<p>gra_csh_nw_a_vis_20220908_AB_15_CT_2</p>

<p>Step 2: Transition area: 1. Japanese paper 1x 2. Poultice/ 2h00 3. Cleaning with ammonium bicarbonate on toothbrush / 10 min</p>	<ul style="list-style-type: none"> softened the limewash. <p>Step 2:</p> <ul style="list-style-type: none"> it removes the dirty on the wall, remove partially the white veil. <p>Reduced the limewash.</p>	<p>gra_csh_nw_a_vis_20220908_AB_14_CT_2</p> <p>gra_csh_nw_a_vis_20220908_AB_14_CT_3</p>
AB-15-CT	AB5	<p>1. Japanese paper 1x 2. Poultice /1h45 3. Cleaning with cotton swab (water)/ 10 min</p>	White veil and whitewash	No result, whitewash even more apparent.	gra_csh_nw_a_vis_20220912_AB_01_CT_1

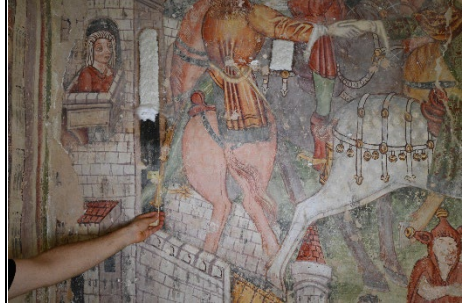
<p>gra_csh_nw_a_vis_20220908_AB_16_CT_2</p>

<p>gra_csh_nw_a_vis_20220908_AB_15_CT_3</p>
AB-16-CT	AB4 + AG 2	<p>Step 1:</p> <ol style="list-style-type: none"> 1. Japanese paper 1x 2. Poultice /1h30 3. Cleaning with ammonium bicarbonate and toothbrush / 10 min <p>Step 2:</p> <ol style="list-style-type: none"> 1. Gel/ 10 min 2. Cleaning with cotton swab (water)/ 10 min 	White veil and whitewash	<p>Step 1</p> <p>Very good result:</p> <ul style="list-style-type: none"> • it removes the dirty on the wall, • reduced the limewash, • remove partially the white veil. <p>Step 2:</p> <ul style="list-style-type: none"> • no visible effect to the naked eye.

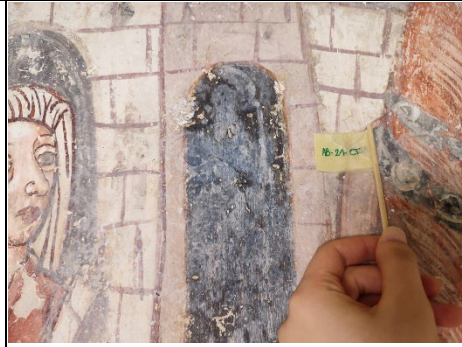
<p>gra_csh_nw_a_vis_20220908_AB_16_CT_3</p>
	AB-17-CT	AG2	1. Gel/ 2 min 2. Cleaning with cotton swab (water)/ 10 min	White veil and whitewash	No result for the white veil and whitewash, but it weakens the pigments (too aggressive).

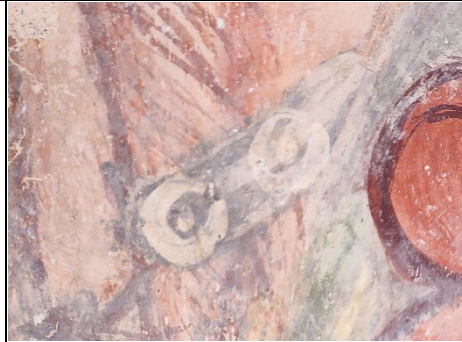
<p>gra_csh_nw_a_vis_20220908_AB_17_CT_3</p>
	AB-18-CT	AG2	1. Gel/ 4 min 2. Cleaning with cotton swab (water)/ 10 min	White veil and whitewash	No result for the white veil and whitewash, but it weakens the pigments (too aggressive).

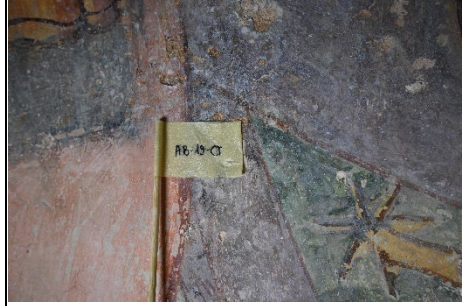
<p>gra_csh_nw_a_vis_20220908_AB_19_CT_2</p>

<p>gra_csh_nw_a_vis_20220908_AB_18_CT_2</p>
	AB-19-CT	AG2	1. Gel/ 5 min 2. Cleaning with cotton swab (water)/ 10 min	White veil and whitewash	No result for the white veil and whitewash, but it weakens the pigments (too aggressive).

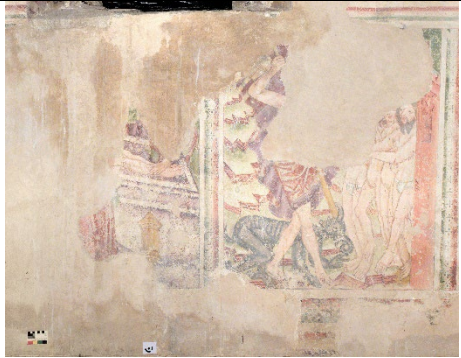
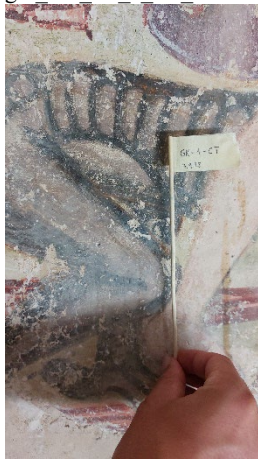
GROUP NUMBER	TEST TRIAL NUMBER	MATERIAL CODE	APPLICATION/ CONTACT TIME	COMMENTS		REFERENCE PHOTOS
				PROBLEM	RESULT	
4/sw	MP - 1 - CT	AB4 AB5	<ol style="list-style-type: none"> 1. Japanese paper 1x 2. Poultice/30min Paste/10min 3. Water rinsing over JP, removal of JP 4. Cleaning with sponge (water) 5. Removal of Limewash with scalpel 	Dirt White veil Limewash	White veil appearance softened, limewash softened and removable with scalpel.

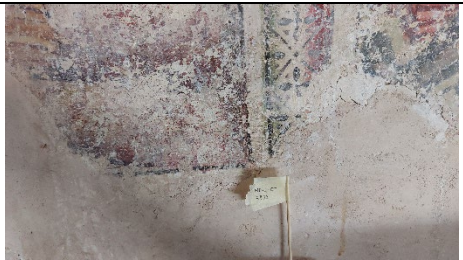
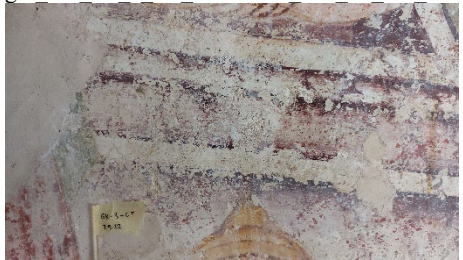
<p>gra_csh_sw_a_vis_20220907_MP_01_CT_3</p>
	MP - 2 – CT	WB3	<ol style="list-style-type: none"> 1. Japanese paper 1x 2. Poultice/30min 3. Water rinsing over JP, removal of JP 4. Cleaning with sponge (water) 	Dirt White veil Limewash	White veil appearance softened, limewash softened and removable with scalpel.	<p>gra_csh_sw_a_vis_20220907_MP_01_CT_1</p>

MP - 3 - CT	W1		<ol style="list-style-type: none"> 1. Japanese paper 1x 2. Poultice/30min 3. Water rinsing over JP, removal of JP 4. Cleaning with sponge (water) 5. Removal of Limewash with scalpel 	Dirt White veil Limewash	White veil appearance softened, limewash softened and removable with scalpel, but hardened again quickly.	<p>gra_csh_sw_a_vis_20220907_MP_02_CT_3</p>

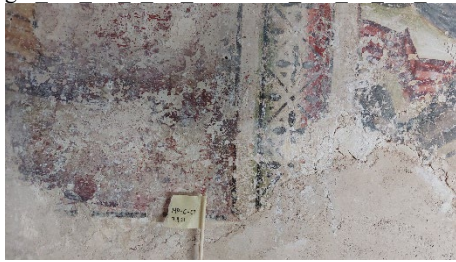
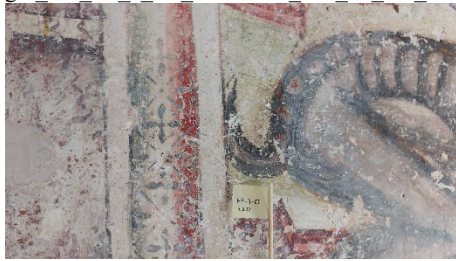
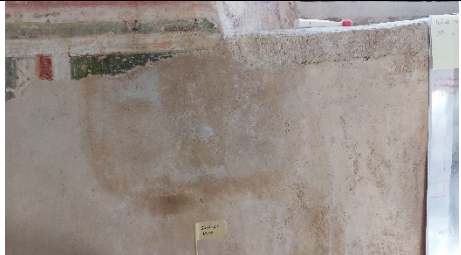
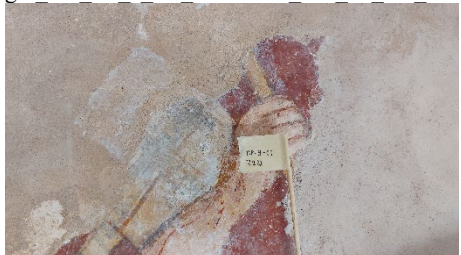
gra_csh_sw_a_vis_20220907_MP_05_CT_3
MP - 6 – CT	AB5	<ol style="list-style-type: none"> 1. Japanese paper 1x 2. Paste/10min 3. Water rinsing over JP, removal of JP 4. Cleaning with sponge (water) 5. Removal of Limewash with scalpel 	Dirt White veil Limewash	White veil appearance softened, limewash softened and is removable with scalpel.	gra_csh_sw_a_vis_20220907_MP_01_CT_1

gra_csh_sw_a_vis_20220907_MP_06_CT_3
MP - 7 – CT	IER1	<ol style="list-style-type: none"> 1. Japanese paper 1x 2. Paste/1st Half 15min, 2nd Half 30min 3. Water rinsing over JP, removal of JP 4. Cleaning with sponge (water) 5. Removal of Limewash with scalpel 	Dirt White veil Limewash	White veil disappeared, limewash softened and is removable with scalpel. No difference between contact times.	gra_csh_sw_a_vis_20220907_MP_01_CT_1

gra_csh_sw_a_vis_20220907_MP_07_CT_3
MP - 8 – CT	AB4	<ol style="list-style-type: none"> 1. Japanese paper 1x 2. Poultice/24h 3. Cleaning with brush 	Salts within wall Water stains on plaster	Appearance of salts on the surface, easily removable with a brush.	gra_csh_sw_a_vis_20220907_MP_01_CT_1

<p>gra_csh_sw_a_vis_20220907_MP_08_CT_3</p>
MP - 9 – CT	AB1	<ol style="list-style-type: none"> 1. Japanese paper 1x 2. Poulitice/30min 3. Water rinsing over JP, removal of JP 4. Cleaning with sponge (water) 	Dirt White veil Limewash Salts within wall Water stains on plaster	Appearance of salts on the surface.

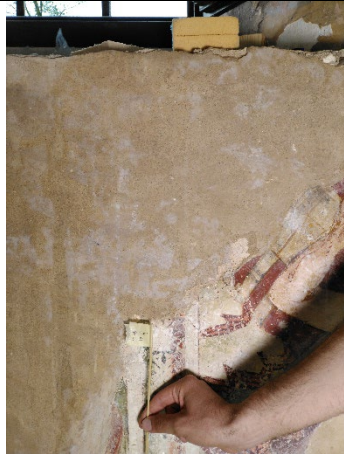
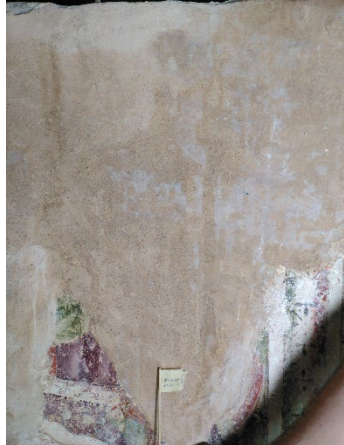
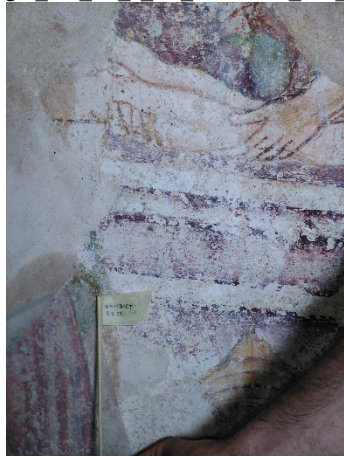
MP - 16 – CT	W1	<ol style="list-style-type: none"> 1. Japanese paper 1x 2. Poultice/24h (foil over poultice) 3. Water rinsing over JP, removal of JP 	<p>Salts within wall</p> <p>Water stains</p>	<p>Appearance of salts on the surface.</p> <p>Easily removable by brush.</p>	<p>gra_csh_sw_a_vis_20220908_MP_15_CT_3</p> <p>gra_csh_sw_a_vis_20220907_MP_01_CT_1</p>

MP - 17 – CT	W3	<ol style="list-style-type: none"> 1. Japanese paper 1x 2. Poultice/24h (Sepiolite in water over poultice, separated by Japanese paper) 	<p>Salts within wall</p> <p>Water stains</p>	<p>Appearance of salts on the surface.</p> <p>Easily removable by brush.</p>	<p>gra_csh_sw_a_vis_20220908_GK_16_CT_3</p> <p>gra_csh_sw_a_vis_20220907_MP_01_CT_1</p>

MP - 19 – CT	IER1	<ol style="list-style-type: none"> 1. Japanese paper 1x 2. Paste/1st Half 10min 3. Water rinsing over JP, removal of JP 4. Cleaning with sponge (water) 	<p>Dirt White veil Limewash</p>	<p>White veil appearance softened, limewash softened and is removable with scalpel.</p>	<p>gra_csh_sw_a_vis_20220908_GK_18_CT_3 gra_csh_sw_a_vis_20220907_MP_01_CT_1</p>

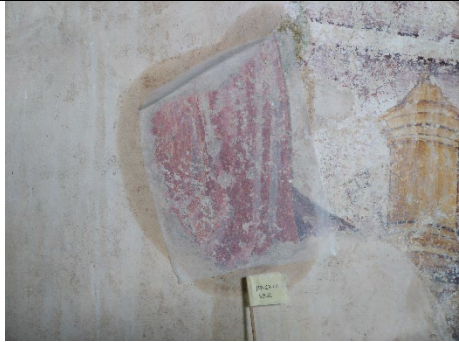
<p>gra csh sw a vis 20220909 MP 23 CT 2</p>
--	--	--	--	--	--	---

MP - 23 - CT	AB4 IER1	1. Japanese paper 2x 2. Poultice/15min Paste/15min 3. Water rinsing over JP, removal of JP	Dirt White veil Limewash		gra_csh_sw_a_vis_20220907_MP_01_CT_1

<ol style="list-style-type: none"> 4. Cleaning with sponge (water) 5. Removal of Limewash with scalpel 6. Japanese paper 1x (water)

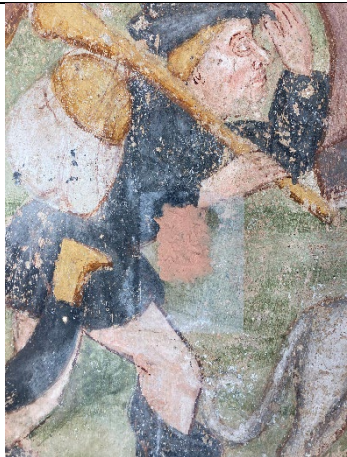
MB-3-CT	IER1	<ol style="list-style-type: none"> 1. Japanese paper applied with H₂O 2. Paste; 3x wetting; contact time 30 min 3. Removal of JP 4. Cleaning with cotton swab (water) 	White veil	White veil was slightly reduced but less than MB-1-CT.

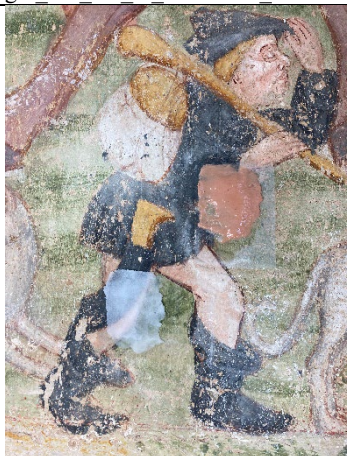
<p>gra csh nw in MB-3-CT 20220907 la_002</p>
	MB-4-CT	AB5	<ol style="list-style-type: none"> 1. Direct application of paste; contact time 10 min 2. Removal of paste and rinsing with H₂O and cotton swab 	White veil	White veil was not reduced.

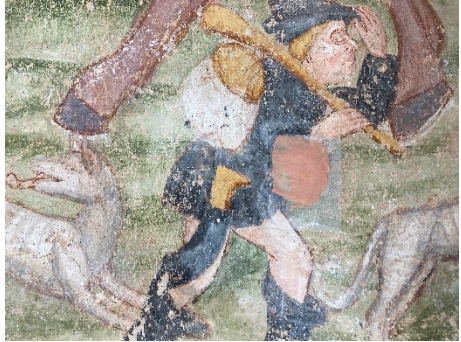
MB-5-CT	AG6	<ol style="list-style-type: none"> 1. Direct application of hardened gel; contact time 10 min 2. Removal of gel and rinsing with H₂O and cotton swab 	White veil	White veil was not reduced.

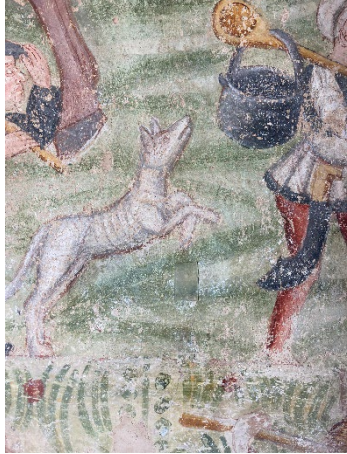
<p>gra csh nw in MB-6-CT 20220908 la 002</p>

<p>gra csh nw in MB-5-CT 20220907 la 002</p>
	MB-6-CT on MB-2-CT area	AG6	<ol style="list-style-type: none"> 1. Direct application of hardened gel; contact time 10 min 2. Removal of gel and rinsing with H₂O and cotton swab 	White veil, limewash	White veil was not reduced and limewash was not weakened.

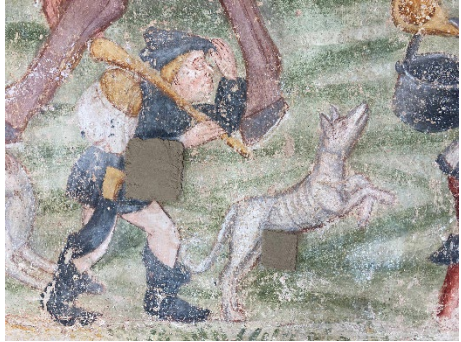
Deterioration phenomenon	Test trial number	Material code + application/sequence	Results	Photo reference
White veil and limewash/whitewash residues	AB-13-CT	AB4 1. Japanese paper 1 x 2. Poultice/2h30 3. Cleaning with cotton swab (water)/10 min.	Very good result. Limewash softened, good surface cleaning, easily removes white veil.	gra_csh_nw_a_vis_20220912_AB_01_CT_1 gra_csh_nw_a_vis_20220908_AB_13_CT_2 gra_csh_nw_a_vis_20220908_AB_13_CT_3
White veil and limewash/whitewash residues	MB-8-CT	AB1 u. IER1 1. Japanese paper applied with ammonium bicarbonate 2. Poultice/45 min. 3. Removal of poultice and Japanese paper 4. Rinsing with H ₂ O and cotton swab 5. Japanese paper applied with H ₂ O	White veil was strongly reduced; limewash was easier to remove; The saturation of the colour is higher and the surface seems to be clean; very little residues of the red and yellow pigments visible on the cotton swab after treatment.	gra_csh_nw_in_MB-8-CT_20220908_la_002

<p>gra csh nw in MB-7-CT 20220908 la 002</p>
	MB-8-CT	AB1 IER1	<ol style="list-style-type: none"> 1. Japanese paper applied with ammonium bicarbonate 2. Poultice/45 min 3. Removal of poultice and JP 4. Rinsing with H₂O and cotton swab 5. Japanese paper applied with H₂O 6. Resin paste; 3x wetting; contact time 30 min 7. Removal of paste and rinsing with H₂O and cotton swab 	White veil, limewash	White veil was strongly reduced; limewash was easier to remove. The saturation of the colour is higher and the surface seems to be clean. Very little residues of the red and yellow pigments visible on the cotton swab after treatment.

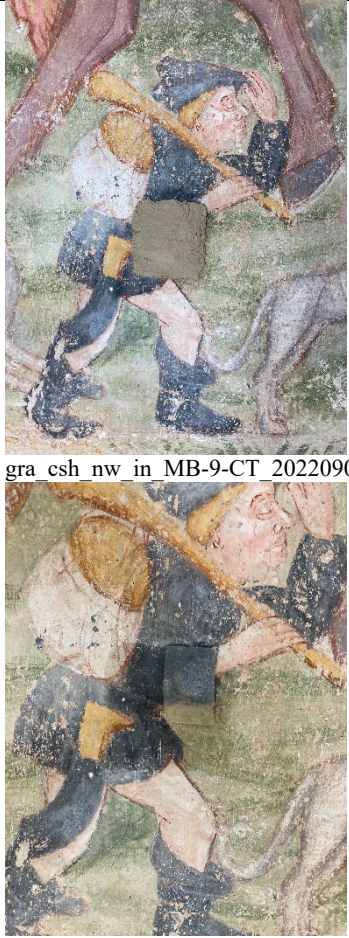
<p>gra csh nw in MB-9-CT 20220908_la_002</p> <p>gra csh nw in MB-9-CT 20220908_la_02.1</p>
------	---------	------------	---	-------------------------------	---	---

5/nw	MB-9-CT	AB1 AG6	<ol style="list-style-type: none"> 1. Japanese paper applied with ammonium bicarbonate 2. Poultice/45 min 3. Removal of poultice and JP 4. Rinsing with H₂O and cotton swab 5. Direct application of hardened gel; contact time 10 min 6. Rinsing with H₂O and cotton swab 	White veil, limewash residues	White veil was slightly reduced, limewash was easier to remove.

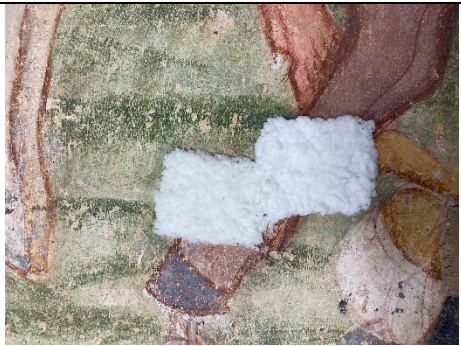
5/nw	MB-10-CT	AB3	<ol style="list-style-type: none"> 1. Japanese paper applied with ammonium bicarbonate 2. Poultice/ 45 min 3. Removal of poultice and JP 4. Rinsing with H₂O and cotton swab 	Limewash	Limewash was very easy to remove due to swelling.
