REPORT: INTERNATIONAL 2022 SUMMER SCHOOL GRADIŠČE PRI DIVAČI (SLOVENIA)

CHURCH OF ST. HELEN
CONSERVATION-RESTORATION OF WALL
PAINTINGS

VOLUME 2 FINAL REPORT

FINAL REPORT

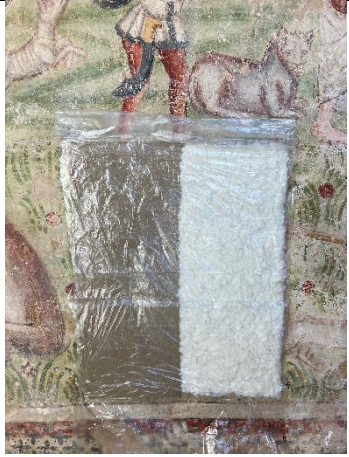
<p>gra_csh_nw_in_MB-12-CT_20220908_la_002</p>

<p>gra_csh_nw_in_MB-11-CT_20220908_la_002</p>
5/nw	MB-12-CT	AB1 IER1	<ol style="list-style-type: none"> 1. 2x Japanese paper applied with ammonium bicarbonate 2. Poultice/ 45 min 3. Removal of poultice and JP 4. Rinsing with H₂O and cotton swab 5. Japanese paper applied with H₂O 6. Resin applied by brush; 3x wetting; contact time 30 min 7. Removal of paste and rinsing with H₂O and cotton swab 	Limewash, white veil	Limewash was swollen and it was able to remove it mechanically. The white veil was reduced but reappeared in some areas. The trial area was too large to fully remove the limewash residues.
